Report Type: Closure Report

Site:	Berry A #33				
Company:	Alamo Permian Resources LLC				
Section, Township and Range	Unit K	Sec. 24	T-17-S	R-27-E	
Lease Number:	API 30-015-25154				
County:	Eddy County				
GPS:	32.81698° N			104.23447° W	
Surface Owner:	Federal				
Mineral Owner:					
Directions:	From NM-82 and Hwy 360, travel west 4.5 miles to Crane Road. Turn right 0.1 miles to Southern Union, Turn right 0.1 to location on right.				
	JRA-881		JRA-891

Re: Closure Report for the Alamo Permian Resources LLC., Berry A #33, Tank Battery, Unit K, Section 24, Township 17 South, Range 27 East, Eddy County, New Mexico.

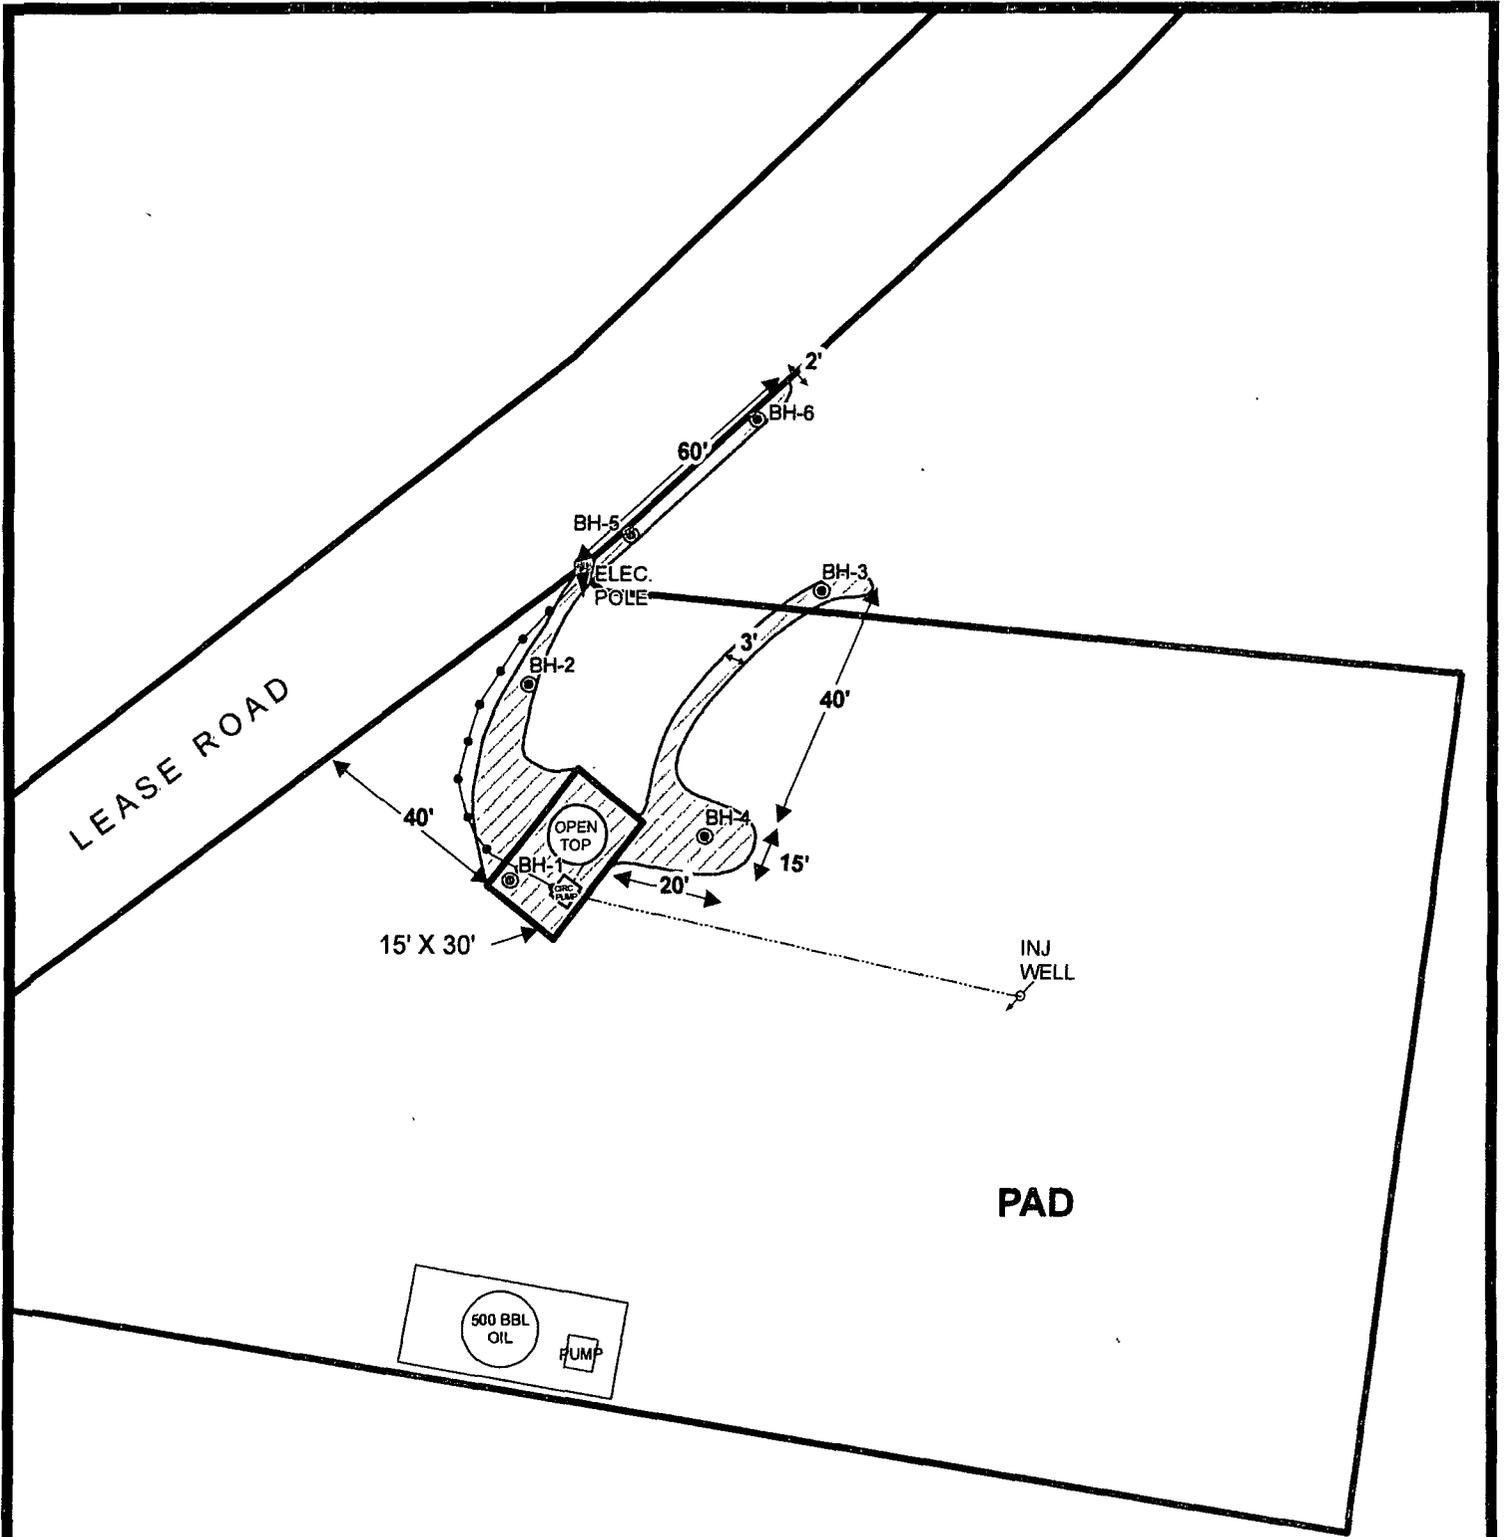
Referring to Table 1, all submitted samples were below the RRAL for TPH and BTEX. Elevated chloride concentrations were detected in BH-1, BH-2, and BH-4. Borehole (BH-1) located inside the berm area had chloride

concentrations ranging from 1,010 mg/kg at 6-7' bgs to 14,200 mg/kg at 14-15' bgs. Chloride concentrations had a significant decrease to 1,480 mg/kg at 29-30' bgs and declined to <200 mg/kg at 39-40' bgs.

Boreholes (BH-2 and BH-4) were installed outside of the berm area on the east and west side, respectively. BH-2, west of berm area had chloride concentrations ranging from 2,800 mg/kg at 9-10' bgs to 15,100 mg/kg at 0-1' bgs. BH-2 was vertically defined with a chloride concentration of 291 mg/kg at 24-25' bgs. BH-4, east of the berm had chloride concentrations ranging from 771 mg/kg at 6-7' bgs to 12,200 mg/kg at 14-15' bgs. BH-4 was vertically defined with a chloride concentration of 256 mg/kg at 39-40' bgs.

At BH-3, a chloride concentration spike was detected at 6-7' bgs of 3,050 mg/kg. Samples above at 4-5' (482 mg/kg) and below at 9-10' (386 mg/kg) did not show a significant impact. The detected chloride spike does not appear to be an environmental concern.

ALAMO PERMAIN RESOURCES	
Figure 3	
Berry A #33	
Spill Assessment Map	
Eddy County, New Mexico	
Project : 114-6401102	
Date : 2/8/2012	
File : H:\GIS\6401102

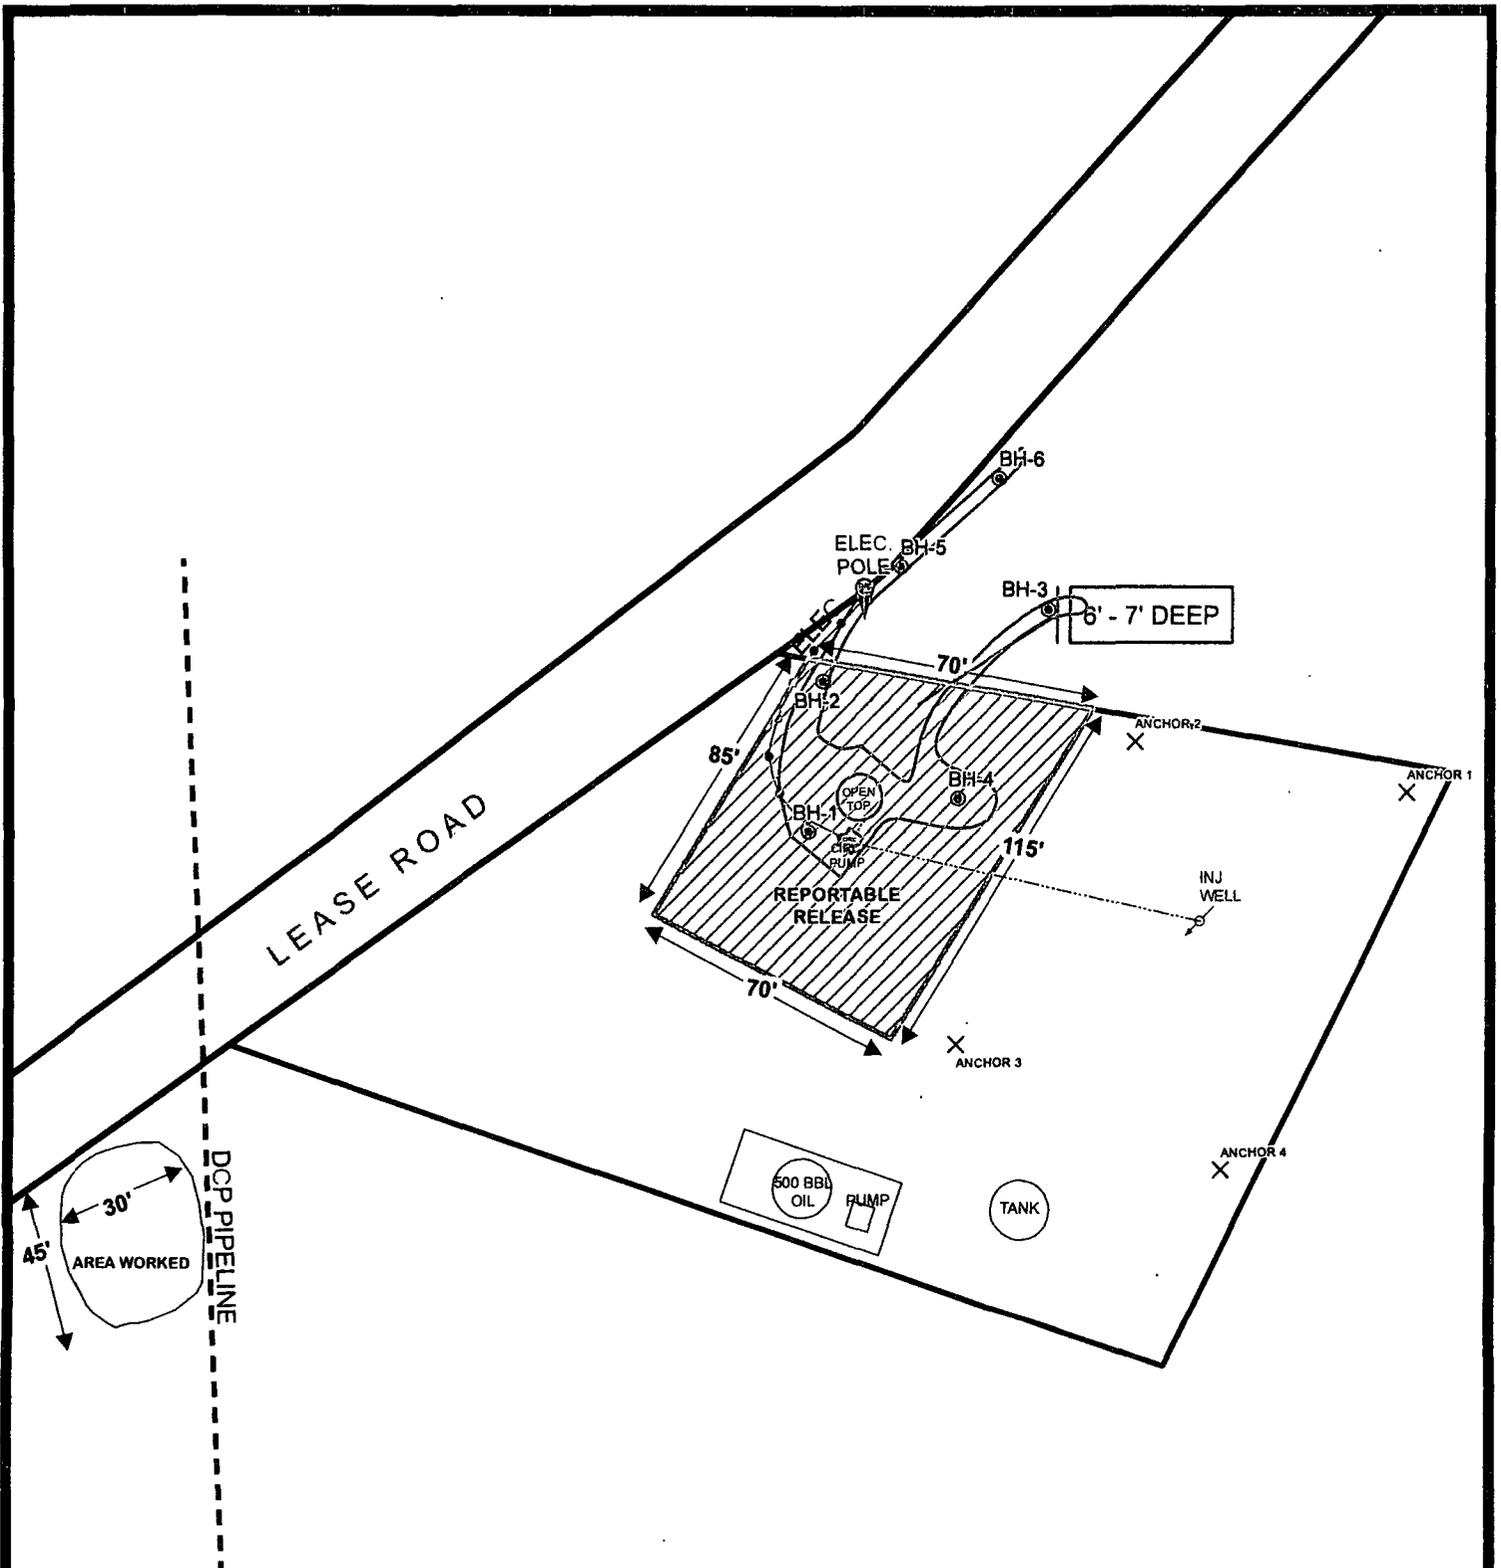
ALAMO PERMAIN RESOURCES	
Figure 4	
Berry A #33	
Excavation Areas & Depths Map	
Eddy County, New Mexico	
Project : 114-6401102	
Date : 2/8/2012	
File : H:\GIS\6401102

March 2012, Tetra Tech personnel supervised the excavation as outlined in the previously submitted and approved work plan. The excavation depths proposed in the work plan were not achieved due to the dense formation encountered at approximately 6.0' below surface. Tetra Tech contacted the NMOCD and BLM to discuss the excavation difficulties at the site. Both agencies approved the excavation depth of 6.0' and capping the remaining impact with a 40 mil liner. Once completed, the liner was placed in the excavation bottom at 4.0' below surface and backfilled with clean material to grade. Approximately 1,300 yards³ of material were removed and disposed of at Gandy Marley Inc. The excavated area and depth are shown on Figure 4.

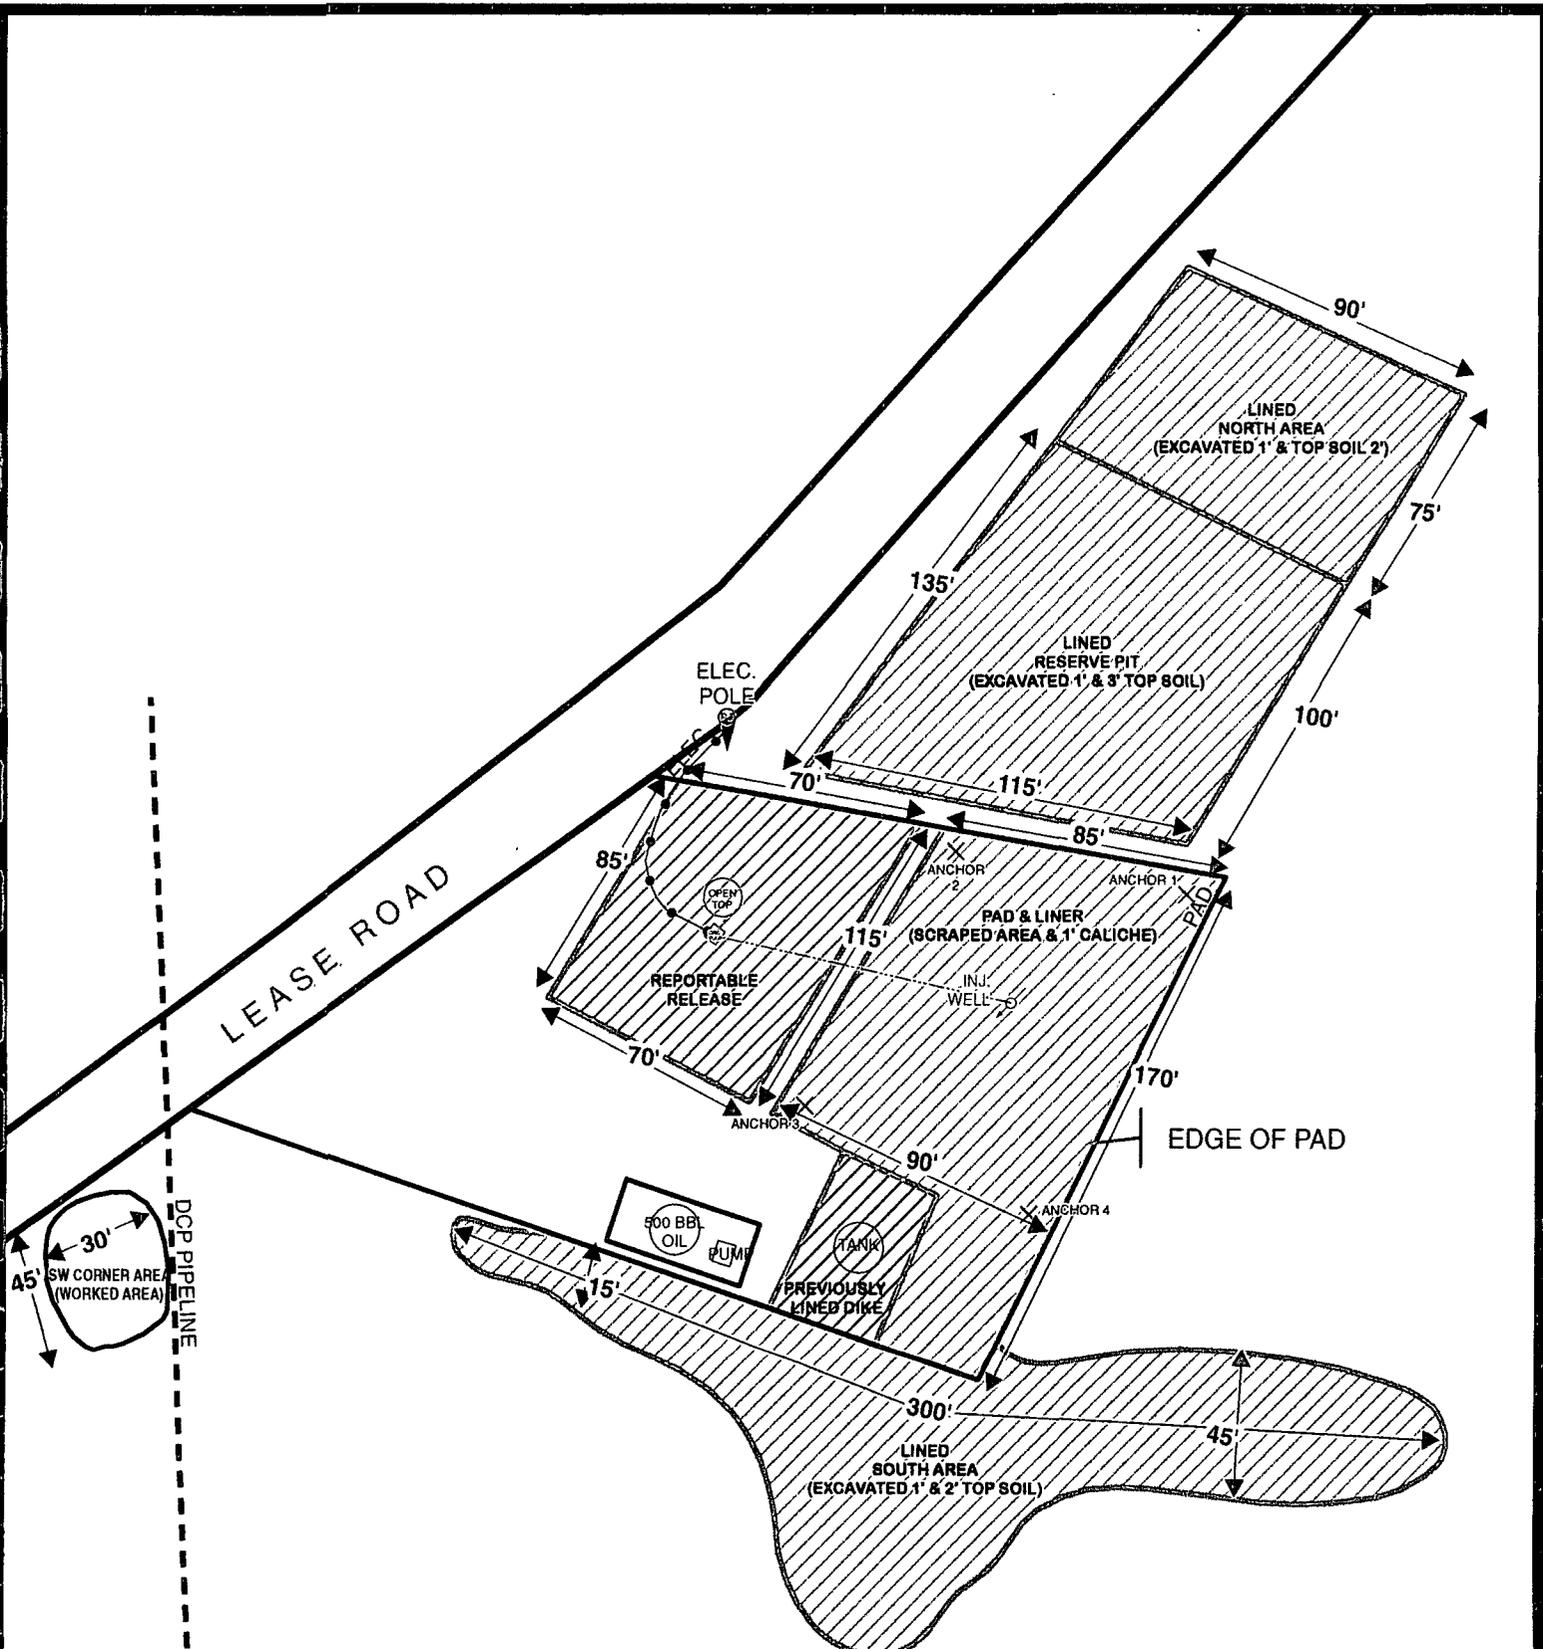
ALAMO PERMAIN RESOURCES	
Figure 5	
Berry A #33	
Excavation Areas & Depths Map	
Eddy County, New Mexico	
Project : 114-6401102	
Date : 2/8/2012	
File : H:\GIS\6401102

At the request of the BLM, additional areas at the facility were addressed as part of the site restoration and cleanup activities (historical spills) at the location. The areas of concern are shown on Figures 5. These areas include the reserve pit, well pad, areas north and south off the pad and the southwest corner off the pad.

As approved by the BLM, the areas were excavated 1.0' below surface and lined with a 20 mil liner and 2.0' to 3.0' of topsoil placed top of the liner, with the exception of the pad area and area southwest corner area off the pad. Due to old spills on the pad, the area around the well was scraped and a 20 mil liner was installed on the pad. Once completed, 1.0' of

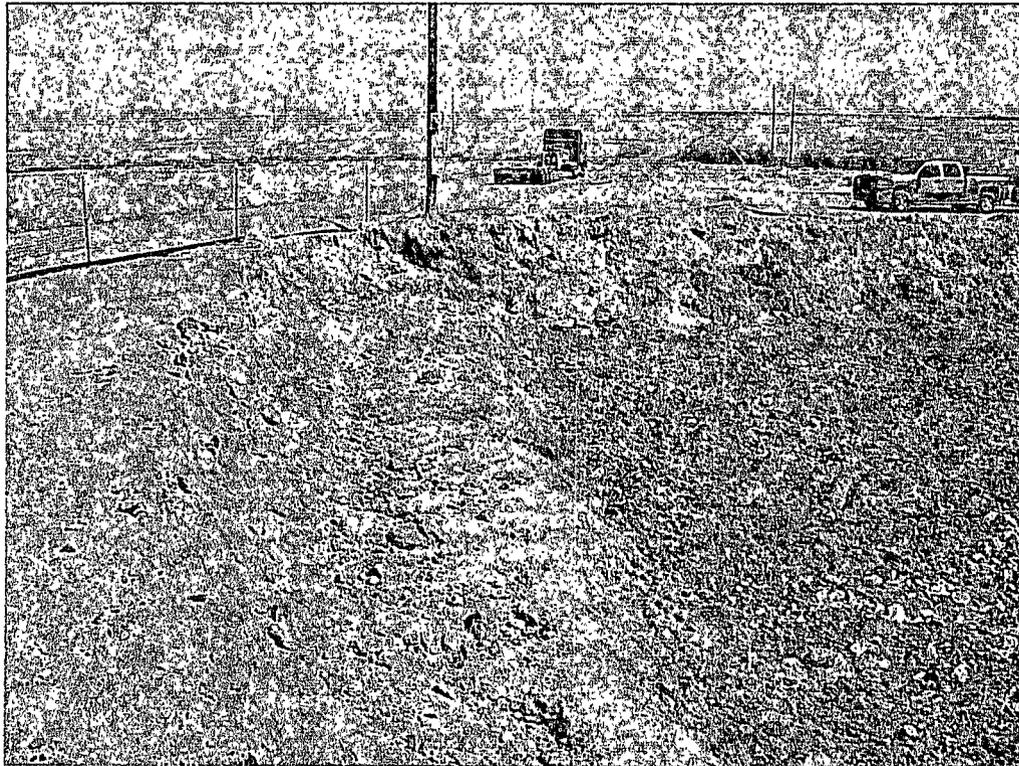
View – excavation of spill area at open top tank

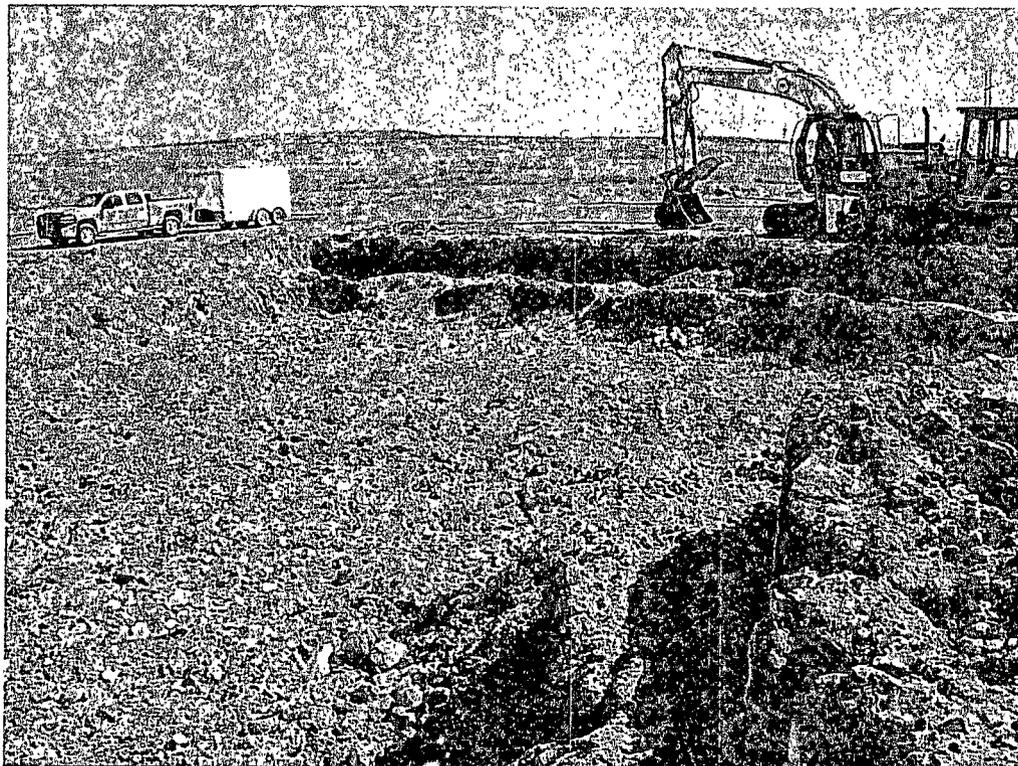
View north – final excavation at open top tank area

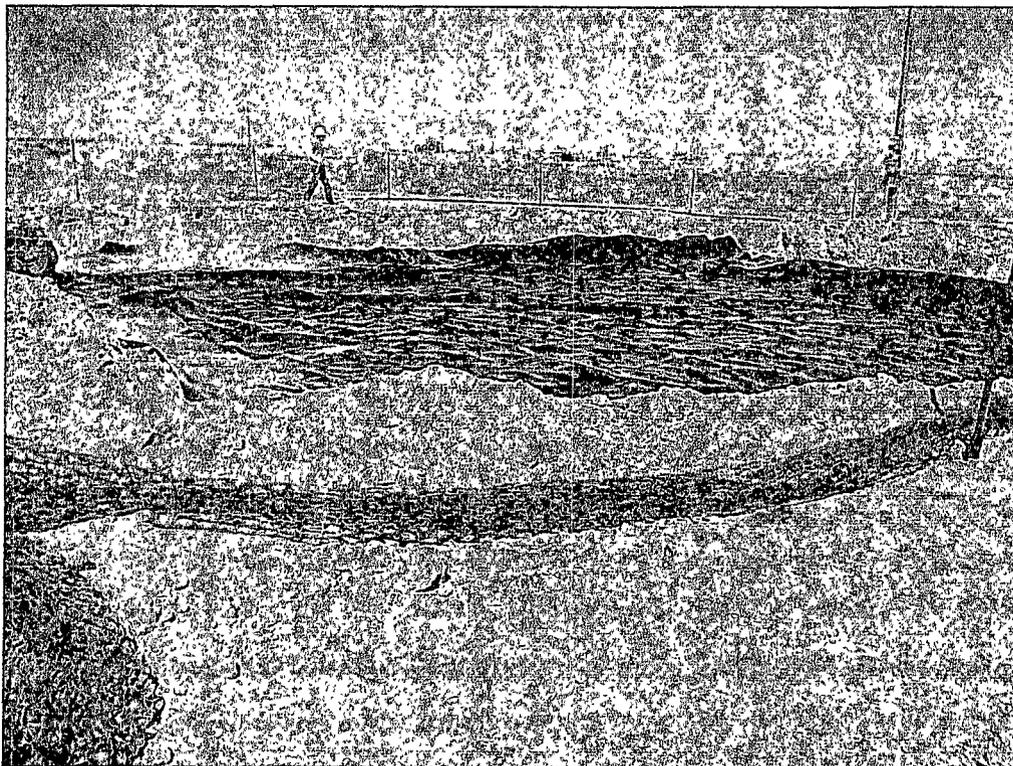
View west – open top tank area, liner and backfilling

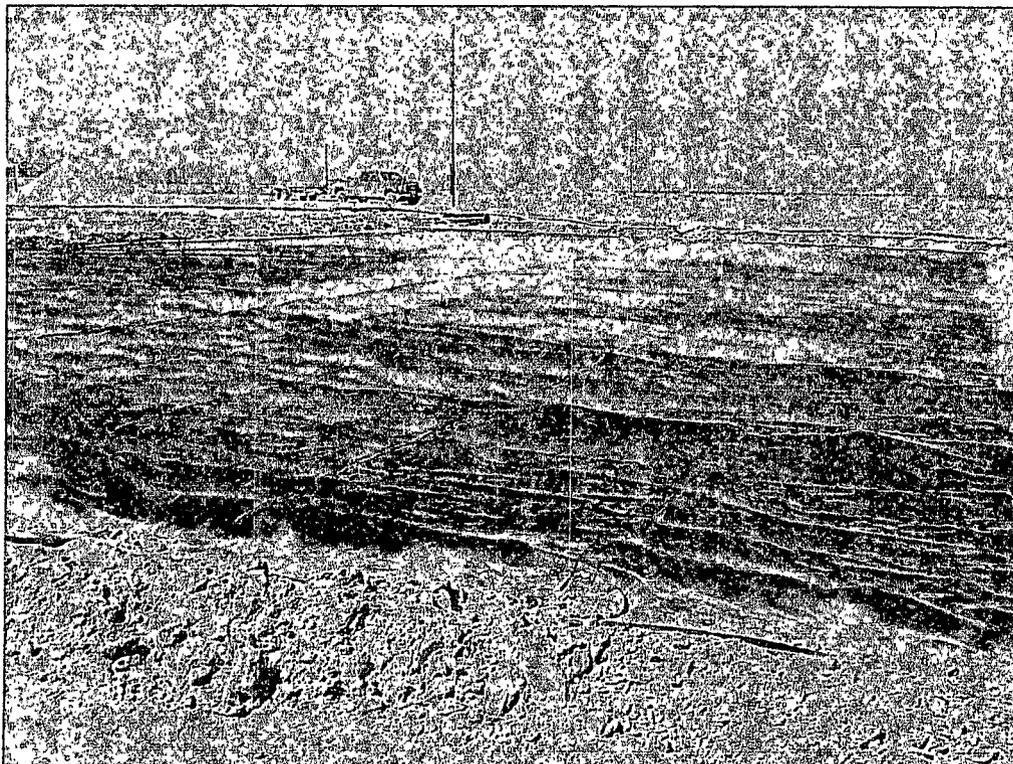
Reserve pit area liner installation

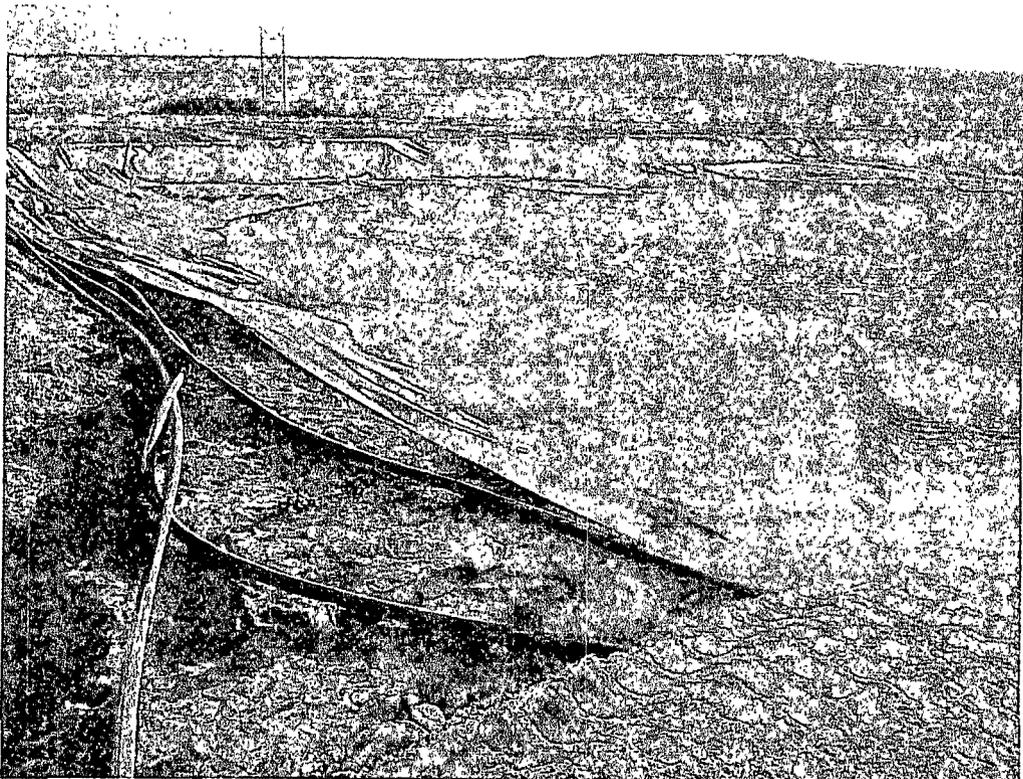
Pad area - 1.0' of caliche material top of liner

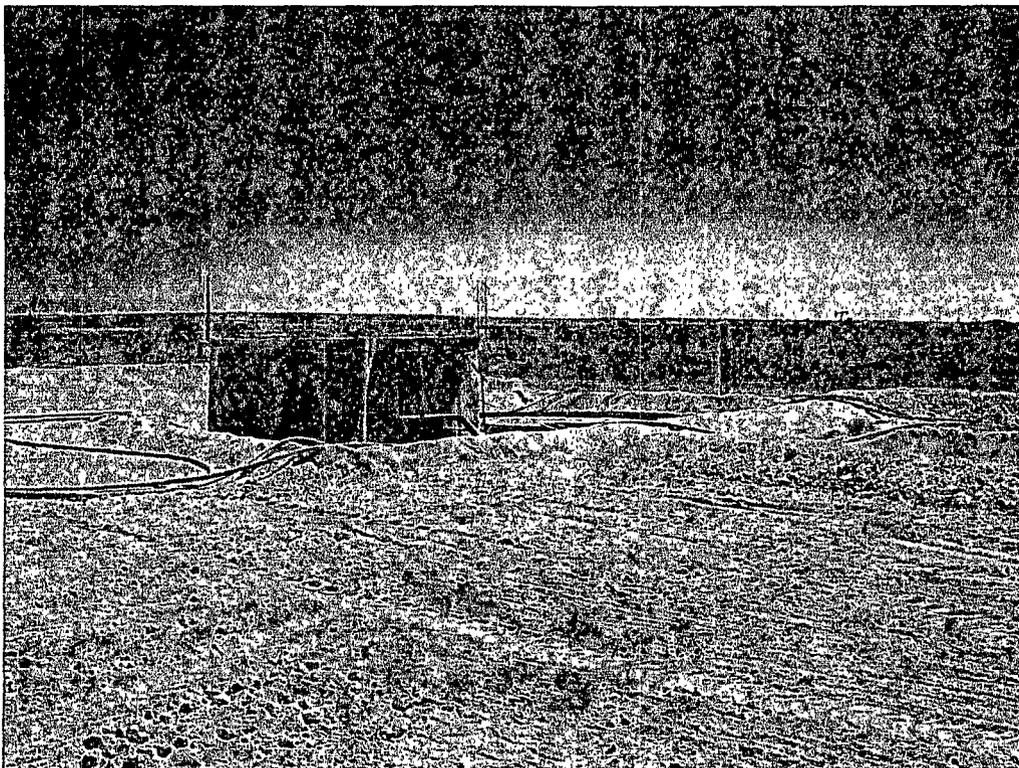
Pad area and new construction of lined area for open top tank
