**Release Notification and Corrective Action**

Name of Company - Clayton Williams Energy, Inc. 25706	Contact - Dave Dunlap
Address - 6 Desta Drive, Ste 2100	Telephone No. 575-390-2062
Facility Name - Jenna Coim	Facility Type - SWD Facility
Surface Owner - BLM	Mineral Owner: BLM
Lease No. 25706

2RP-1816

**Air Photo and Groundwater Elevation**  
**Clayton Williams - Jenna Com 01**

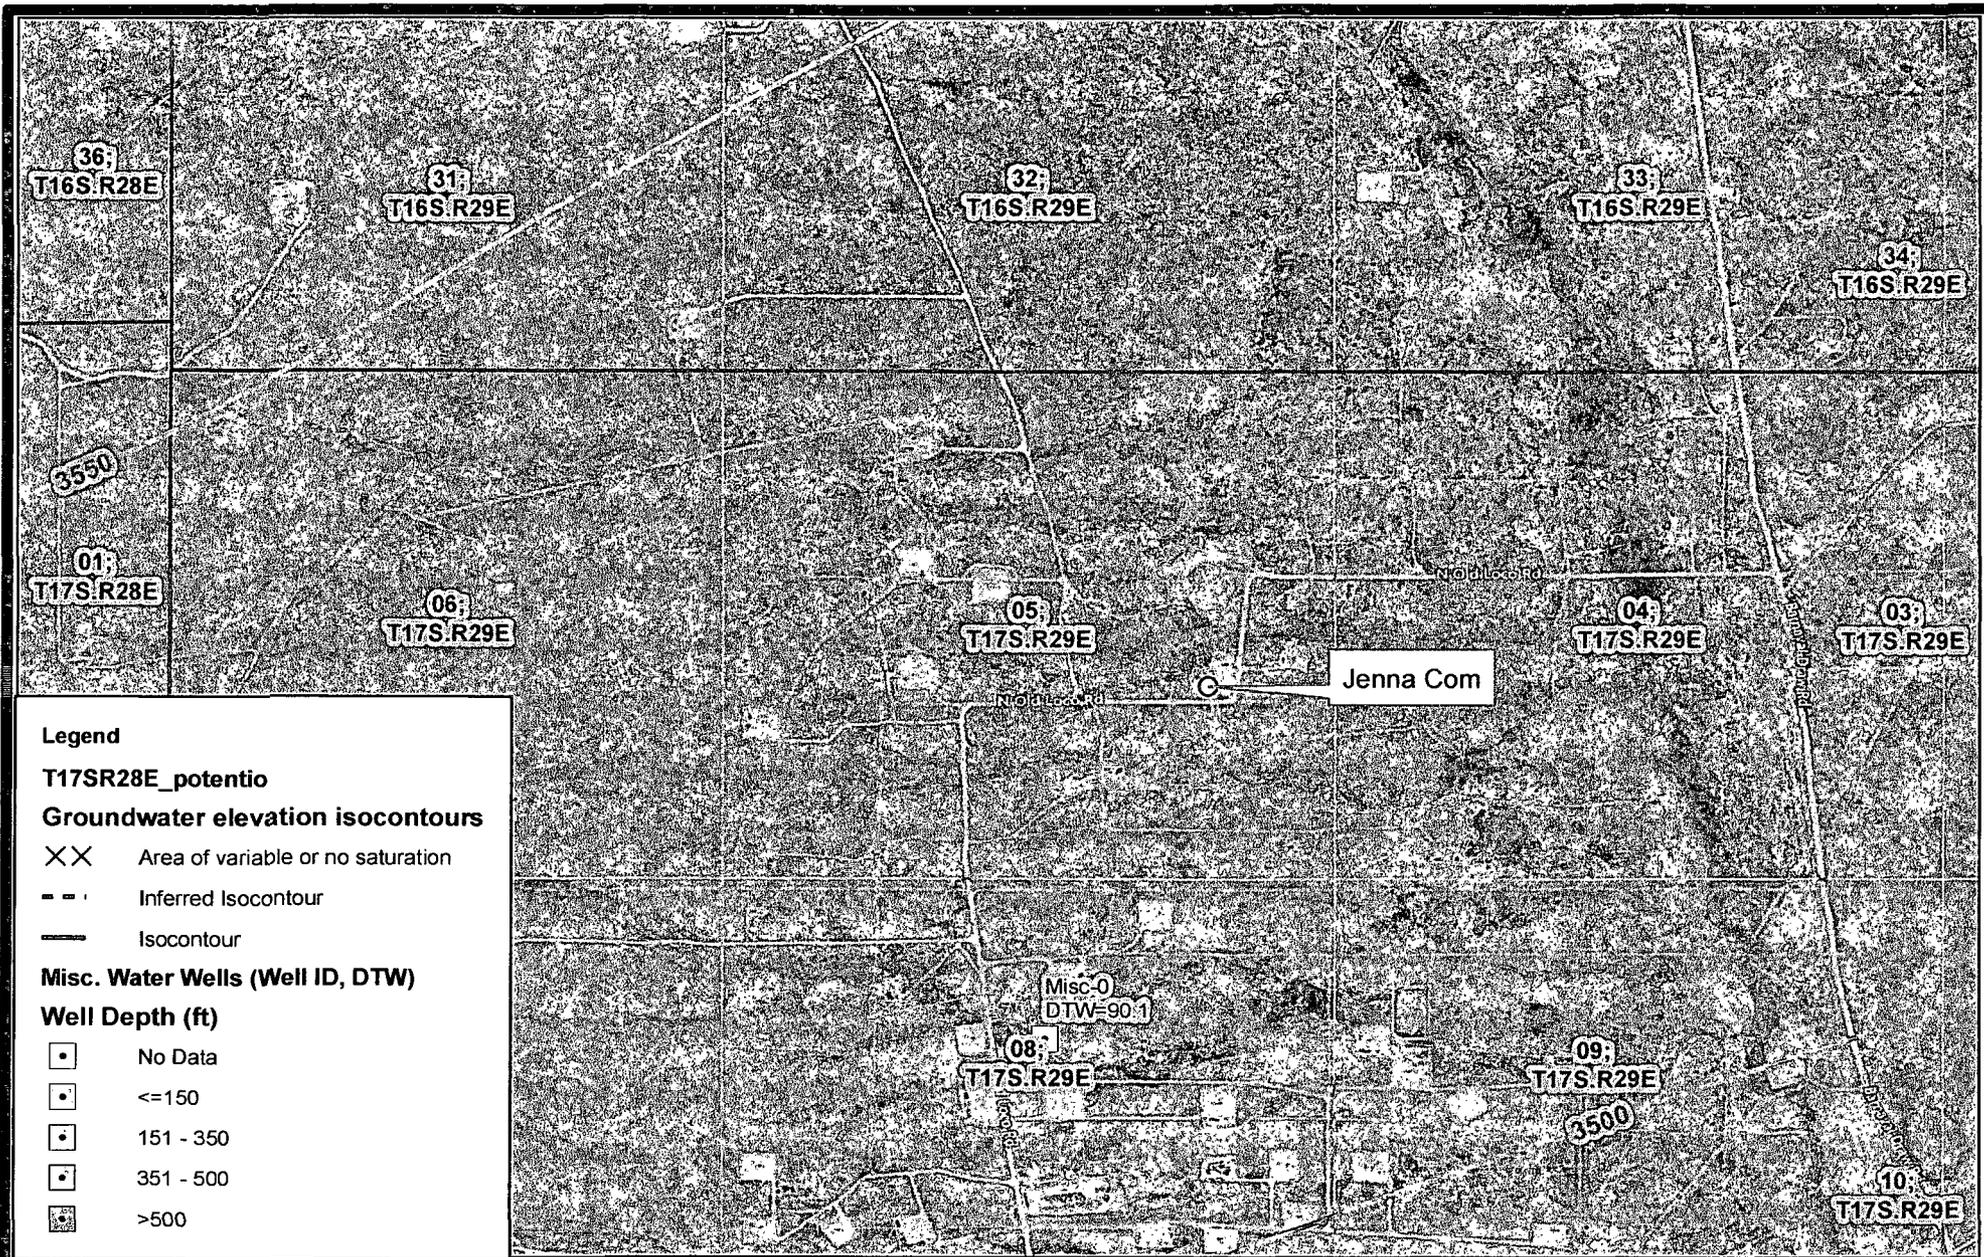
**Figure 1**  
**August 2013**

The attached map shows the location of the site and groundwater elevations determined from measurements of a number of wells in the area between Loco Hills and Artesia. The groundwater elevation beneath the site is about 3525 and the ground elevation is 3604 – thus the depth to water in this area is about 80 feet.
