Report Type: Work Plan

Site:	Resposado 2 State #2H				
Company:	COG Operating				
Section, Township and Range	Unit A	Section 2	T26S	R29E	
Lease Number:	API-30-015-39455				
County:	Eddy County				
GPS:	32.07818° N			103.95021° W	
Surface Owner:	State				
Mineral Owner:					
Directions:	South of Malaga, at the intersection of Hwy 285 and CR 725 (Longhorn Rd). Travel east on CR 725 (Longhorn Rd) for 4.3 miles, turn left and travel 2.7 miles, turn left and travel 1.1 miles to the site on right side of road.

Re: Work Plan for the COG Operating LLC., Resposado 2 State #2H, Well Site, Unit A, Section 2, Township 26 South, Range 29 East, Eddy County, New Mexico.

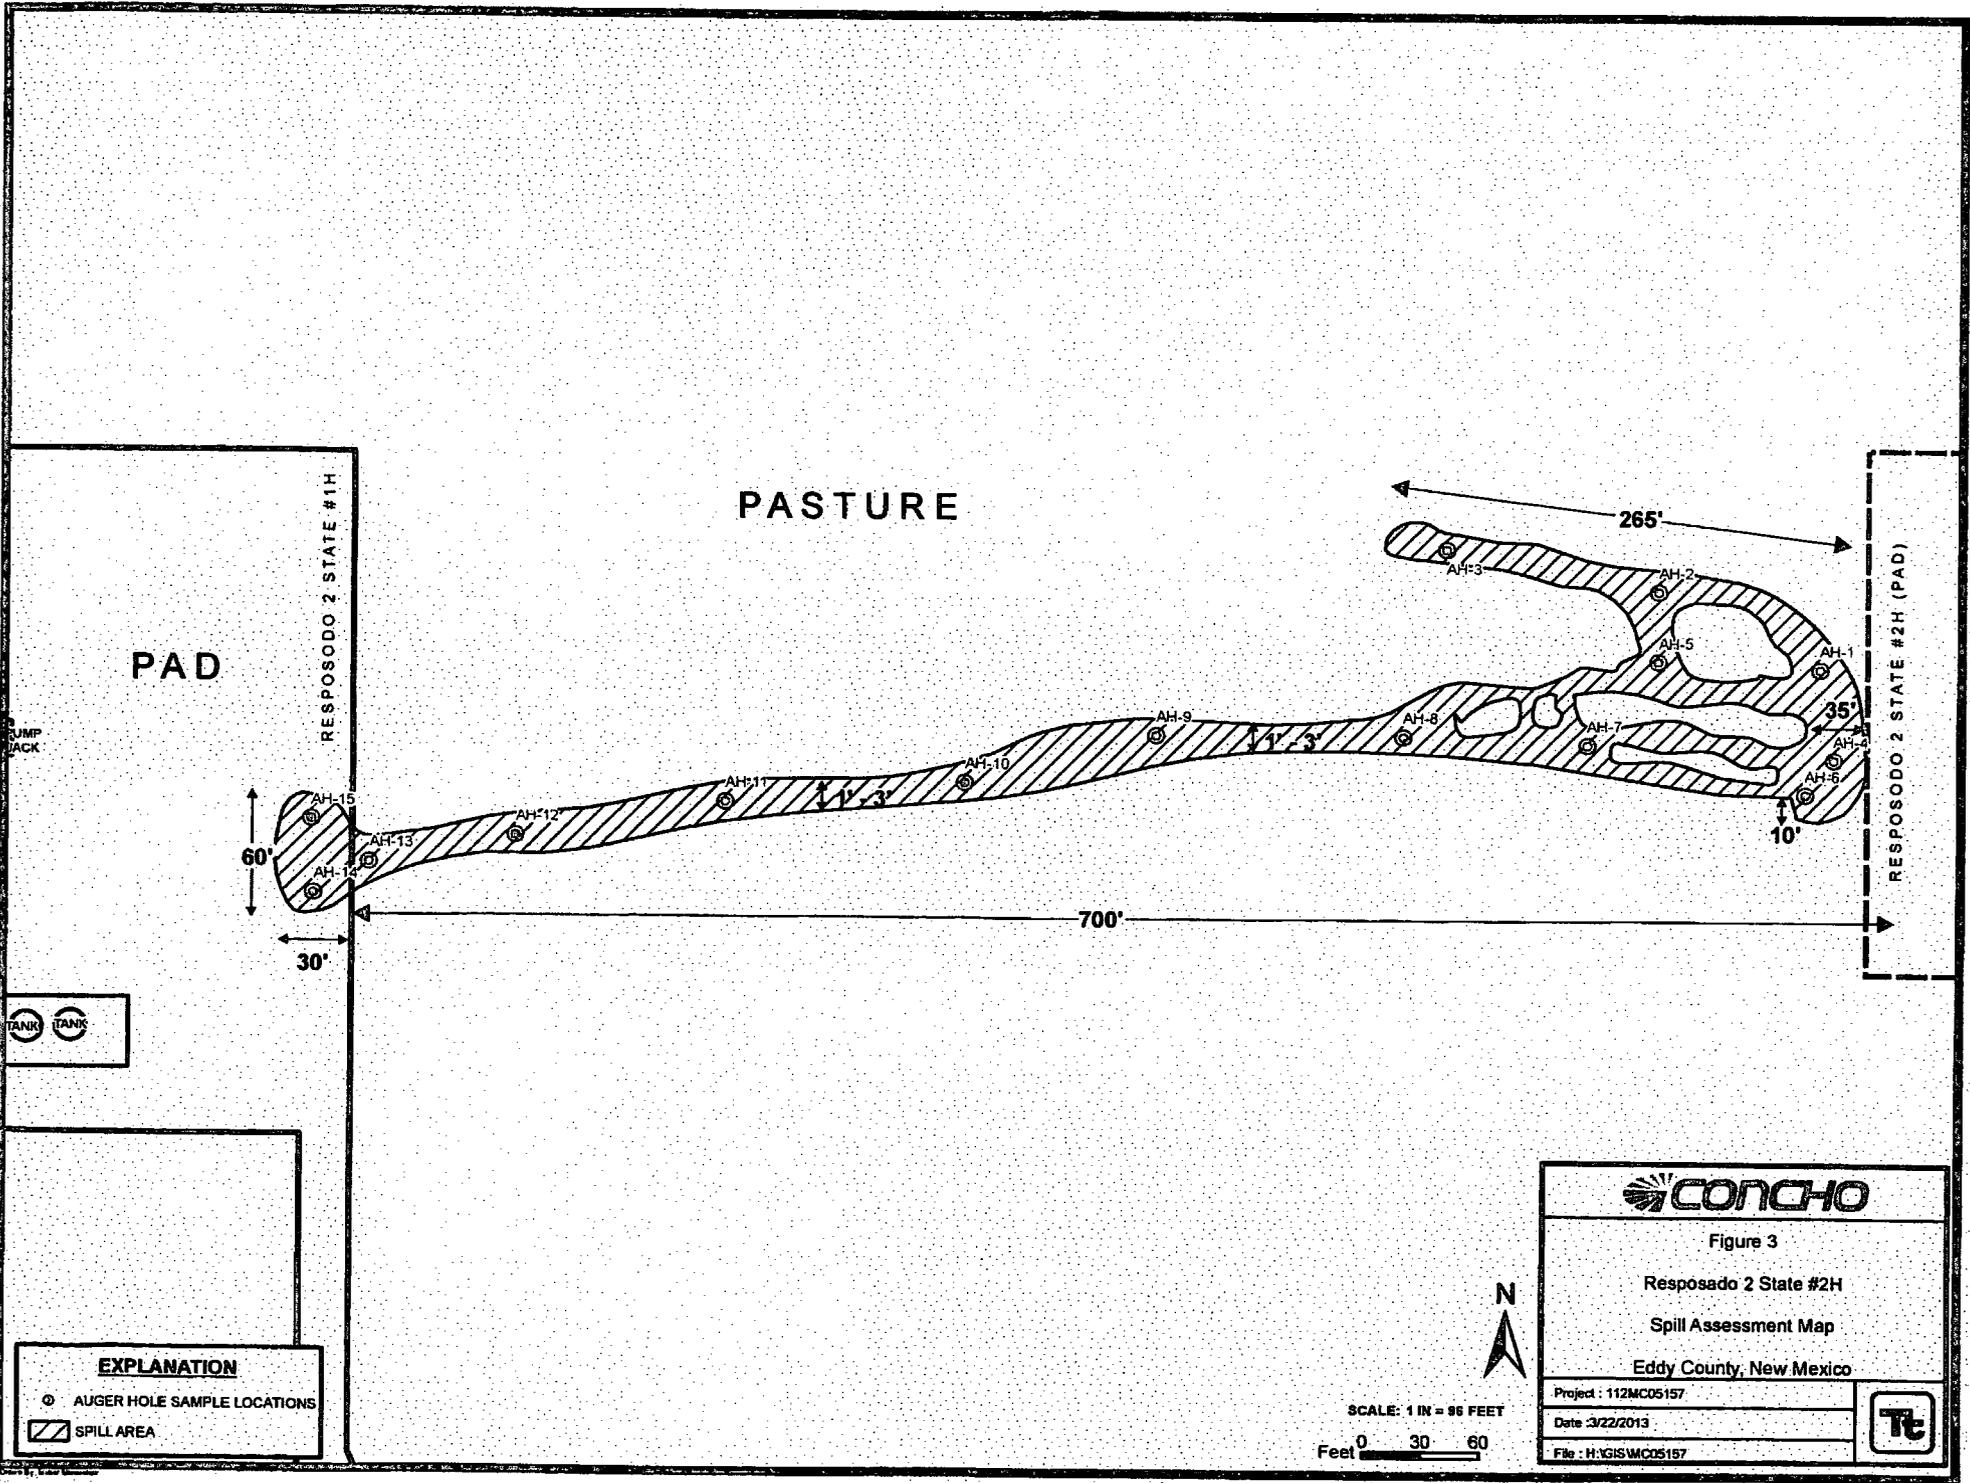
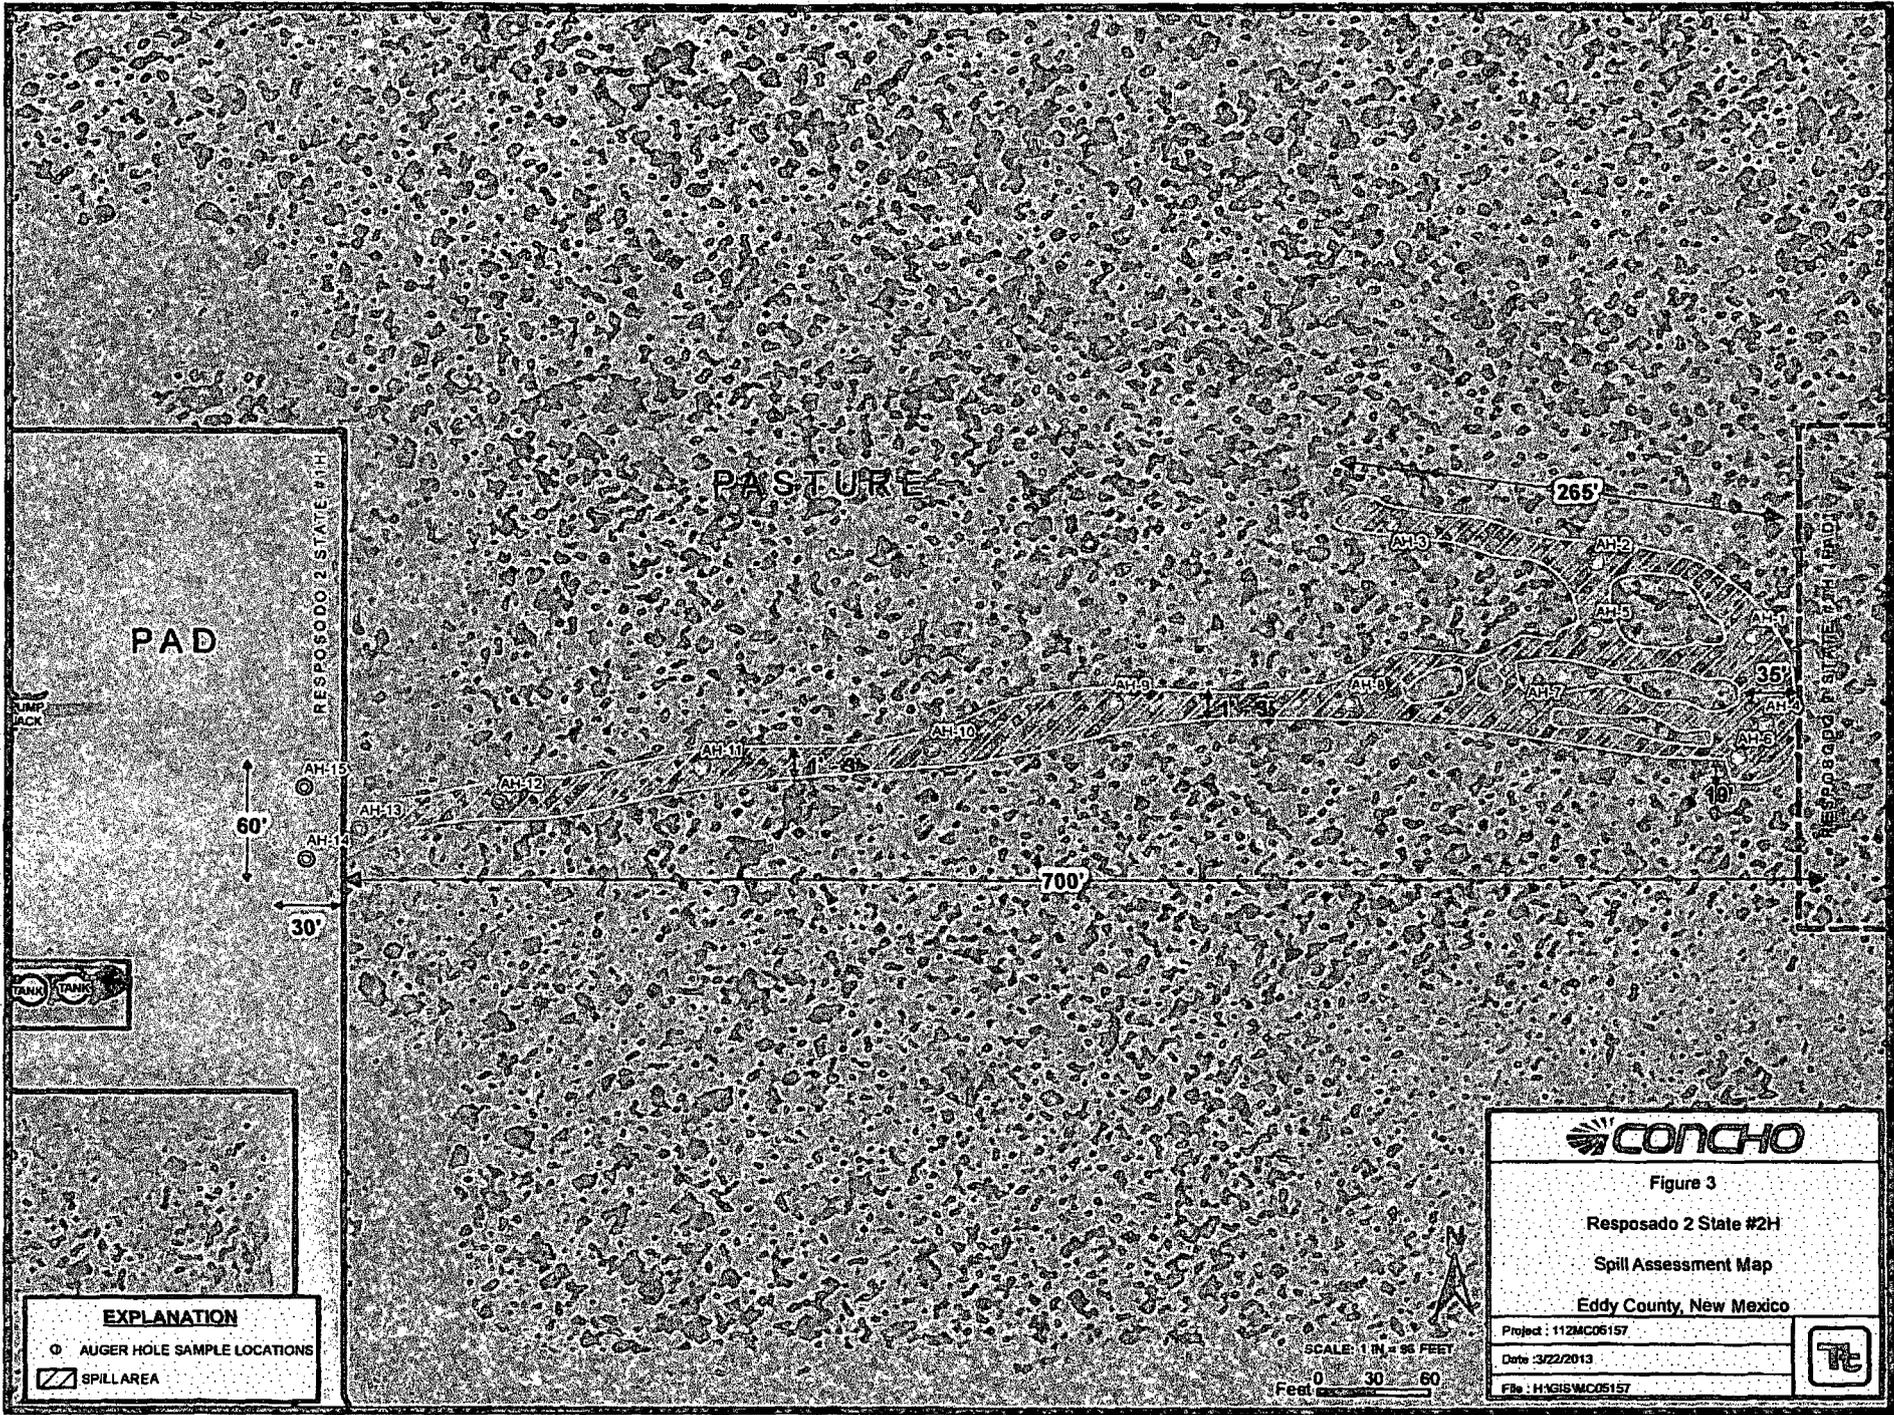
Figure 3
 Resposado 2 State #2H
 Spill Assessment Map
 Eddy County, New Mexico

On March 13, 2013, Tetra Tech personnel inspected and sampled the spill area. A total of fifteen (15) auger holes (AH-1 through AH-15) were installed using a stainless steel hand auger to assess the impacted soils. Selected samples were analyzed for TPH analysis by EPA method 8015 modified, BTEX by EPA Method 8021B and chloride by EPA method 300.0. Copies of laboratory analysis and chain-of-custody documentation are included in Appendix C. The sampling results are summarized in Table 1. The auger hole locations are shown on Figure 3.

Referring to Table 1, none of the samples exceeded the RRAL for TPH and BTEX. The areas of auger holes (AH-7, AH-9, AH-10, AH-11, AH-12, AH-14 and AH-15), the chlorides concentrations did not show a significant impact to the subsurface soil and do not appear to an environmental concern. The remaining areas showed a shallow chloride impact to the soils. Auger holes (AH-1, AH-2, AH-3, AH-6 and H-8) showed chloride concentrations ranging from 1,060 to 1,900 mg/kg at 0-1' and significantly declined with depth at 1-1.5' below surface. In the areas of AH-4, AH-5 and AH-13, the chloride impacted soils were not vertically defined, with concentrations of 1,220 mg/kg, 1,490 mg/kg and 1,690 mg/kg, respectively.

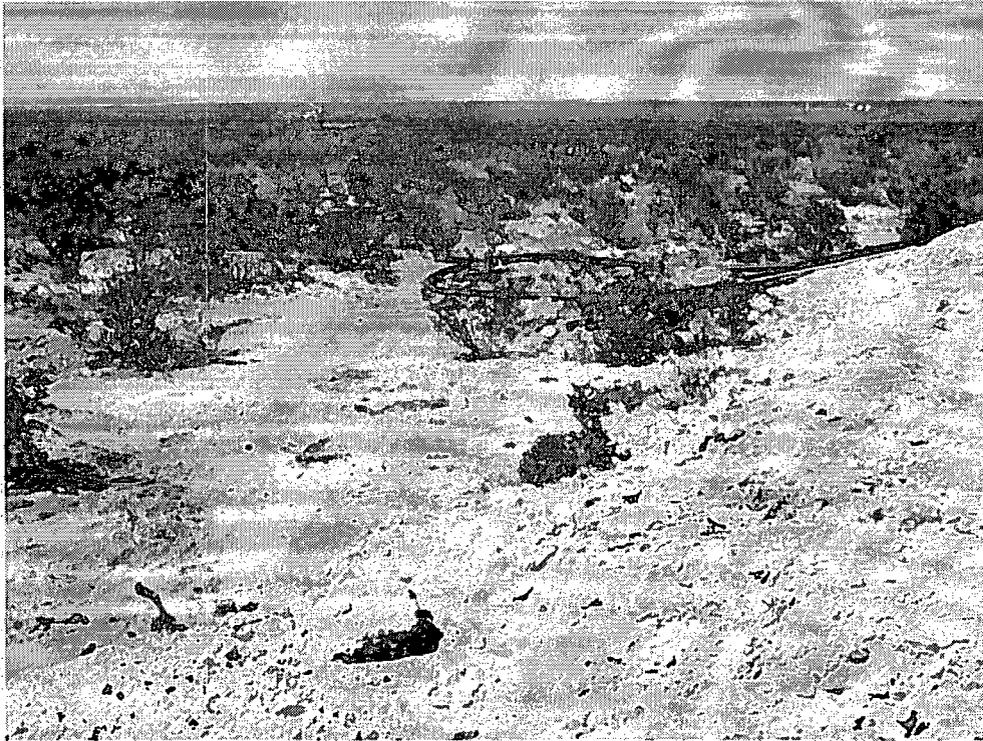
View Northwest – Area of AH-1

Param	Flag	Result	Units	RL
Chloride		1900	mg/Kg	4

Sahara proposes to remove the impacted material as highlighted (green) in Table 1 and shown on Figure 4. The areas of AH-1, AH-2, AH-3, AH-6 and AH-8 will be excavated to a depth of approximately 1.0' below surface. Backhoe trenches will be installed in the areas of AH-4, AH-5 and AH-13 in order to attempt to vertically define the chloride impact. Based on the field data, these areas will be excavated to the appropriate depths.

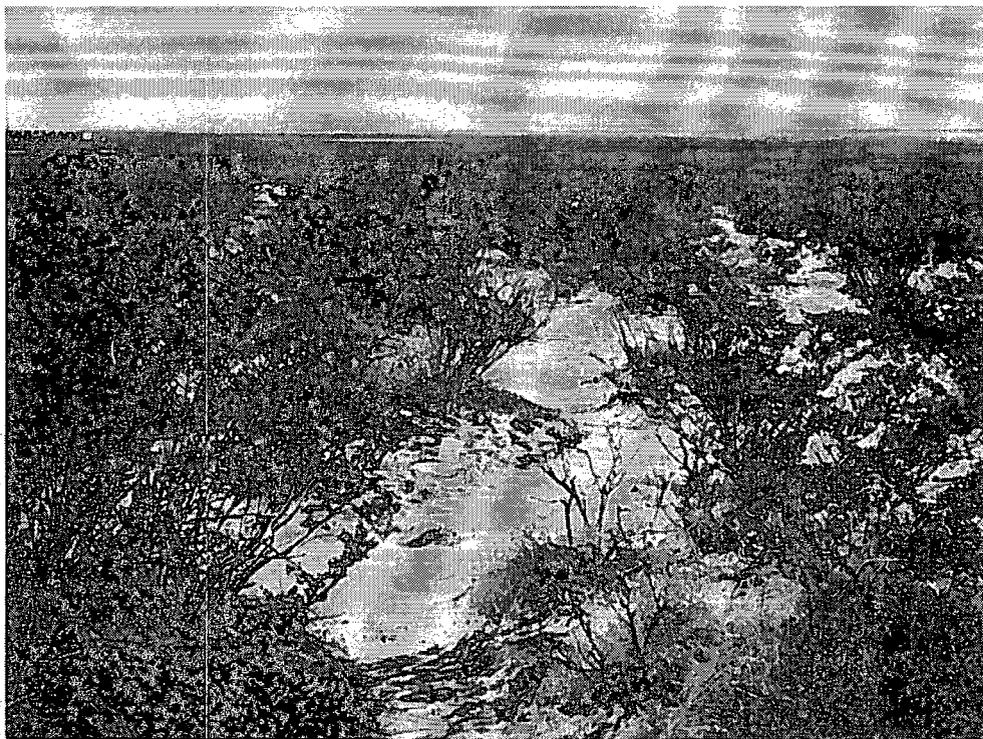
View West – Area of AH-2

Param	Flag	Result	Units	RL
Chloride		1060	mg/Kg	4

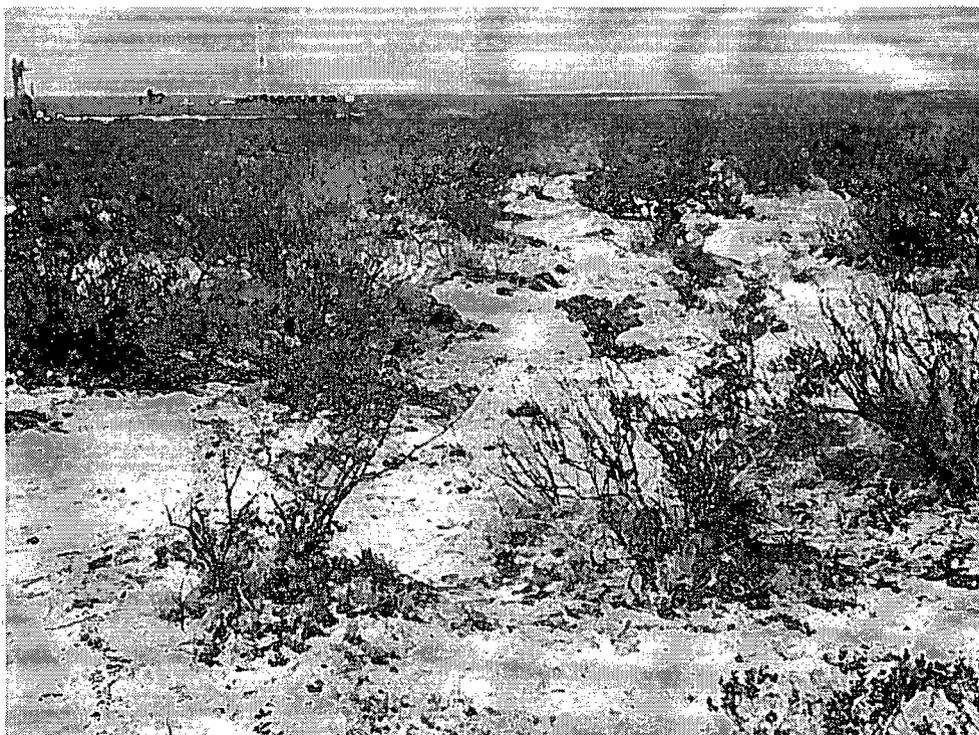
View West – Area of AH-3

Param	Flag	Result	Units	RL
Chloride		1340	mg/Kg	4

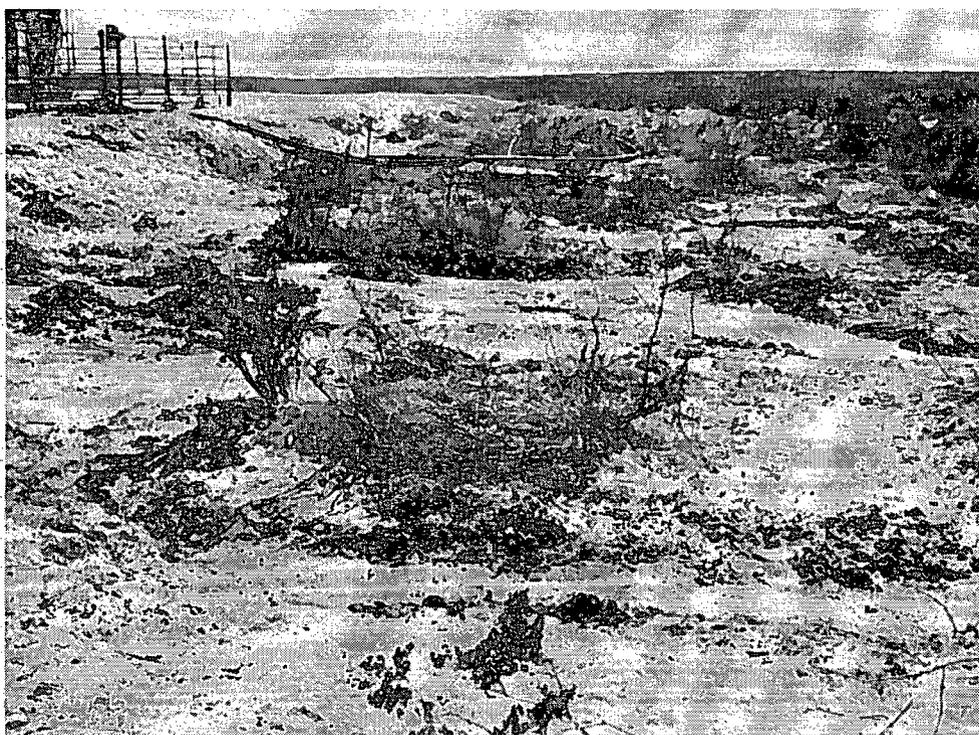
View South – Area of AH-4 and AH-6

Param	Flag	Result	Units	RL
Chloride		1220	mg/Kg	4

Param	Flag	Result	Units	RL
Chloride		1400	mg/Kg	4

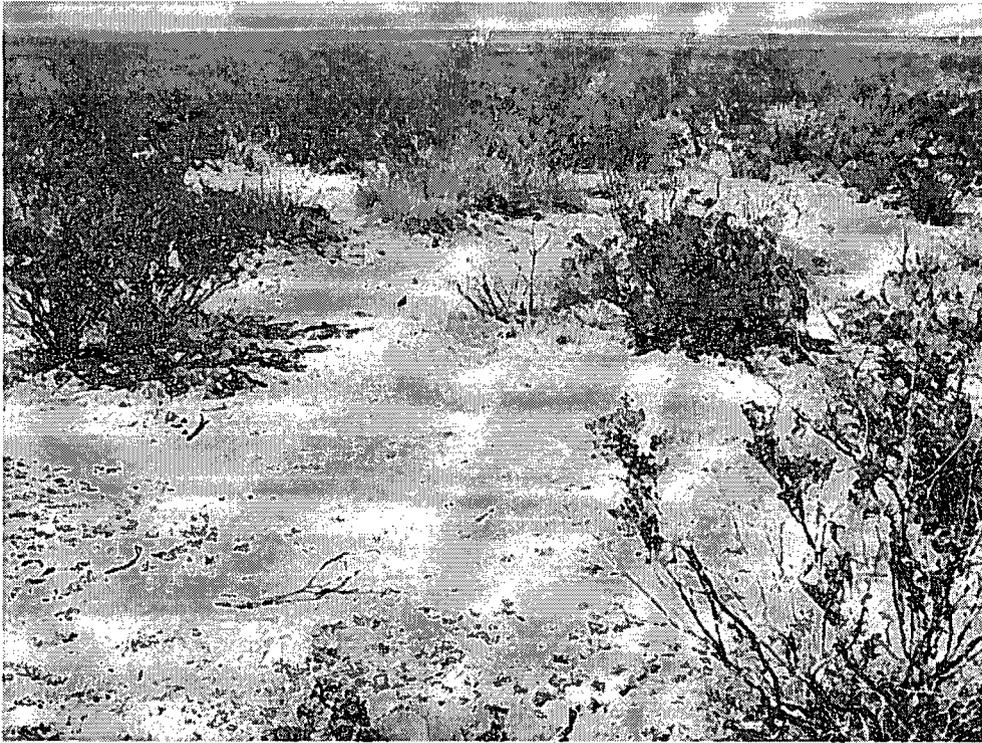
View North – Area of AH-5

Param	Flag	Result	Units	RL
Chloride		1490	mg/Kg	4

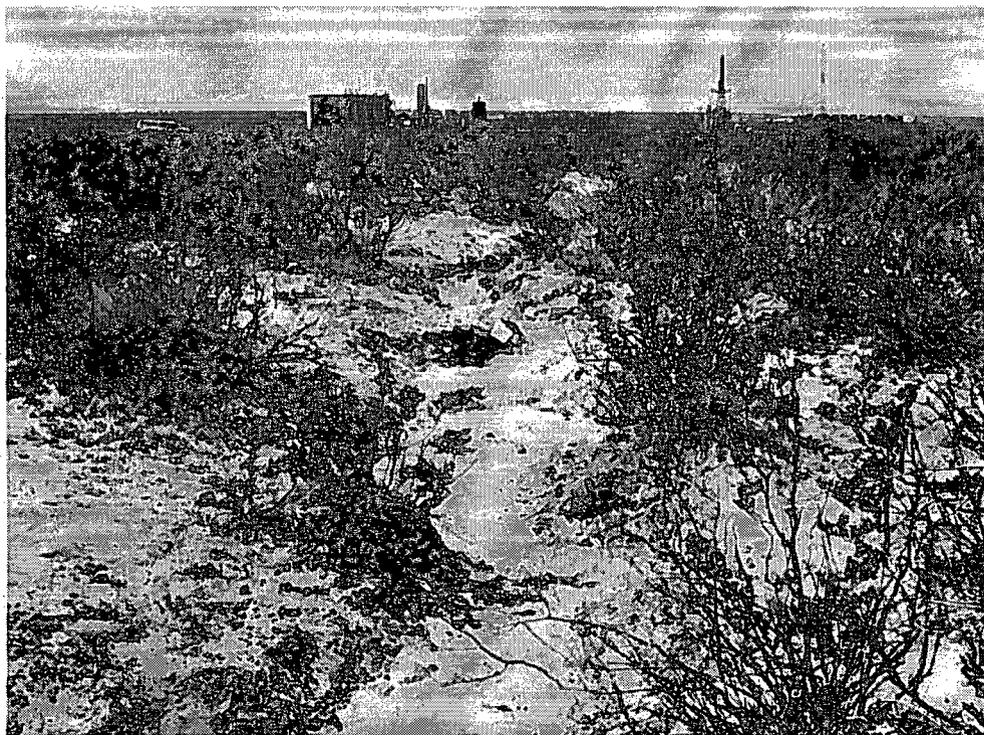
View West – Area of AH-8

Param	Flag	Result	Units	RL
Chloride		1520	mg/Kg	4

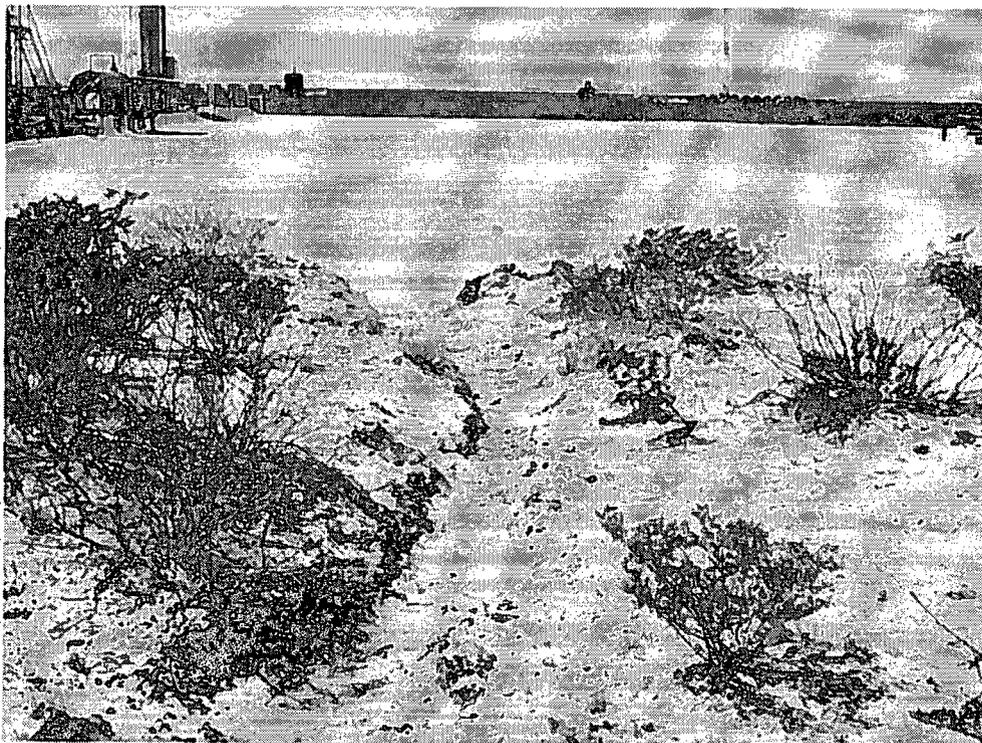
View West – Area of AH-13

Param	Flag	Result	Units	RL
Chloride		1690	mg/Kg	4
