Report Type: Work Plan

Site:	Burch Keely Unit #100 Flow line				
Company:	COG Operating LLC				
Section, Township and Range	Unit P	Sec. 18	T-17-S	R-30-E	
Lease Number:	API-30-015-04213				
County:	Eddy County				
GPS:	32.81382° N			104.00933° W	
Surface Owner:	Federal				
Mineral Owner:					
Directions:	Intersection of 529 and Hagerman Cutoff, travel west on 82 1.6 mi, turn left at COG BKU Yard 300', left 0.2 mi, turn right 0.2 mi, turn left 0.2 mi to location

Re: Work Plan for the COG Operating LLC., Burch Keely Unit #100, Unit P, Section 18, Township 17 South, Range 30 East, Eddy County, New Mexico.

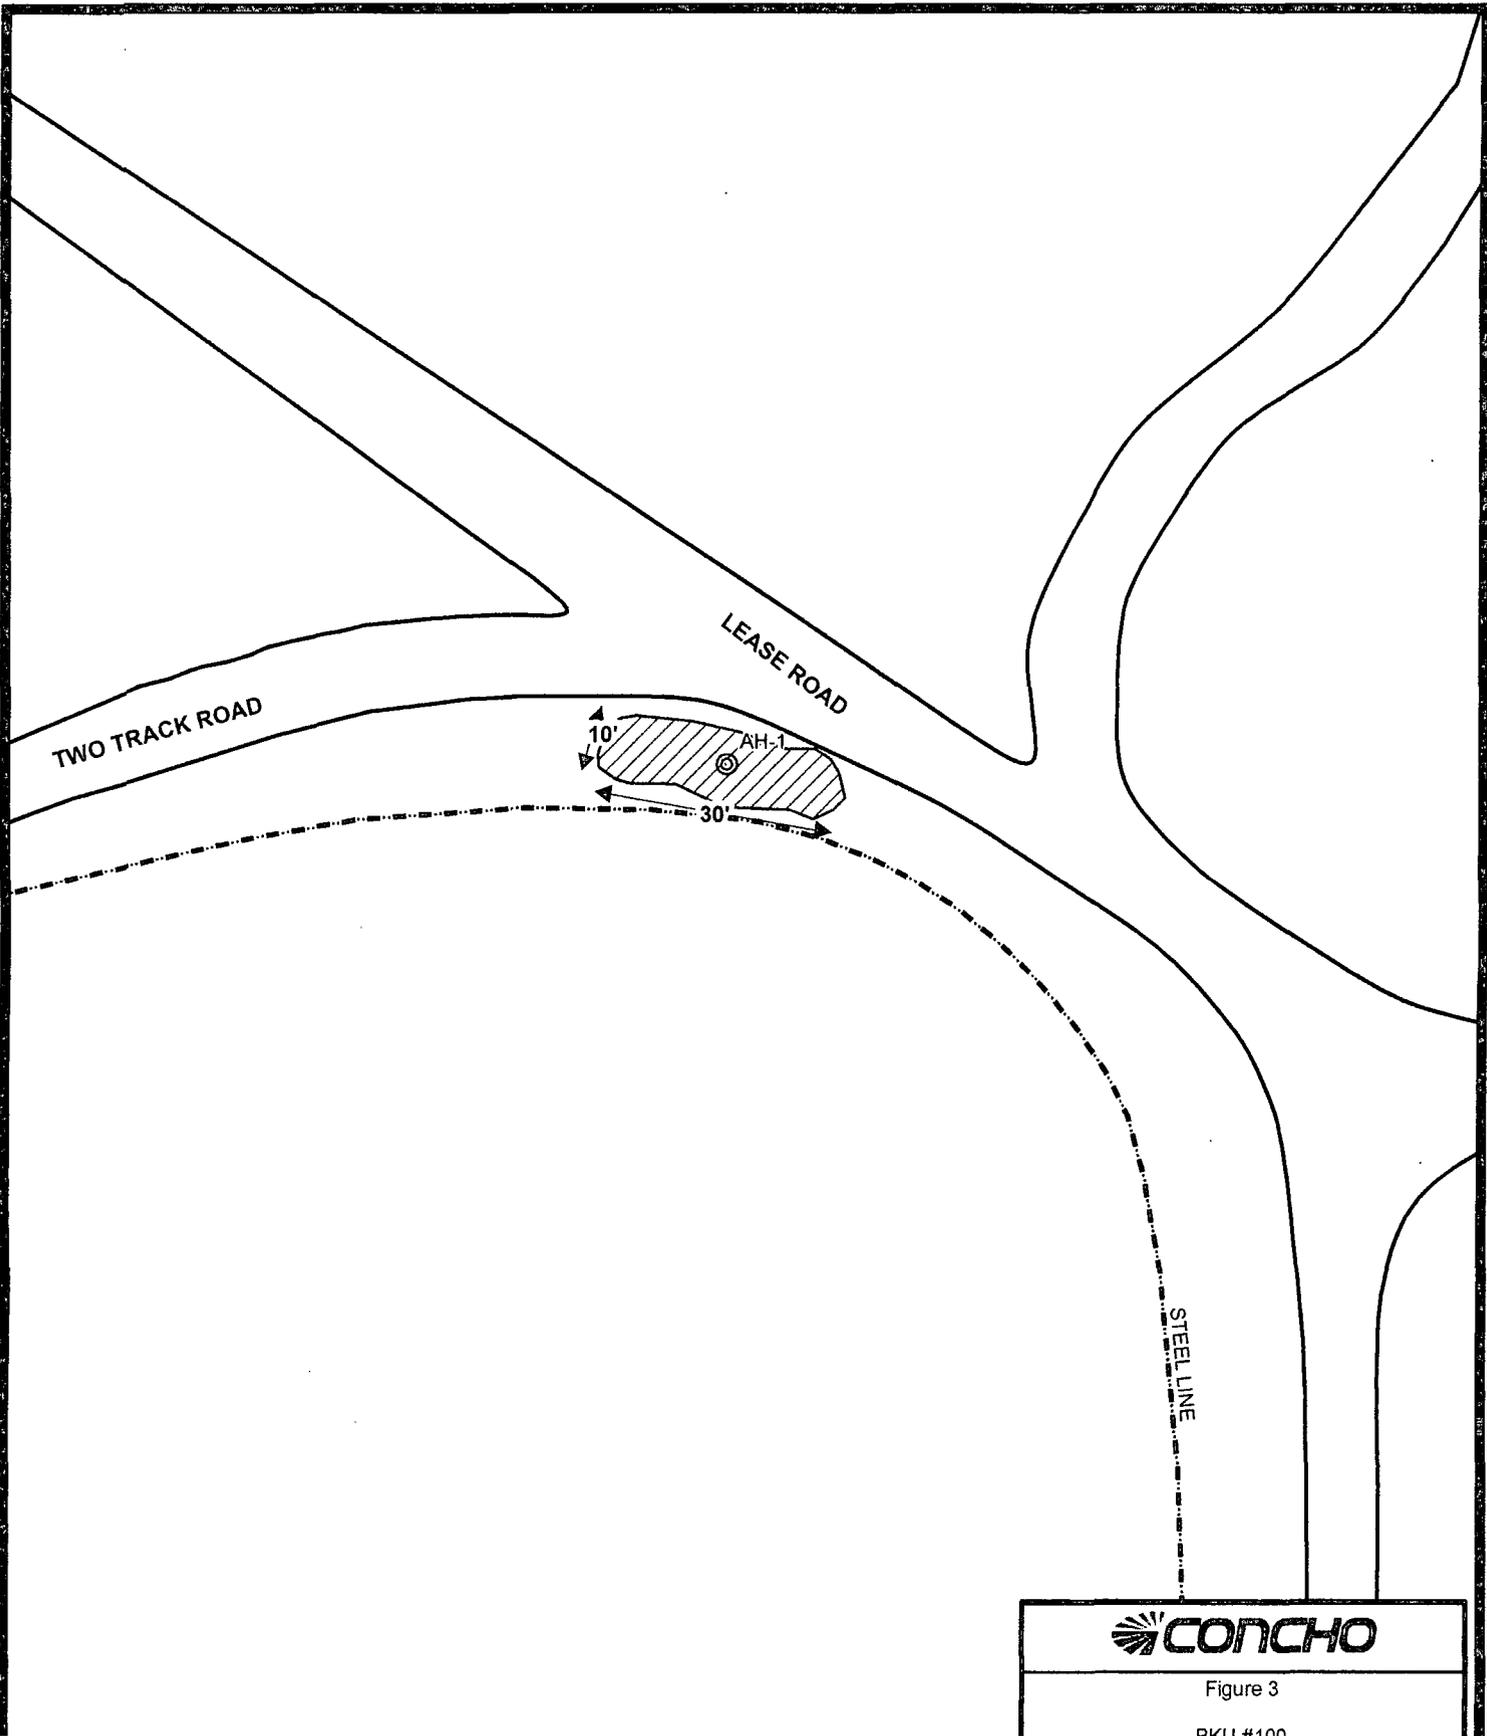
Figure 3	
BKU #100	
Spill Assessment Map	
Eddy County, New Mexico	
Project : 114-6401448

On July 3, 2012, Tetra Tech personnel inspected and sampled the spill area. One (1) auger hole (AH-1) was installed using a stainless steel hand auger to assess the impacted soils. Selected samples were analyzed for TPH analysis by EPA method 8015 modified, BTEX by EPA Method 8021B and chloride by EPA method 300.0. Copies of laboratory analysis and chain-of-custody documentation are included in Appendix C. The sampling results are summarized in Table 1. The auger hole location is shown on Figure 3.

Referring to Table 1, the samples were below the RRAL for TPH and BTEX. Elevated chloride concentrations were detected in the auger hole, with concentrations of 11,700 mg/kg at 0-1' and 10,000 mg/kg at 1-1.5' below surface. The chloride impact was not vertically defined at the site. Deeper samples could not be collected due to a dense caliche formation.

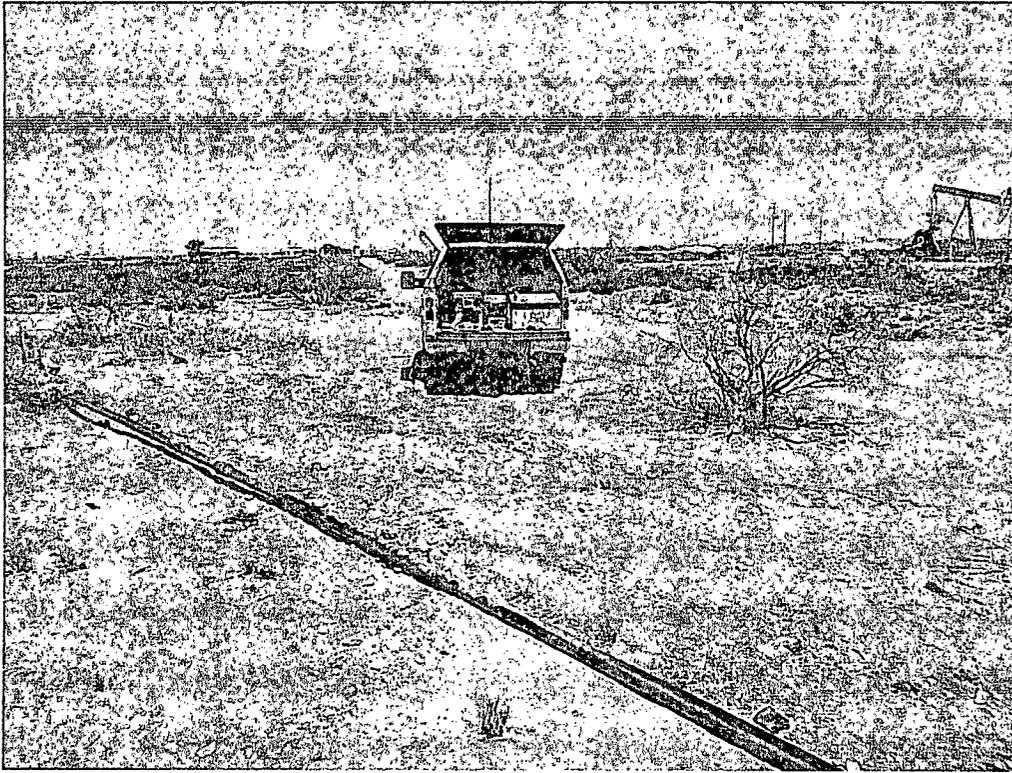
View north – Steel line (source) AH-1

COG proposes to excavate the impacted soil to a minimum depth of 4.0' below surface. Due to the limited spill area, a backhoe trench will be installed to assess and attempt to vertically define the chloride impact at the site. Based on the field data, the spill area will be excavated to the appropriate depth. All of the excavated material will be transported offsite for proper disposal. Once final excavation depths are achieved, the site will be backfilled with clean material and brought to grade.
