**Release Notification and Corrective Action**

Name of Company: BOPCO, L.P. <u>260737</u>		OPERATOR	<input checked="" type="checkbox"/> Initial Report	<input type="checkbox"/> Final Report
Address: 522 W. Mermod, Suite 704 Carlsbad, N.M. 88220		Contact: Tony Savoie		
Facility Name: PLU-158 Tank Battery		Telephone No. 575-887-7329		
		Facility Type: Exploration and Production		
Surface Owner: Federal		Mineral Owner: Federal	API No. 30-015-31690

2RP-2297

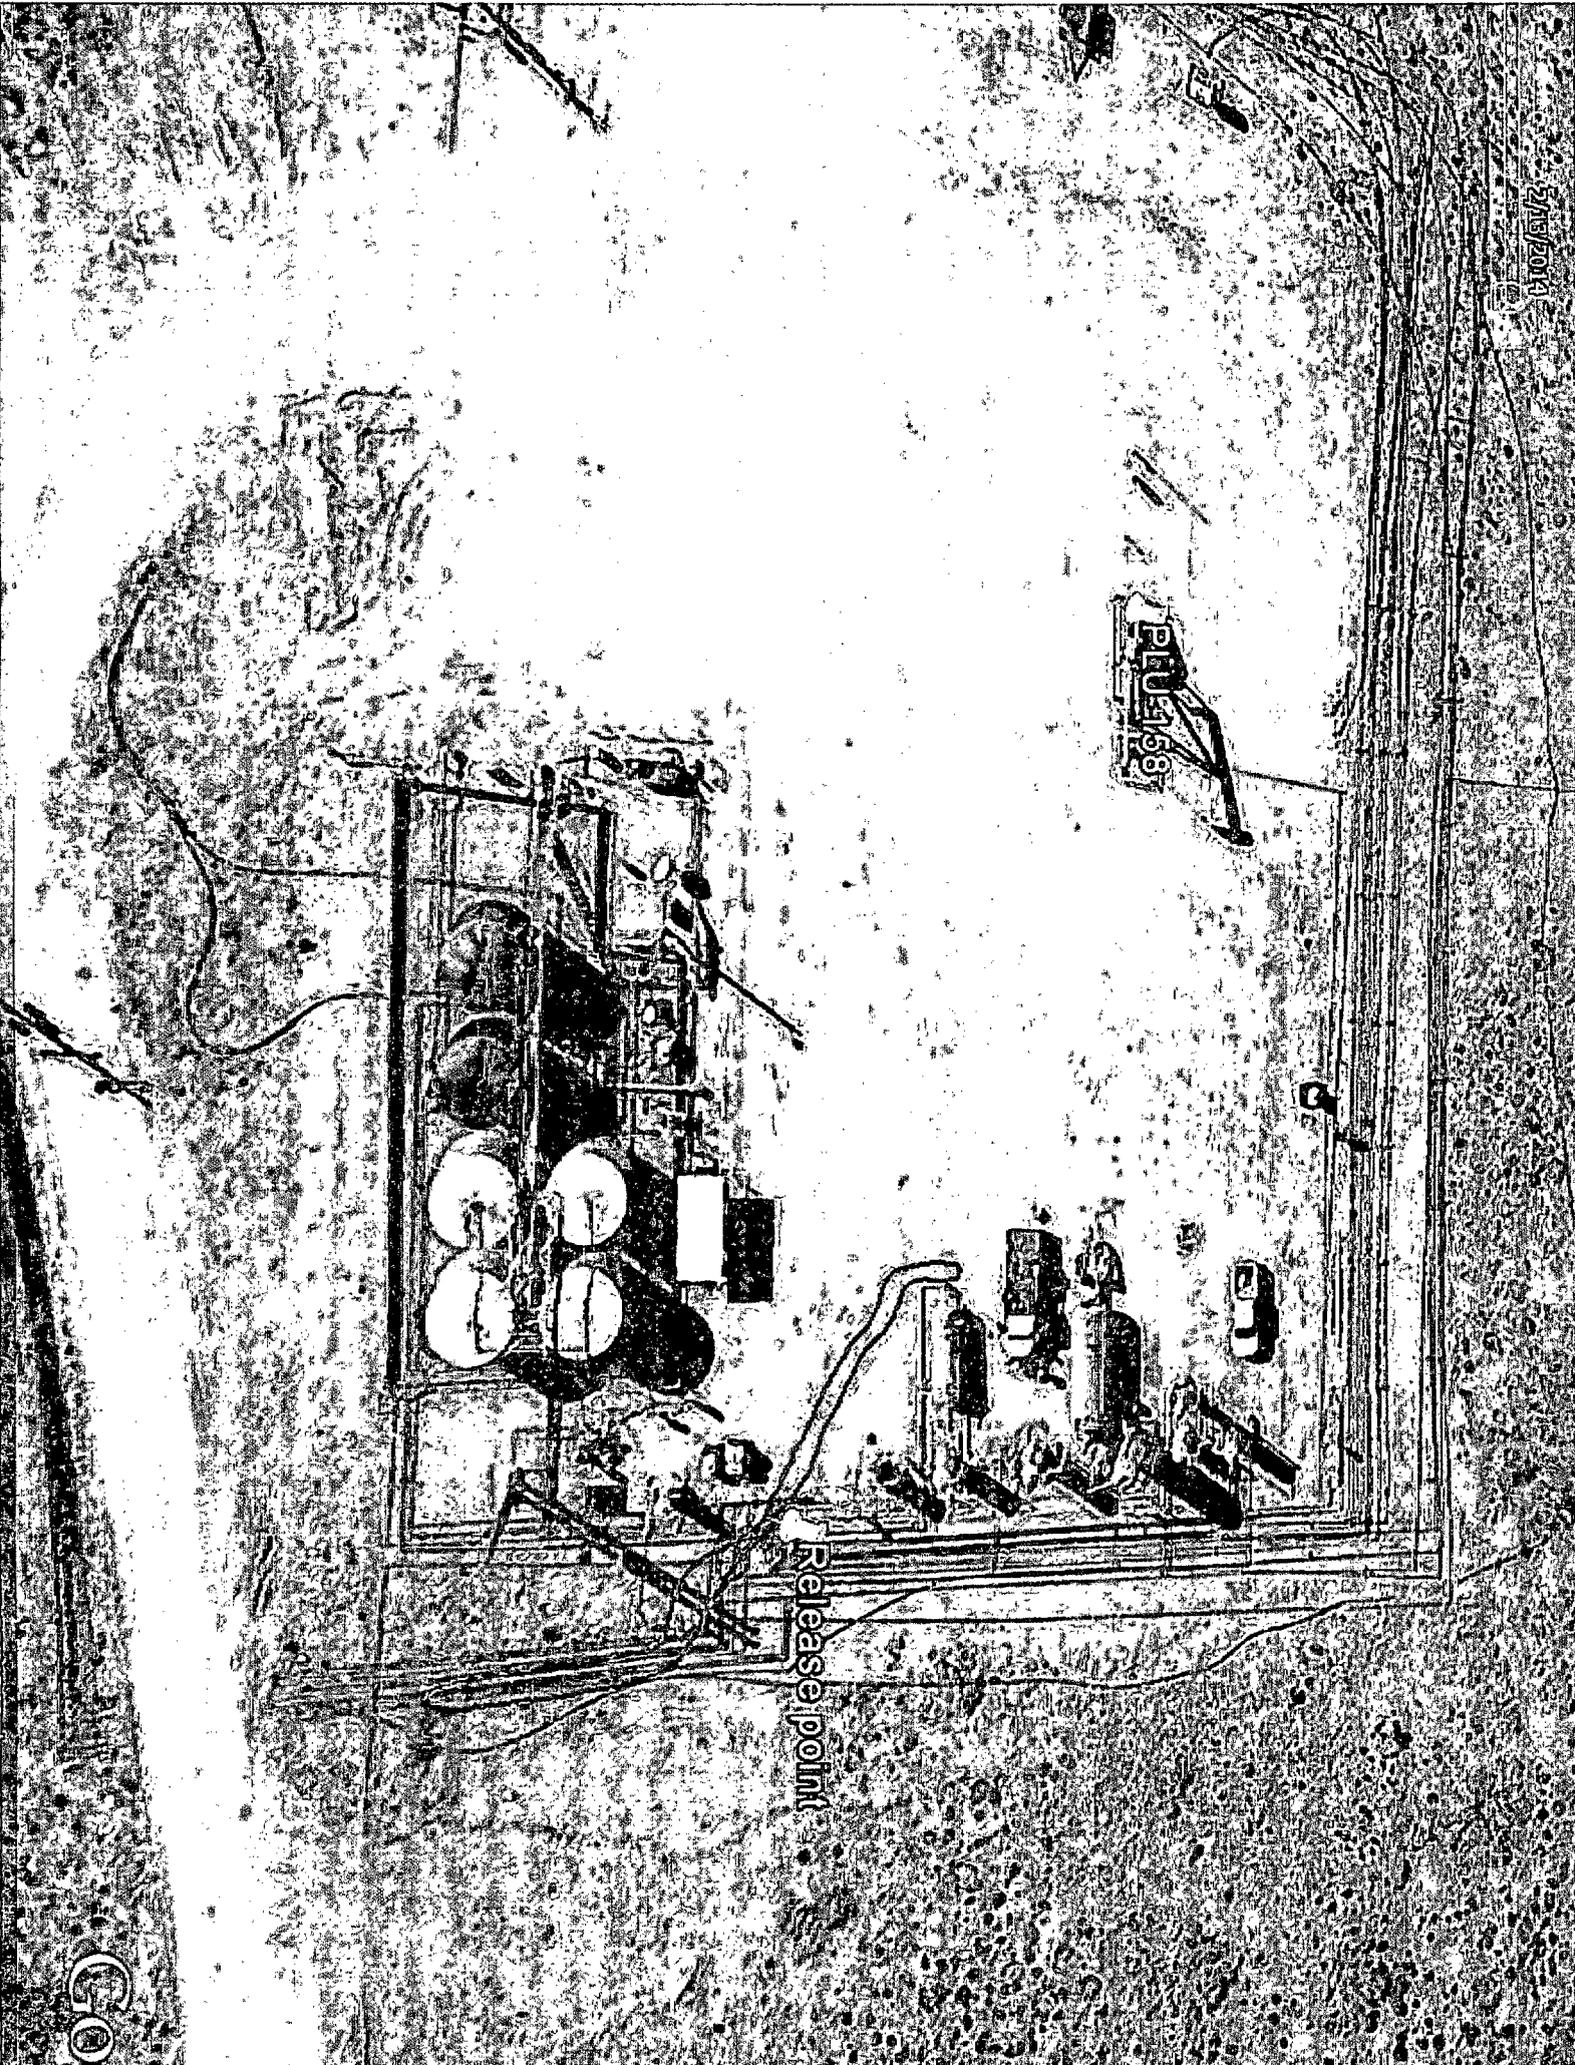
PLU 4168

Release point
