Release Notification and Corrective Action

Name of Company COG Operating LLC	Contact Robert McNeil
Address 600 West Illinois Avenue, Midland, Texas 79701	Telephone No. (432) 230-0077
Facility Name Spruce Goose Federal #1	Facility Type Flowline
Surface Owner: Federal	Mineral Owner
Lease No. (API#) 30-025-38445

Report Type: Closure Report

Re: Closure Report for the COG Operating LLC., Spruce Goose Federal #1 Flow line, Unit A, Section 7, Township 19 South, Range 32 East, Lea County, New Mexico.

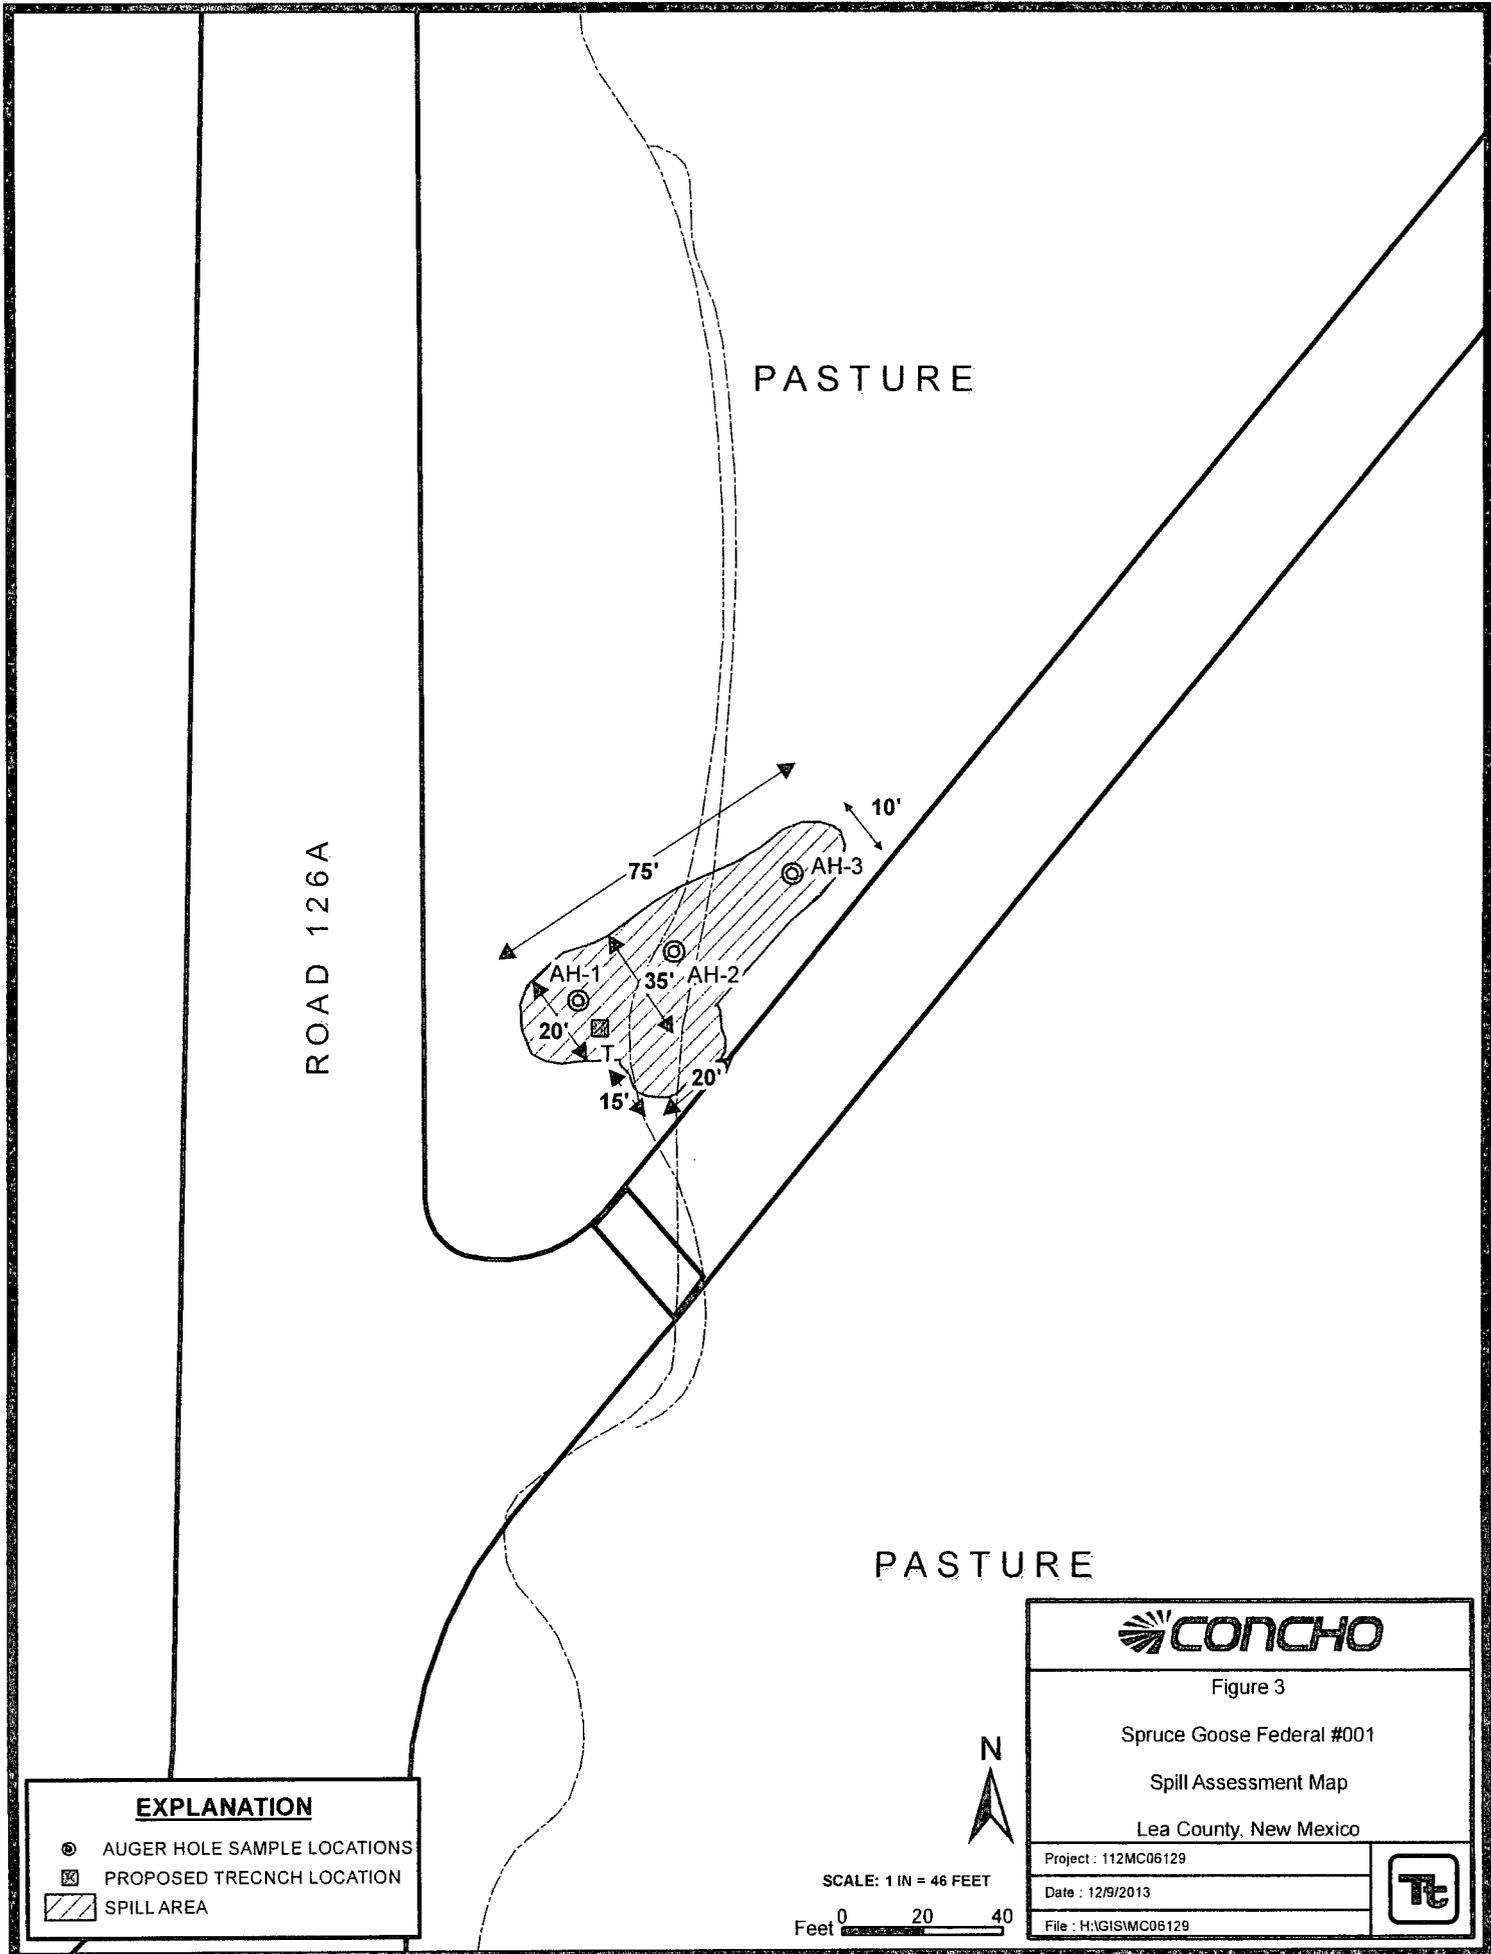
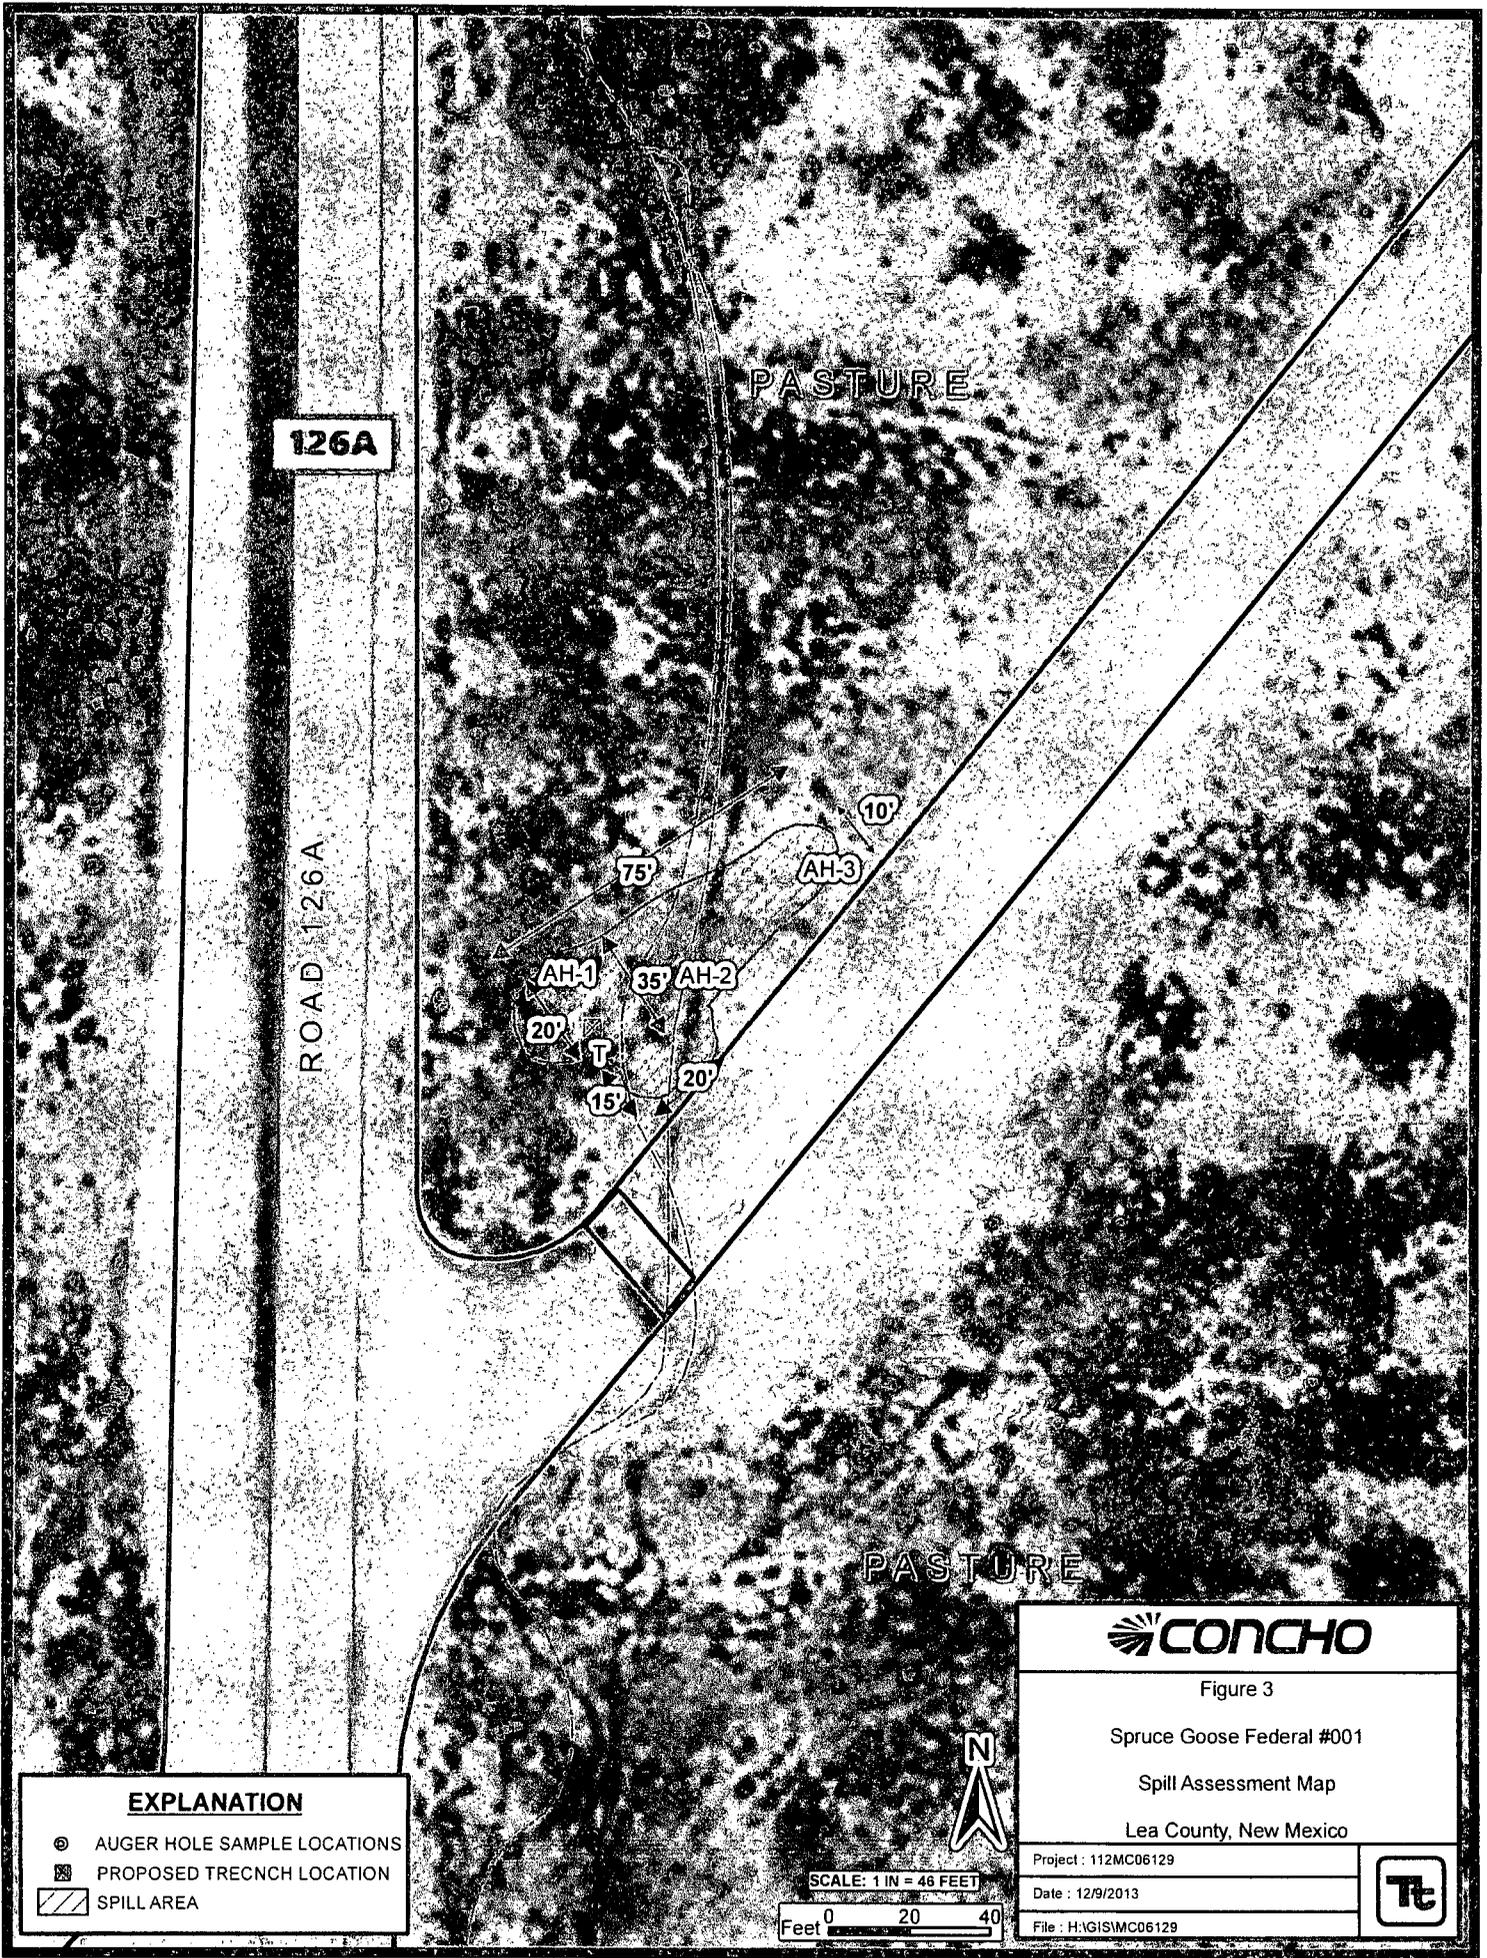
Figure 3

On October 29, 2013, Tetra Tech personnel inspected and sampled the spill area. Three (3) auger holes (AH-1 through AH-3) were installed using a stainless steel hand auger to assess the impacted soils. Selected samples were analyzed for TPH analysis by EPA method 8015 modified, BTEX by EPA Method 8021B and chloride by EPA method 300.0. Copies of laboratory analysis and chain-of-custody documentation are included in Appendix C. The results of the sampling are summarized in Table 1. The auger hole locations are shown on Figure 3.

Referring to Table 1, none of the auger holes (AH-1, AH-2, and AH-3) showed any concentrations for TPH or BTEX. However, the auger holes did show elevated chloride concentrations in the subsurface soils. The area of AH-1 showed a deeper chloride impact to the soils and declined with depth. However, the bottom auger hole sample (9-9.5') showed a chloride of 1,360 mg/kg, which may be cross-contamination from the upper soils. The remaining auger holes (AH-2 and AH-3) significantly declined at 4.0' below surface and vertically defined.

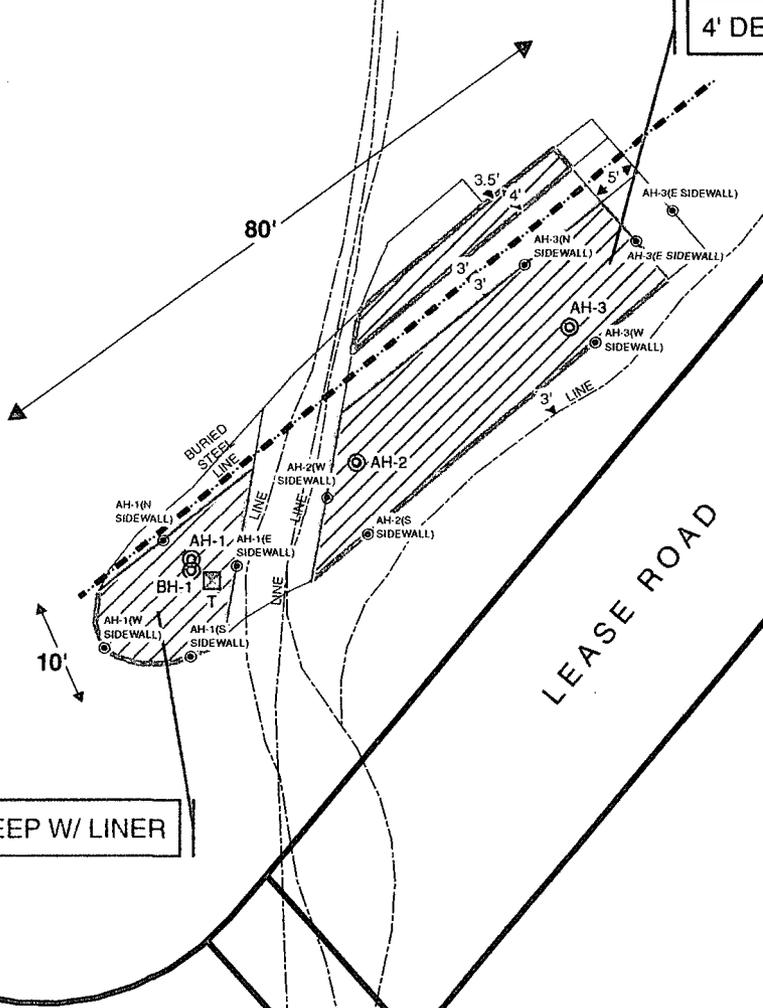
Figure 4

On May 27, 2014, Tetra Tech supervised the removal impacted material as highlighted (green) in Table 1 and shown on Figure 4.

Based on the field data, the area of auger hole (AH-1) was excavated to a depth of approximately 6.0' below surface and auger holes (AH-2 and AH-3) were excavated to approximately 4.0' below surface and all of the excavated areas were lined with a 40 mil plastic liner to cap area and prevent further migration of chlorides left in place as shown on Figure 4.

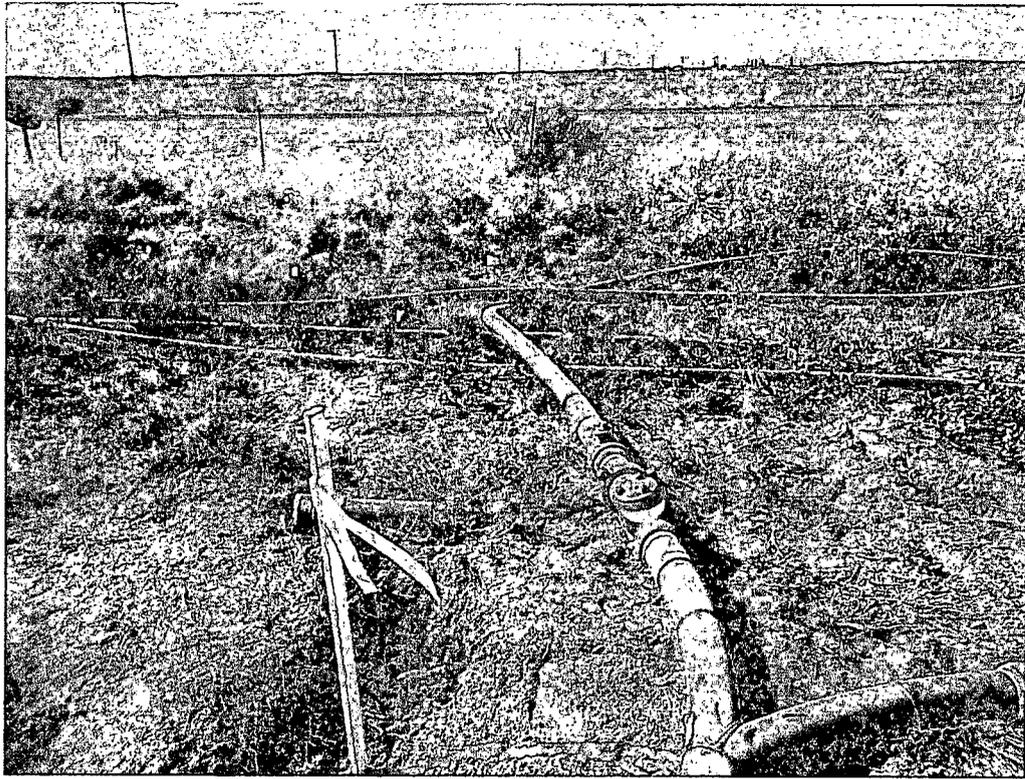
View West – AH-1

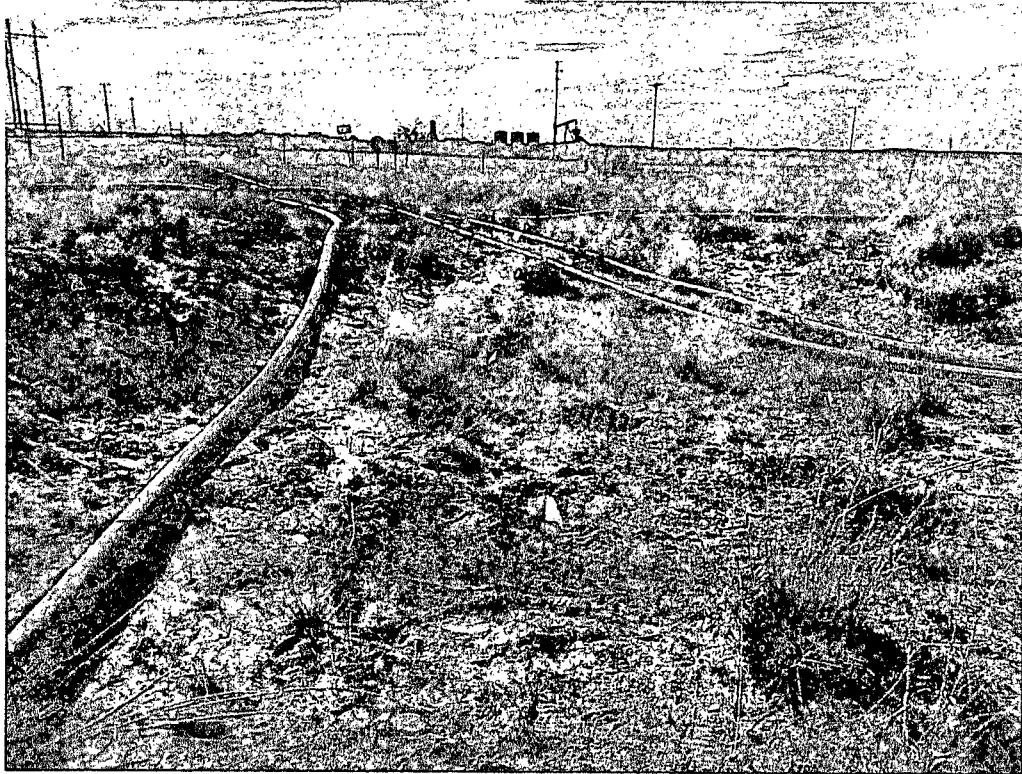
View West – AH-2 and AH-3

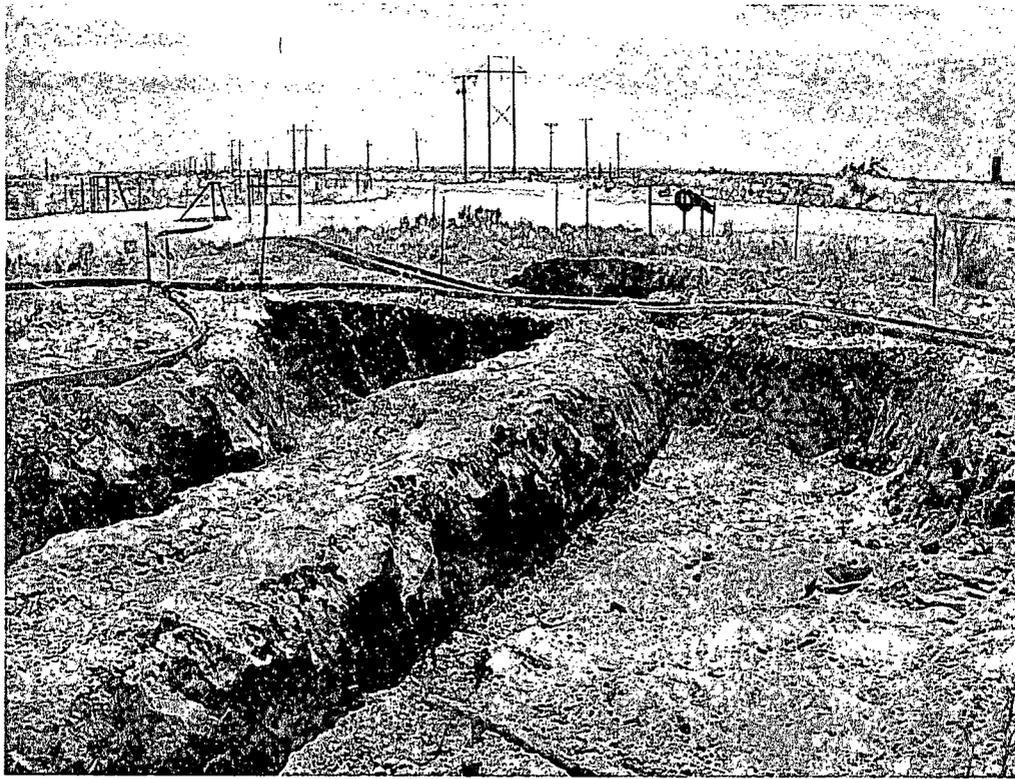
Confirmation samples were collected at the North, East, West, and South sidewalls in the area of auger hole (AH-1) which showed chloride concentrations of 12,000 mg/kg, 11,900 mg/kg, 130 mg/kg, and 2,160 mg/kg, respectively. In the area of auger hole (AH-2) North, West, South sidewalls and a Bottom hole confirmation sample were taken which showed chloride concentrations of 104 mg/kg, 17,100 mg/kg, 1,340 mg/kg, and 543 mg/kg, respectively.

View West – Excavated area of AH-2

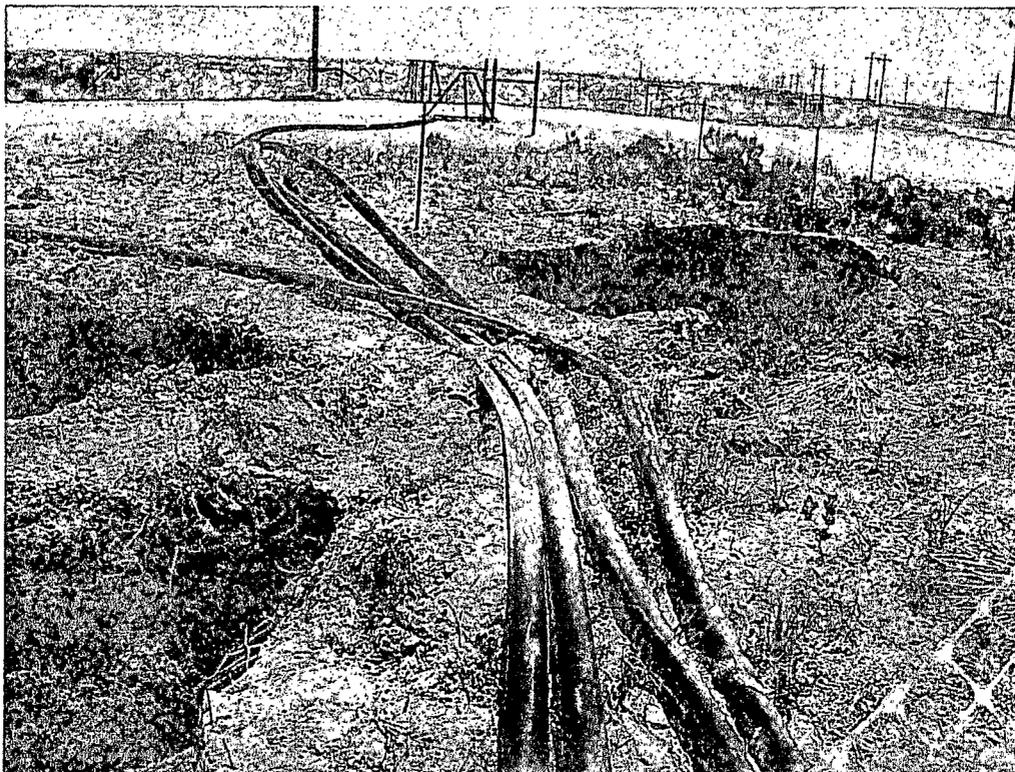
View West – Excavated area of AH-1

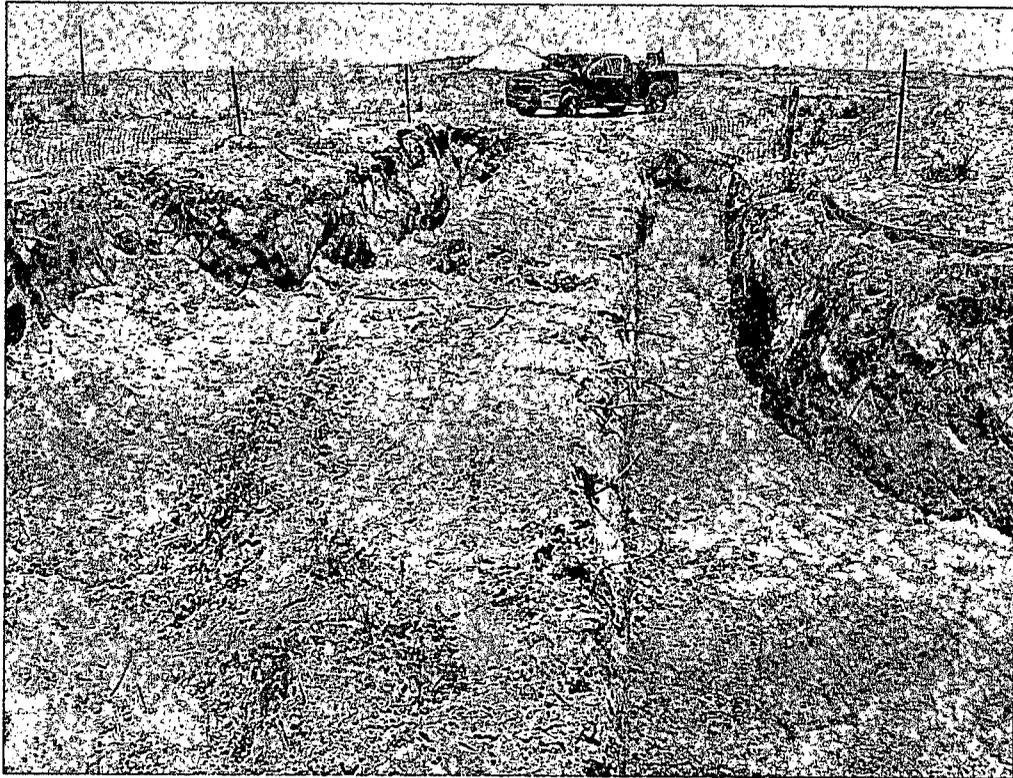
Confirmation samples were also collected in the area of auger hole (AH-3) at the North, South, and East sidewalls and a Bottom hole which showed chloride concentrations of 284 mg/kg, 4,240 mg/kg, 52.0 mg/kg, and 2,510 mg/kg, respectively. All of the sidewalls showing elevated chlorides were not excavated further due to safety concerns for the locations of the above ground, below ground lines and lease road in the area.

View Northeast – Excavated area of AH-3

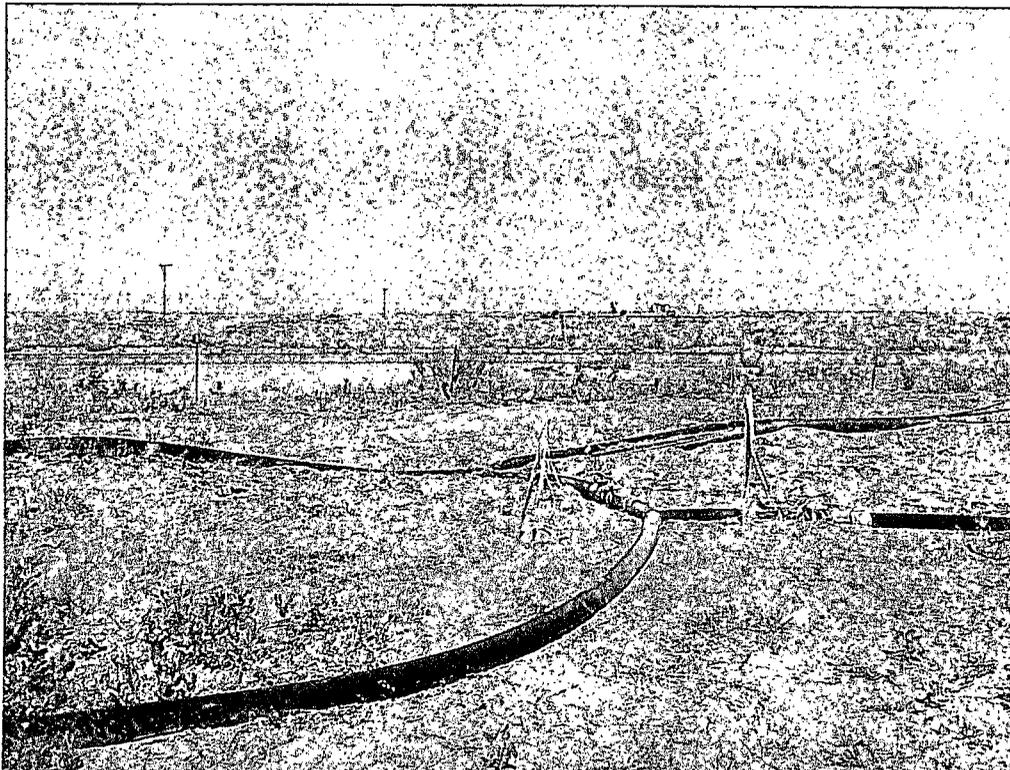
On June 19, 2014, Tetra Tech installed one (1) borehole (BH-1) in order to vertically define the chloride impact in the areas of AH-1. Borehole (BH-1) showed elevated chloride concentrations of 8,710 mg/kg at 6'-7' below surface, which significantly declined with depth at 19'-20' to 381 mg/kg and the area was vertically defined.

View West – Area of BH-1 (AH-1)
