**Release Notification and Corrective Action**

Name of Company: BOPCO, L.P. <i>210731</i>	Contact: Tony Savoie
Address: 522 W. Mermod, Suite 704 Carlsbad, N.M. 88220	Telephone No. 575-887-7329
Facility Name: James Ranch Unit #48	Facility Type: Exploration and Production
Surface Owner: Federal	Mineral Owner: Federal
API No. 30-015-27791

## FIELD SPILL REPORT

LOCATION OF SPILL SITE: JRU 48 Battery API 30-015-27791 (M-12-22S-30E)

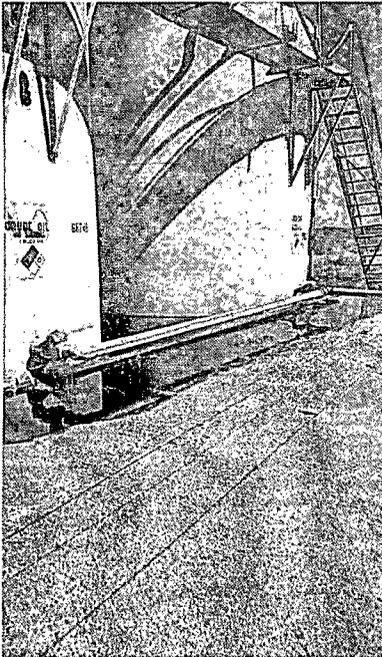
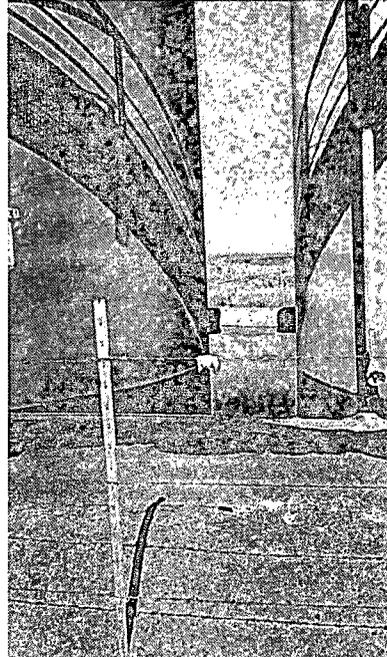
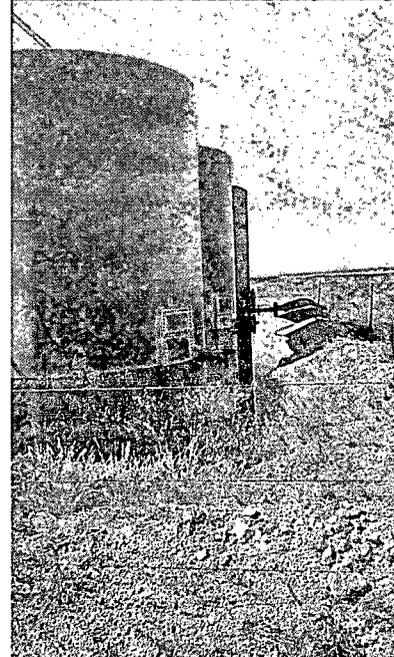
### PICTURE ATTACHMENT:

Describe Area Affected and Cleanup Action Taken.\*  
The spill impacted approximately 2400 sq.ft. of earthen containment around the production tanks. The free standing fluid was recovered and the tanks were washed down. This is the second reportable spill around the tanks. The tank battery will be re-located on-site or the production will be routed to another facility, the tanks will be removed and the area impacted by the release will be cleaned up in accordance to the NMOCD and BLM remediation guidelines.

Water transfer pump went down on electrical failure (blown panel fuse). Pump was returned to normal operation.

Vacuum truck recovered 2 BBL Oil & 56 bbl PW. EH&S was notified same day and was on-site first thing 10-16-14. The BLM and OCD were notified 10-15-14 at 3:25 PM by TS.
