Release Notification and Corrective Action

Name of Company: BOPCO, L.P. <i>2100737</i>	Contact: Tony Savoie
Address: 522 W. Mermod, Suite 704 Carlsbad, N.M. 88220	Telephone No. 575-887-7329
Facility Name: Big Eddy Unit #74 Tank Battery	Facility Type: Exploration and Production

FIELD SPILL REPORT

LOCATION OF SPILL SITE: BEU #74 Battery (API 30-015-22839)

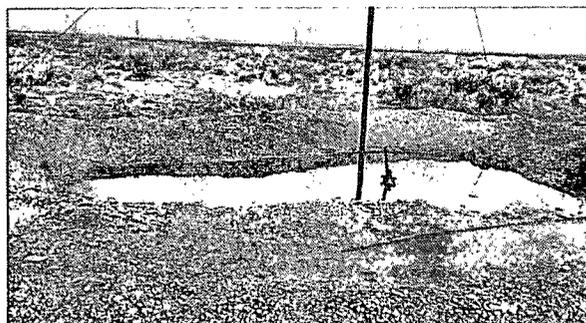
PICTURE ATTACHMENT:

Flare scrubber loaded up due to water dump line on top of tank being closed. In addition float failed on flare scrubber.

Valve on water tank was returned to open position. Contract gang to replace failed float in flare scrubber. Vac truck recovered 1.5 bbls fluid. (1 bbl pw, .5 bbl oil)
