**Release Notification and Corrective Action**

Name of Company: BOPCO, L.P. <i>810737</i>	Contact: Tony Savoie
Address: 522 W. Mermod, Suite 704 Carlsbad, N.M. 88220	Telephone No. 575-887-7329
Facility Name: PLU-333H Flow Line spill approximately 1.64 miles S.E. of the well and approximately 963 ft. N.E. of the Tank Battery at the PLU-78	Facility Type: Exploration and Production <i>T.S. 39294</i>

## FIELD SPILL REPORT

**Facility Name:** PLU 333H Flowline (API-30-015-39294)

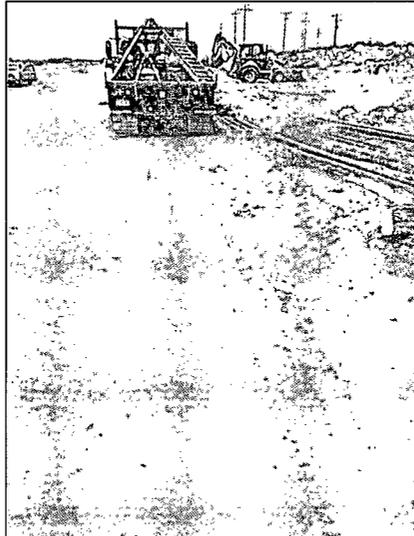
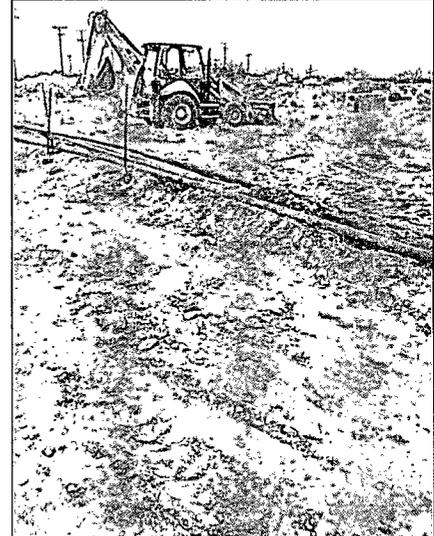
**PICTURE ATTACHMENT:**

Describe Cause of Problem and Remedial Action Taken.\*  
The flow line developed a leak due to external corrosion. A repair clamp was placed on the affected area until the flow line could be drained and a section of pipe replaced.

Flowline failed due to corrosion. Flow lines were partially buried at the point of release

Most of fluid was recovered from the bell hole at the point of release while trying to get the flowline to stop leaking fluid. Flowline will be replaced.
