Release Notification and Corrective Action

Name of Company: BOPCO, L.P. <i>260737</i>	Contact: Tony Savoie
Address: 522 W. Mermod, Suite 704 Carlsbad, N.M. 88220	Telephone No. 575-887-7329
Facility Name: North Indian Flats 26 Federal #1	Facility Type: Exploration and Production

FIELD SPILL REPORT

LOCATION OF SPILL SITE: North Indian Flats 26 Federal 001 (API-30-015-27556)

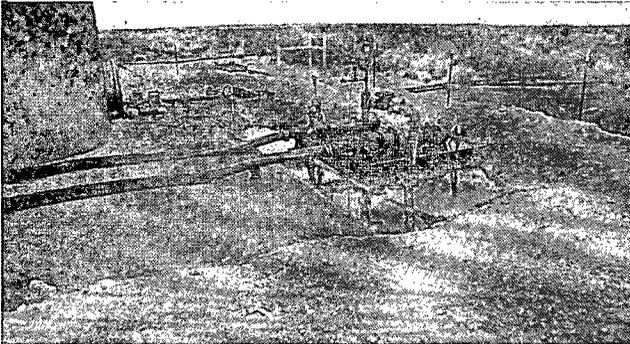
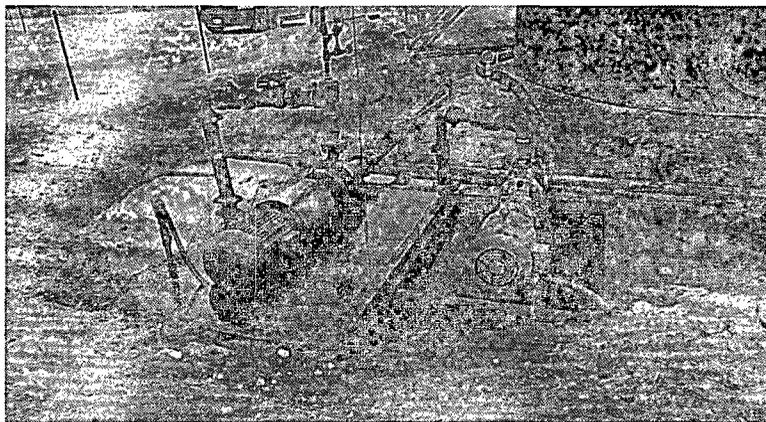
PICTURE ATTACHMENT:

Describe Area Affected and Cleanup Action Taken.* The spill affected approximately 450 sq. ft. of earthen containment berm around the water storage tank. Same area impacted as previous spill on 9/24/14, reference spill report #2RP-2523. The spill area will be remediated following the NMOCD and BLM guidelines for spills and releases.

Air eliminator on discharge line of main water transfer pump began leaking.

Describe Cause of Problem and Remedial Action Taken.* An air eliminator on the water transfer pump failed, the part was replaced.

Vac truck recovered 4 bbls. Gang to replace failed air eliminator.
