From: Tavarez, Ike <Ike.Tavarez@tetrattech.com>
Sent: Tuesday, July 16, 2013 1:38 PM
To: Bratcher, Mike, EMNRD
Cc: Joshua Russo; Robert Grubbs; Pat Ellis (PEllis@concho.com); Michelle Mullins (MMullins@concho.com)
Subject: COG - F.M. Robertson #1 Tank Battery - Approval Request
Attachments: COG -F.M. Robertson 1 Tank Battery - Work Plan .pdf

Report Type: Work Plan

General Site Information:					
Site:	F.M. Robinson #1 Tank Battery				
Company:	COG Operating LLC				
Section, Township and Range	Unit E	Sec 27	T17S	R29E	
Lease Number:	API-30-015-22037				
County:	Eddy County				
GPS:	32.80775° N			104.06894° W	
Surface Owner:	State				
Mineral Owner:					
Directions:	In Loco Hills at the intersection of CR 217 and Hwy 82. Travel west on Hwy 82 for 5.1 miles, turn left (south) on CR 212 and travel 0.7 mile, turn left (east) and travel 0.1 mile to the site.

Re: Work Plan for the COG Operating LLC., F.M. Robinson #1 Tank Battery, Unit E, Section 27, Township 17 South, Range 29 East, Eddy County, New Mexico.

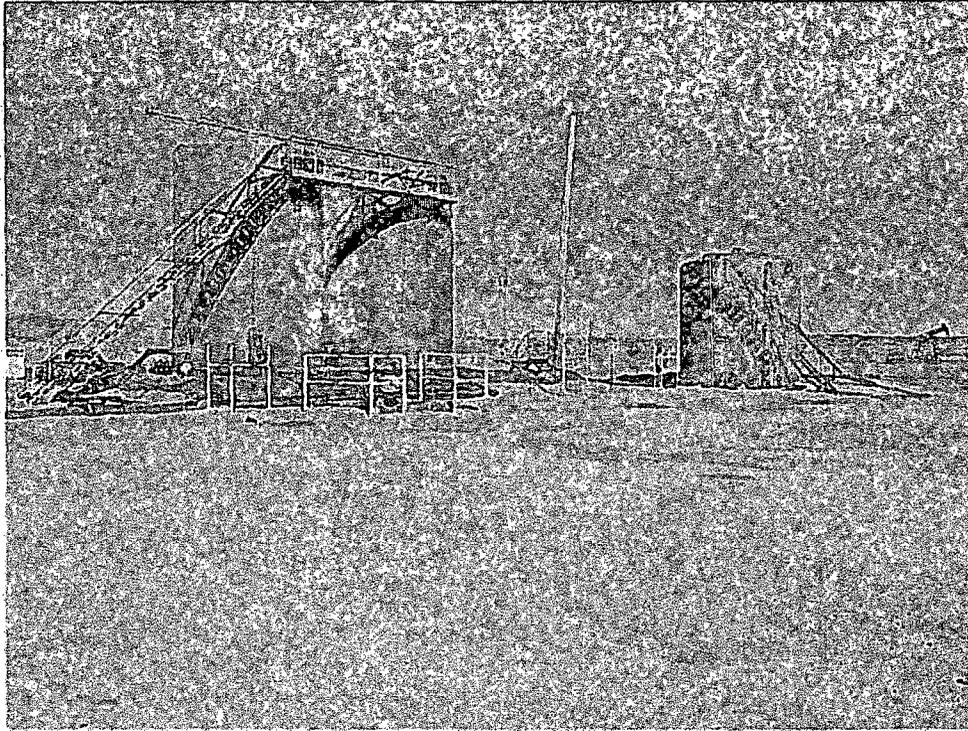
View Northeast – Area of AH-1(SB-1) and AH-2

Referring to Table 1, SB-1 (AH-1) was installed to define the chloride spike detected at 8.0' to 9.0' below surface. Soil boring (SB-1) showed a spike of 9-10' and declined to 150 mg/kg at 14-15' below surface. SB-2 (AH-6) did detect elevated chlorides from surface to a depth of approximately 30.0' below surface, which significantly declined to 1,300 mg/kg at 39-40' and 356 mg/kg at 49-50' below surface. Soil borings SB-3 (AH-7) and SB-4 (AH-9) showed vertical delineation and declined below 1,000 mg/kg chlorides at 24-25' below surface.

COG proposes to remove the impacted material as highlighted (green) in Table 1 and shown on Figure 4. In the areas of AH-2, AH-3, AH-4, AH-5, AH-10 and AH-12 will be excavated to a depth of approximately 1.0' below surface. The area of AH-1 (SB-1) will be excavated to a depth of 2.0' to 3.0' below surface. Due to the proximity of the facility, lines and tanks, the area of AH-6 (SB-2) on the pad will be excavated to an approximate depth of 3.0' to 4.0' and capped either clay or 40 mil liner for safety concerns.

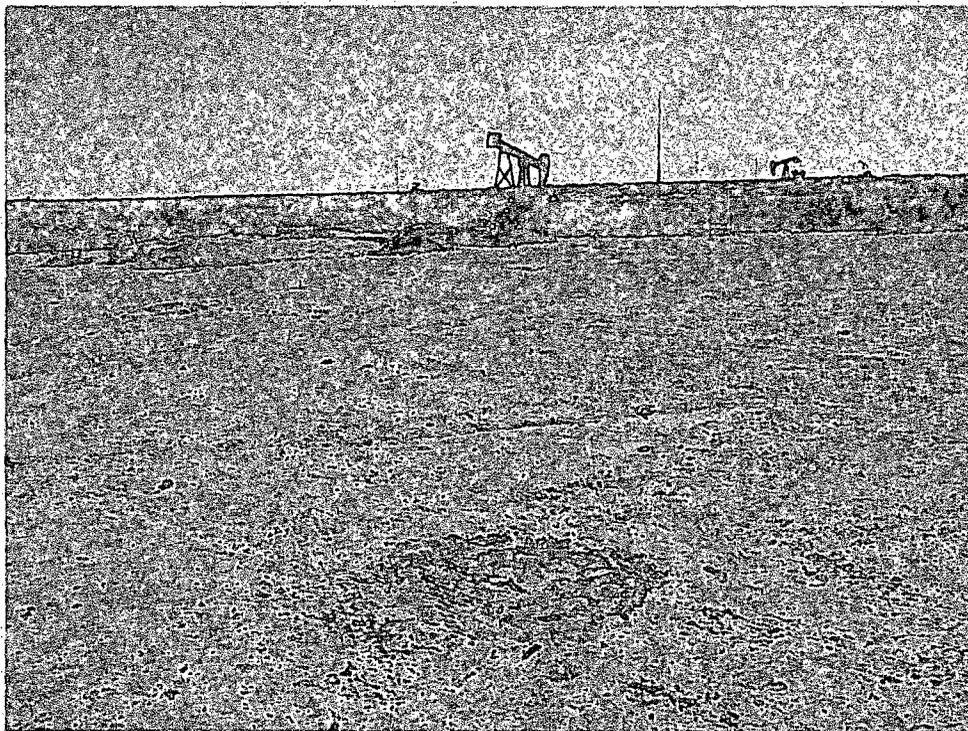
View South – Area of AH-3, AH-4 and AH-5

Chloride concentrations were detected in majority of the auger holes. Auger holes (AH-8 and AH-11) did not show a significant chloride impact to the areas. A shallow chloride impact (0-1') was detected in the areas of AH-2, AH-3, AH-4 and AH-10, which declined at 1-1.5' below surface. A deeper impact was encountered in the areas of AH-1 and AH-5, but declined with depth at 3-3.5' to 82.5 mg/kg and 589 mg/kg, respectively. The area of AH-1 did show a chloride spike at 8-8.5' and 9-9.5'. The remaining areas of were not vertically defined showing bottom auger hole samples of 5,220 mg/kg (AH-6), 2,500 mg/kg (AH-7) and 3,830 mg/kg (AH-9) at 7.0' below surface.
