Release Notification and Corrective Action

Facility Name: PLU-100 **Facility Type:** Exploration and Production

FIELD SPILL REPORT

LOCATION OF SPILL SITE: Poker Lake Unit 100 (API 30-015-27961)
UL O-24-24S-30E 660 FSL & 1980 FEL, Eddy Co.

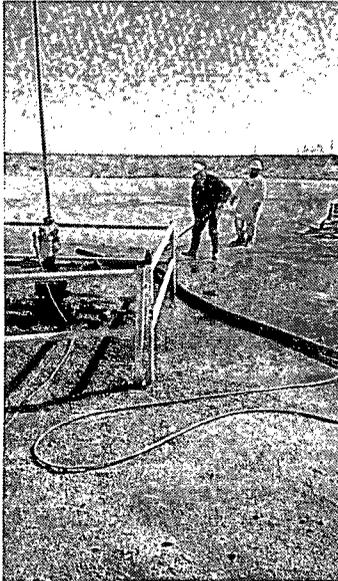
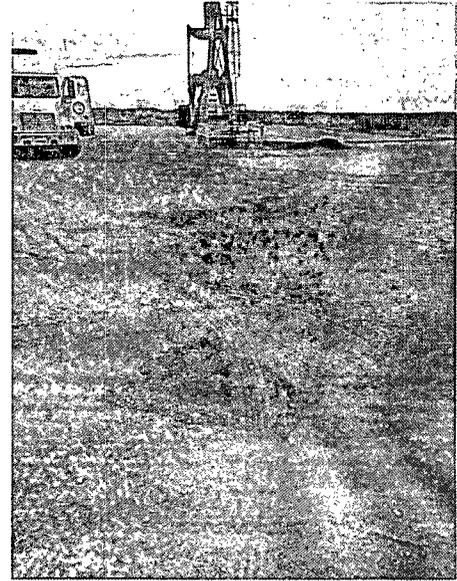
PICTURE ATTACHMENT:

2" pipe nipple between pumping tee and t&g valve failed.

Vacuum truck recovered 2bbbls pw and 1 bbl oil
