Release Notification and Corrective Action

Name of Company: BOPCO, L.P. <i>210737</i>	Contact: Tony Savoie
Address: 522 W. Mermod, Suite 704 Carlsbad, N.M. 88220	Telephone No. 575-887-7329
Facility Name: PLU-105	Facility Type: Exploration and Production

FIELD SPILL REPORT

LOCATION OF SPILL SITE: PLU 105 (API 30-015-27895)

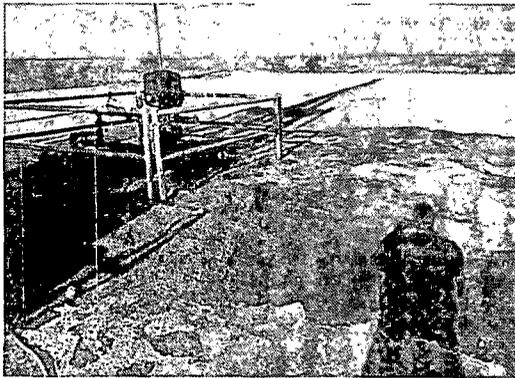
PICTURE ATTACHMENT:

Type of Release: Crude oil and Produced water	Volume of Release: 4 bbls crude oil and 3 bbls PW	Volume Recovered: 1 bbl oil and 2 bbls PW
Source of Release: 1/4" high pressure hose	Date and Hour of Occurrence: 4/8/15 time unknown	Date and Hour of Discovery: 4/8/15 at approximately 2 p.m.
Was Immediate Notice Given? <input type="checkbox"/> Yes <input type="checkbox"/> No <input checked="" type="checkbox"/> Not Required	If YES, To Whom?	
By Whom?	Date and Hour	
Was a Watercourse Reached? <input type="checkbox"/> Yes <input checked="" type="checkbox"/> No	If YES, Volume Impacting the Watercourse.	
If a Watercourse was Impacted, Describe Fully.*		
Describe Cause of Problem and Remedial Action Taken.* A 1/4" high pressure hose going from the wellhead to a high pressure shutdown switch failed. A valve was shut to isolate the line. The hose will be replaced with stainless steel tubing.		
Describe Area Affected and Cleanup Action Taken.* The spill impacted approximately 2,138 sq.ft. of caliche well pad. All of the free standing fluid was recovered with a vacuum truck. An EPI crew responded to the spill location on 4/9/15, all of the saturated soil was scraped up and placed on plastic pending the final remediation.

Hose on high pressure kill switch failed

Vacuum truck recovered 1 bbl oil and 2.5 bbls of produced water.
