Release Notification and Corrective Action

Name of Company: BOPCO, L.P. <i>260737</i>	Contact: Tony Savoie
Address: 522 W. Mermod, Suite 704 Carlsbad, N.M. 88220	Telephone No. 575-887-7329
Facility Name: PLU-213 Tank Battery "Oil Production"	Facility Type: Exploration and Production
Surface Owner: Federal	Mineral Owner: Federal
API No. 30-015-33859

FIELD SPILL REPORT

LOCATION OF SPILL SITE: PLU 213 Oil Load Line (API-30-015-33859)

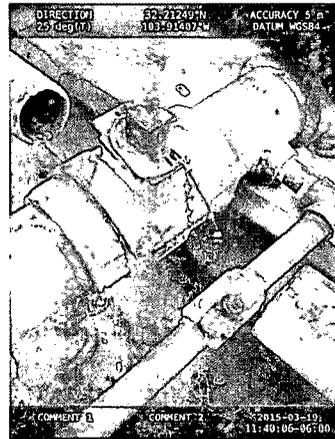
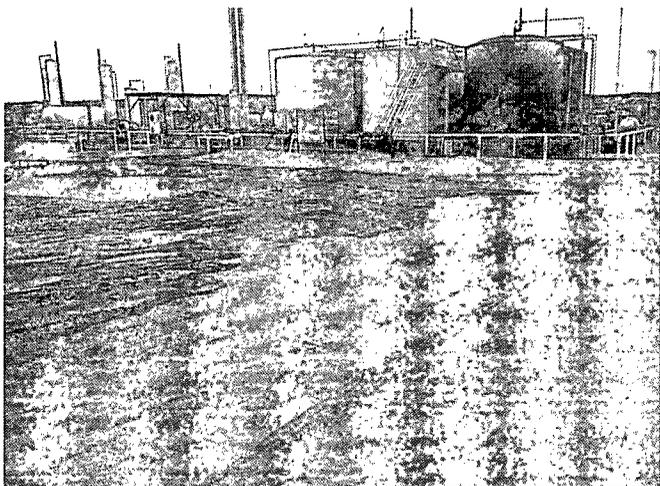
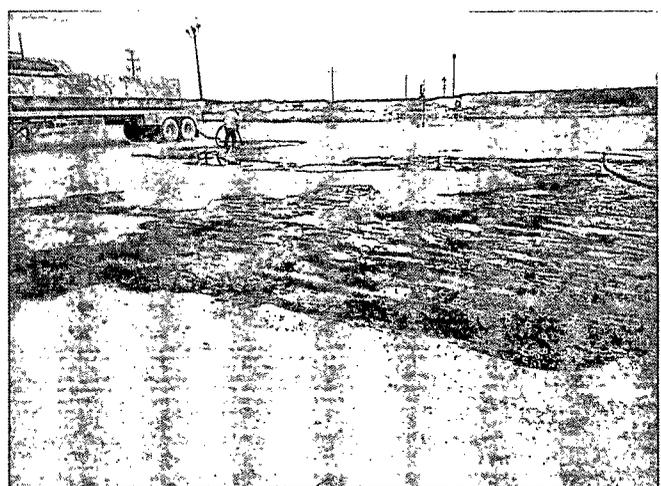
PICTURE ATTACHMENT:

Discovered morning of 3/19: A 4" valve in the PCC and the 4" valve just behind the PCC (both on oil load line) were found cracked open. The 1" valve on the same load line was also cracked open and leaking more than the 4" valves.

An Endura Chemical tech found the spill and closed the valves. Vac truck recovered 50 bbls oil from the pad. Site is now surrounded with stakes and flagging to keep trucks from driving through area and causing more issues.

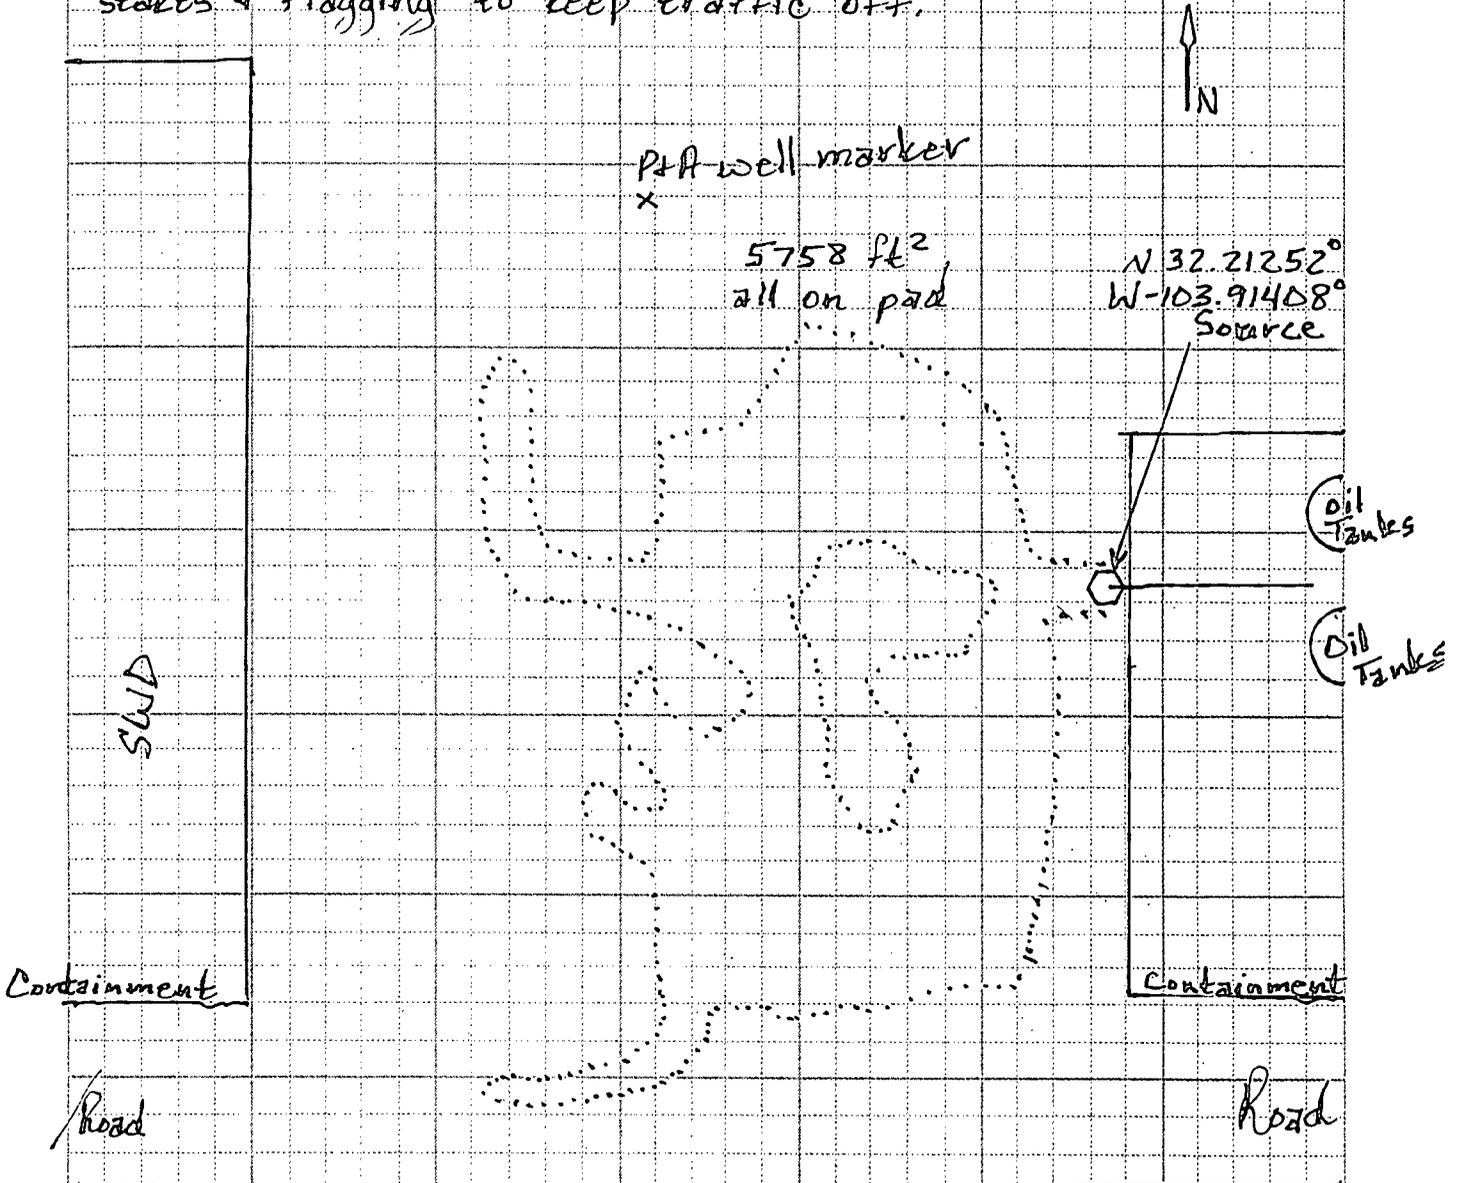
PLU 213 Oil Load Line

cracked
 An oil dump valve was left open sometime this morning. Tire tracks on site indicate that a vac truck or hot oiler backed up to line valve was found cracked open. The valve has been closed. Vac truck recovered 50 bbls oil from the pad. Site is surrounded with stakes + flagging to keep traffic off.

$$5758 \text{ ft}^2 \times 6" = 26 \text{ bbls oil in soil}$$
