December 14, 2012

**Re: Work Plan for the COG Operating LLC., Aid State SWD, Unit O,  
Section 14, Township 17 South, Range 28 East, Eddy County,  
New Mexico.**

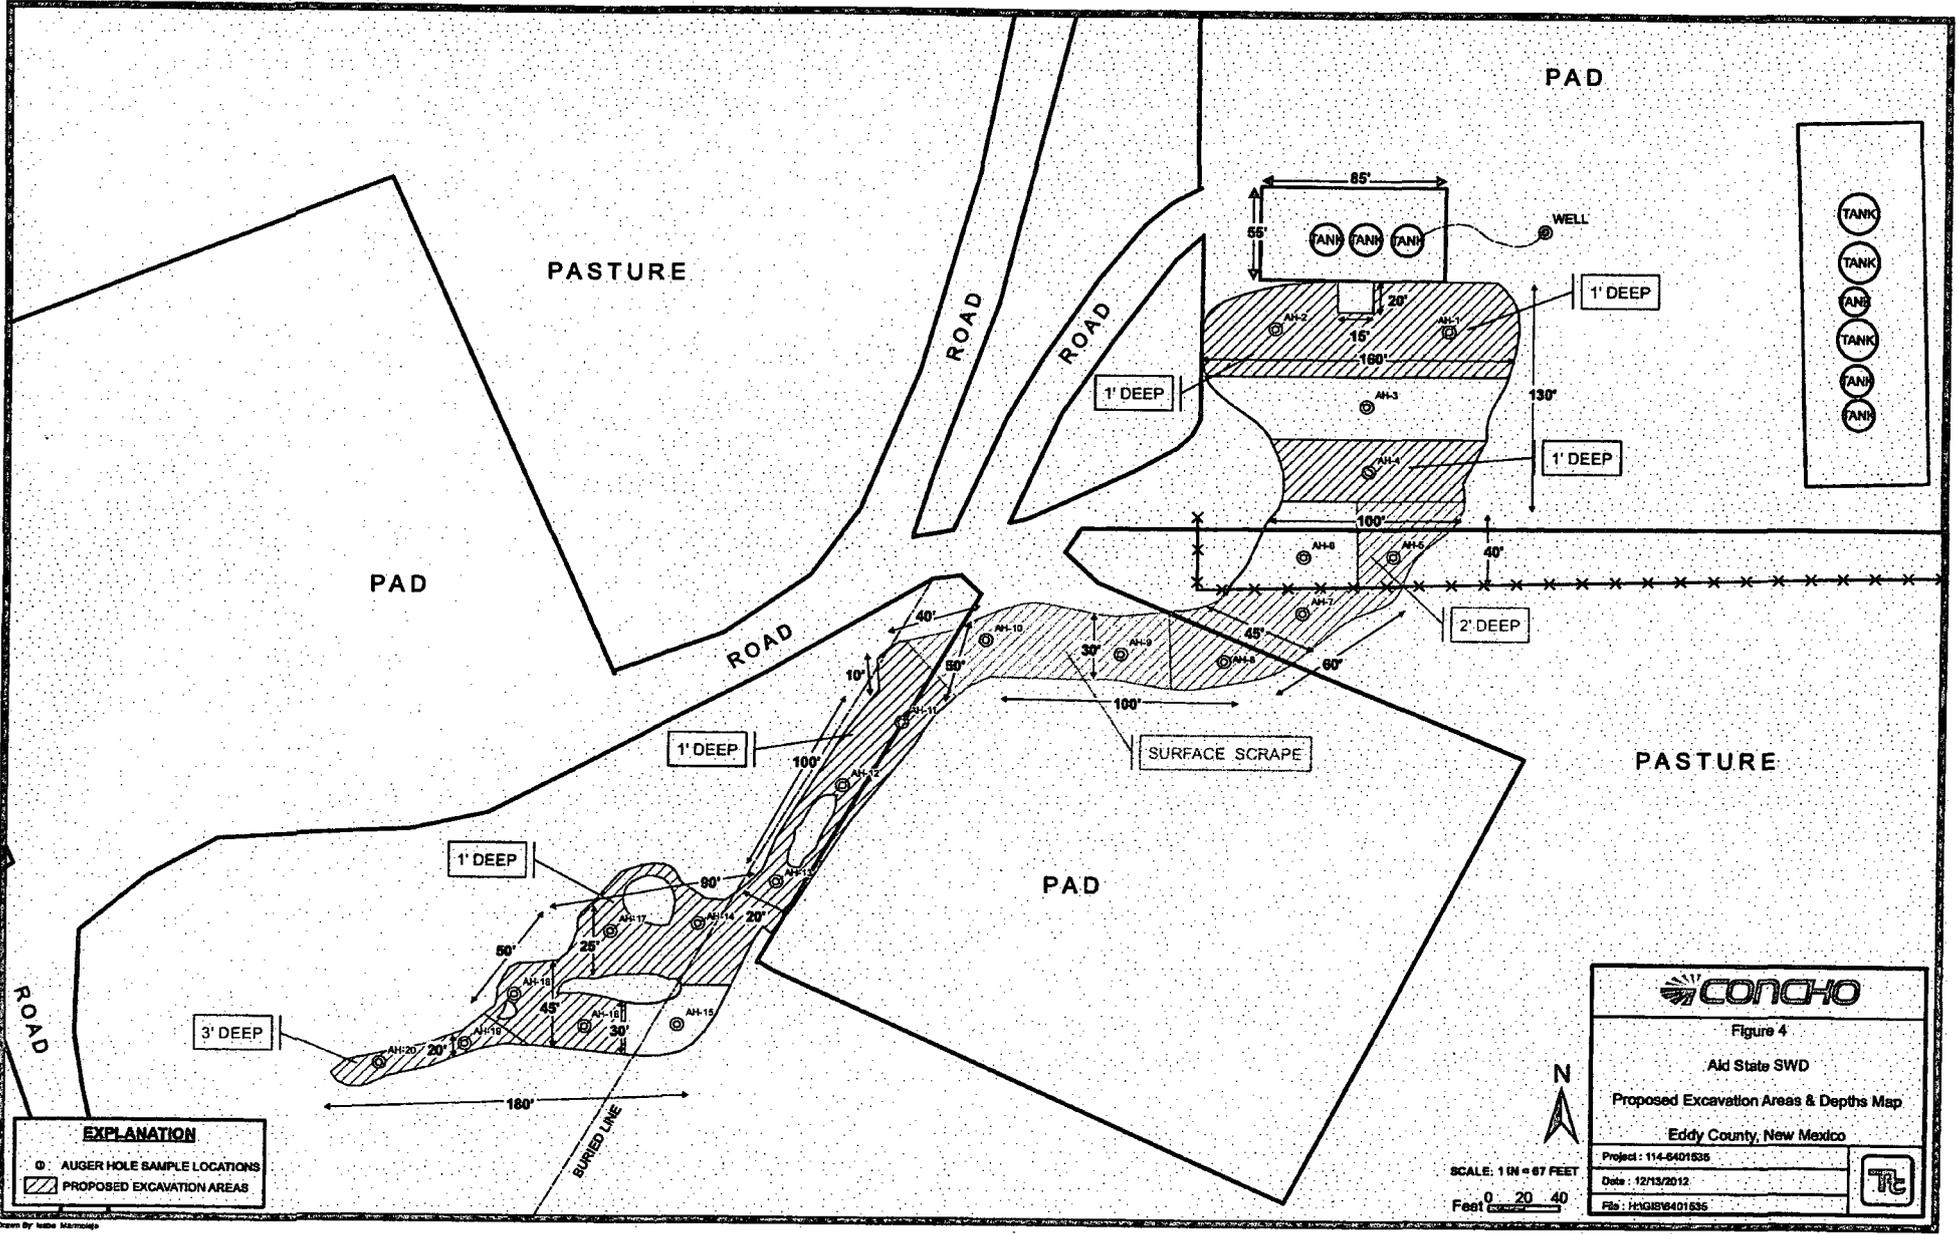
Figure 3	
Ald State SWD	
Spill Assessment Map	
Eddy County, New Mexico	
Project : 114-0401635	
Date : 11/20/2012	
File : H:\GIS\6401635

On October 2, 2012, Tetra Tech personnel inspected and sampled the spill area. Twenty (20) auger holes (AH-1 through AH-20) were installed using a stainless steel hand auger to assess the impacted soils. Selected samples were analyzed for TPH analysis by EPA method 8015 modified, BTEX by EPA Method 8021B and chloride by EPA method 300.0. Copies of laboratory analysis and chain-of-custody documentation are included in Appendix C. The sampling results are summarized in Table 1. The auger hole locations are shown on Figure 3.

Referring to Table 1, all of the auger hole samples were below the RRAL for TPH and BTEX. The chloride concentrations showed a shallow impact (0 to 2.0') to the soils at majority of the auger hole locations. Auger holes (AH-1, AH-2, AH-7, AH-8, AH-13, AH-19 and AH-20) were not vertically defined during the assessment.

The areas of AH-3 and AH-15 did not show a chloride impact to the soils. Auger holes (AH-9 and AH-10) detected chloride concentrations of 1,040 mg/kg (0-1') and 1,440 mg/kg (0-1'), respectively. The deeper samples (1-1.5') declined with depth to 293 mg/kg (AH-9) and 375 mg/kg (AH-10). Auger hole (AH-5) exhibited the highest chloride concentration of 10,600 mg/kg at 1-1.5', but declined to 571 mg/kg at 2-2.5' below surface. All chloride concentrations declined with depth, with the exception of AH-19 and AH-20. These two auger holes exhibited chloride concentrations of 2,080 and 604 mg/kg respectively at 1-1.5' below surface and increased to 5,950 and 3,320 mg/kg at 2-2.5' below surface.
