Release Notification and Corrective Action

Name of Company: BOPCO, L.P. <u>2140737</u>	Contact: Tony Savoie
Address: 522 W. Mermod, Suite 704 Carlsbad, N.M. 88220	Telephone No. 575-887-7329
Facility Name: PLU-392H at the PLU-68 Tank Battery. API will be used for the Tank Battery Location	Facility Type: Exploration and Production
Surface Owner: Federal	Mineral Owner: Federal
API No. 30-015-25781

FIELD SPILL REPORT

LOCATION OF SPILL SITE: PLU 392H flowline at PLU68 Btry (API 30-015-25781)

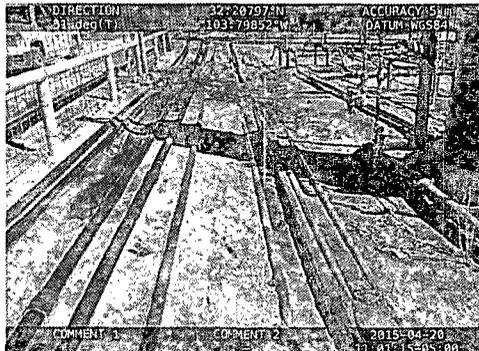
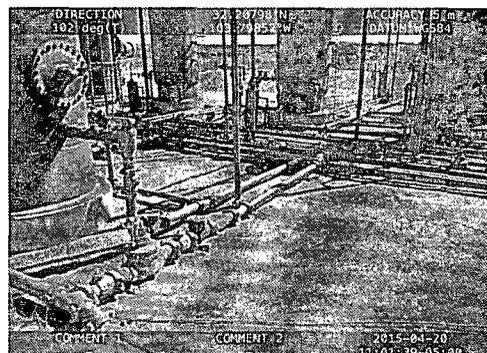
PICTURE ATTACHMENT:

EHS was notified of a release of fluids from a corroded flowline within the confines of the PLU 68 Battery's process equipment earthen containment. The leak was discovered sometime around 10a.m. 4/19. All fluids remained within the berm.

Line was clamped on 4/19 and the crew replaced the line section on 4/20. Notification to NMOCD was made by email at 10:00 am today and BLM was notified by phone. An initial form C-141 will be submitted. Total recovered 10bbbls. (Estimated 2 bbl oil and 8 bbl produced water) Remediation to be planned
