Release Notification and Corrective Action

OPERATOR		<input checked="" type="checkbox"/> Initial Report	<input type="checkbox"/> Final Report
Name of Company: BOPCO, L.P.	<i>360737</i>	Contact: Tony Savoie	
Address: 522 W. Mermod, Suite 704 Carlsbad, N.M. 88220		Telephone No. 575-887-7329	
Facility Name: Remuda Basin 31 State COM #001		Facility Type: Exploration and Production	
Surface Owner: State of NM	Mineral Owner: State of NM	API No. 30-015-31774

FIELD SPILL REPORT

LOCATION OF SPILL SITE: Remuda Basin 31 State Com 001 (API 30-015-31774)

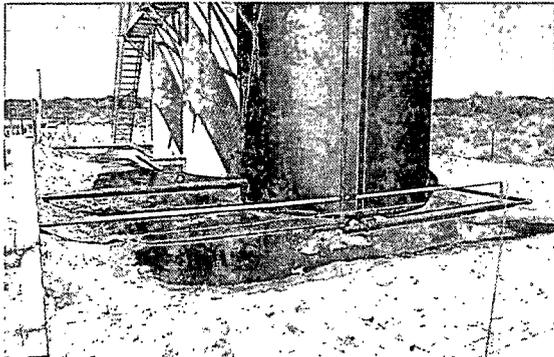
PICTURE ATTACHMENT:

Fluid tech reported water tank overflowed into earthen berm. All fluid stayed in berm area

Vac truck recovered 3 bbls produced water. Hydro vac being called in to remove the remaining water and saturated soil. Further assessment/remediation to be planned.
