Release Notification and Corrective Action

Name of Company: BOPCO, L.P. <i>200737</i>	Contact: Tony Savoie
Address: 522 W. Mermod, Suite 704 Carlsbad, N.M. 88220	Telephone No. 575-887-7329
Facility Name: JRU-106H Flow line, the spill is 2003 ft. East of the well pad. UL "J"	Facility Type: Exploration and Production

FIELD SPILL REPORT

LOCATION OF SPILL SITE: JRU 106 Flowline 2003 Ft. East of well pad (API 30-015-37063)

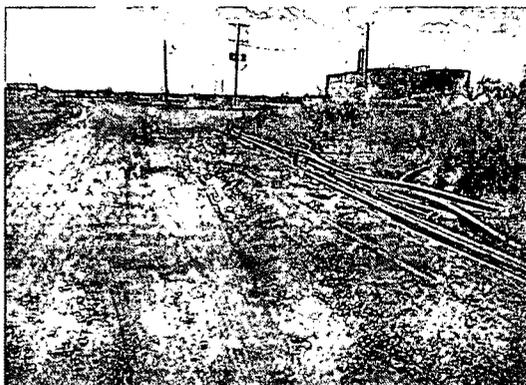
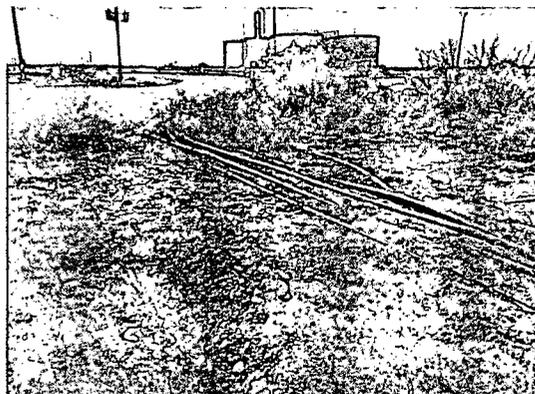
PICTURE ATTACHMENT:

Describe Cause of Problem and Remedial Action Taken.*
The flow line developed a leak due to corrosion, a temporary leak clamp was placed on the affected area until the well could be shut down and a joint of pipe replaced.

EHS was notified of a release that occurred on the JRU 106 flowline. Release was due to external corrosion

Vacuum truck came out to location and recovered 20 bbls of oil. Further remediation will be planned
