**Release Notification and Corrective Action**

Name of Company: BOPCO, L.P. <b>210737</b>	Contact: Tony Savoie
Address: 522 W. Mermod, Suite 704 Carlsbad, N.M. 88220	Telephone No. 575-887-7329
Facility Name: BEU Hackberry 34 Fed. #1	Facility Type: Tank Battery and SWD
Surface Owner: Federal	Mineral Owner: Federal
API No. 30-015-40288

## FIELD SPILL REPORT

LOCATION OF SPILL SITE: BEU Hackberry 34 Fed. #1 Battery (API 30-015-40288)

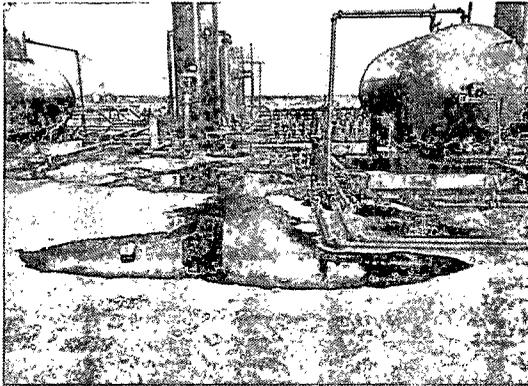
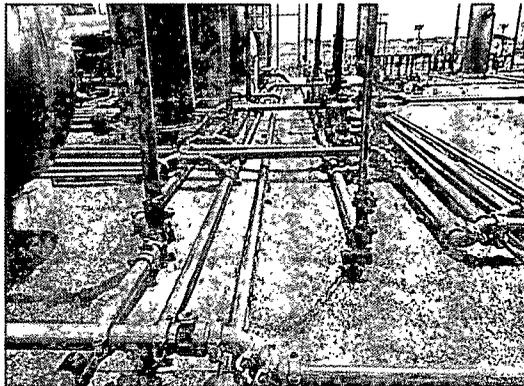
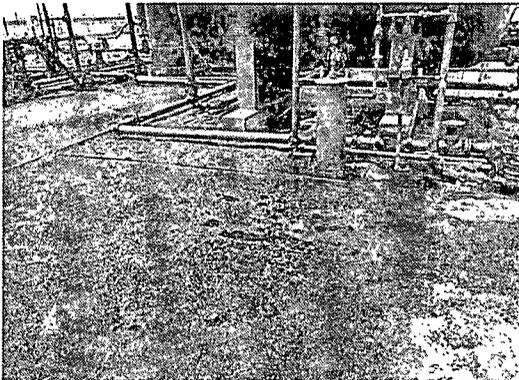
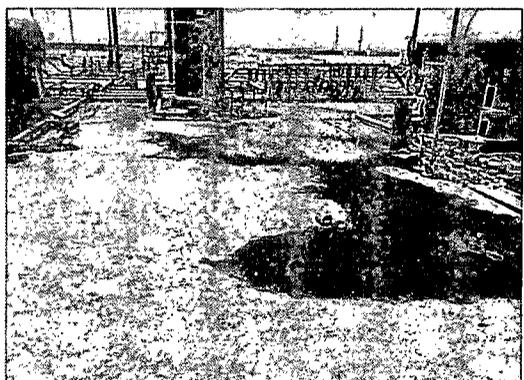
**PICTURE ATTACHMENT:**

EHS was notified of a release that occurred at the Hackberry battery. A sight glass broke and released 12 bbls. of oil to the ground surface.

A vacuum truck was called out and recovered 4 bbls of oil. Future remediation to be planned.
