**Release Notification and Corrective Action**

Name of Company: BOPCO, L.P. <i>260737</i>	Contact: Tony Savoie
Address: 522 W. Mermod, Suite 704 Carlsbad, N.M. 88220	Telephone No. 575-887-7329
Facility Name: JRU-91 Flow line spill 1406 ft. south of the well at the JRU-29 SWD pad	Facility Type: Exploration and Production

## FIELD SPILL REPORT

LOCATION OF SPILL SITE: JRU-91 Flow line (At the JRU-29 Pad) (API 30-015-33601)

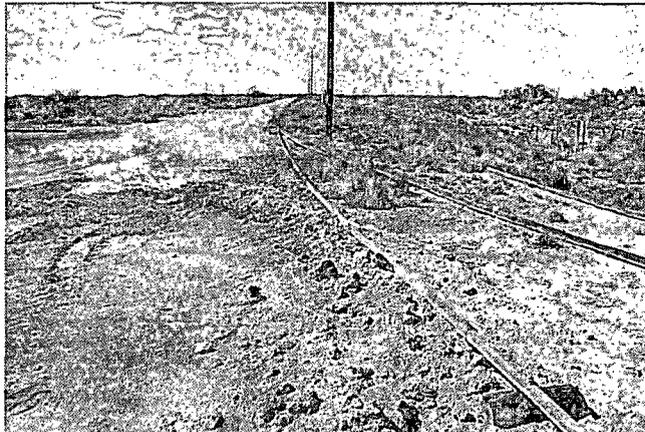
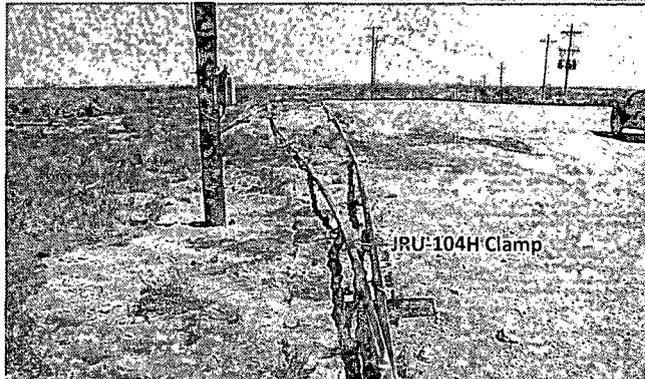
**PICTURE ATTACHMENT:**

Describe Area Affected and Cleanup Action Taken.\*  
The spill impacted approximately 300 sq.ft. of pasture area and approximately 750 sq.ft. of well pad-road area. This is the same general area as the reported spill at the JRU-29 Well pad on 12/25/14. Reference spill #2RP-2726.  
The areas will be cleaned up in accordance to the NMOCD guidelines for spill remediation.

EHS was notified at 2:30 p.m. 5-25-15 of a flow line leak due to external corrosion. A temporary leak clamp was placed on the pipe.

A vacuum truck picked up the free standing fluid from the road. EH%S Reviewed the site on 5/25/15. Most of the spill is located on the JRU-29 SWD and well pad. The same general location as the 97 bbl PW spill on 12/25/14. The clamp on the JRU-104H is about 35 ft. from the recent spill. The salt impacted soil needs to be removed from around the flow lines and well pad-road.

Describe Cause of Problem and Remedial Action Taken.\*  
The flow line developed a leak due to external corrosion. A temporary repair clamp was placed on the leak, the lines will be replaced adjacent to the well pad and placed on cross ties.
