Occidental Permian Limited Partnership

May 16, 2005

RE: Final Closure Letter
8" Cement Lined Steel Injection Trunk Line Leak
UL 'I', Sec. 5, T-19-S, R-38-E

Release Notification and Corrective Action

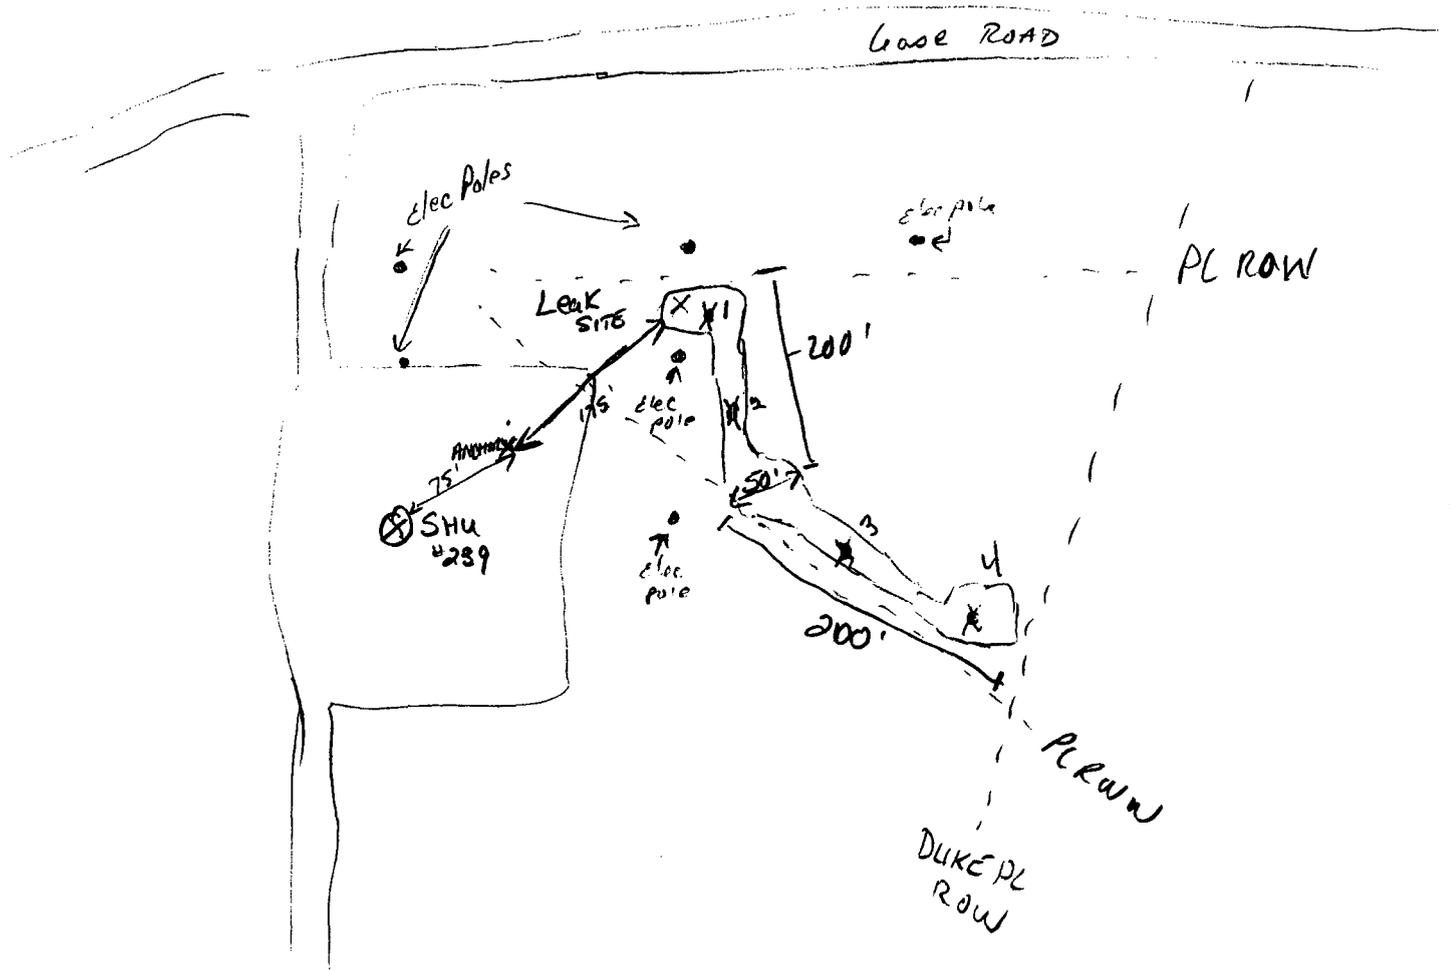
SPILL MAP

41I' Sec 5, T-18-S, R-38E
250' NE SHU #239

0 B0 x 400 BW est.

* Sample point

*1 N32° 41.268' + W 103° 09.747'

*2 N32° 41.255' + W 103° 09.746'

*3 N32° 41.241' + W 103° 09.742'

*4 N32° 41.228' + W 103° 09.728'
