**RE: ConocoPhillips – EVGSAU 6” Injection Line Leak**

BBC International, Inc. respectfully submits this site investigation report for the EVGSAU 6” Injection Line Leak on behalf of ConocoPhillips.

# **ConocoPhillips EVGSAU**

## **6" Injection Line Leak**

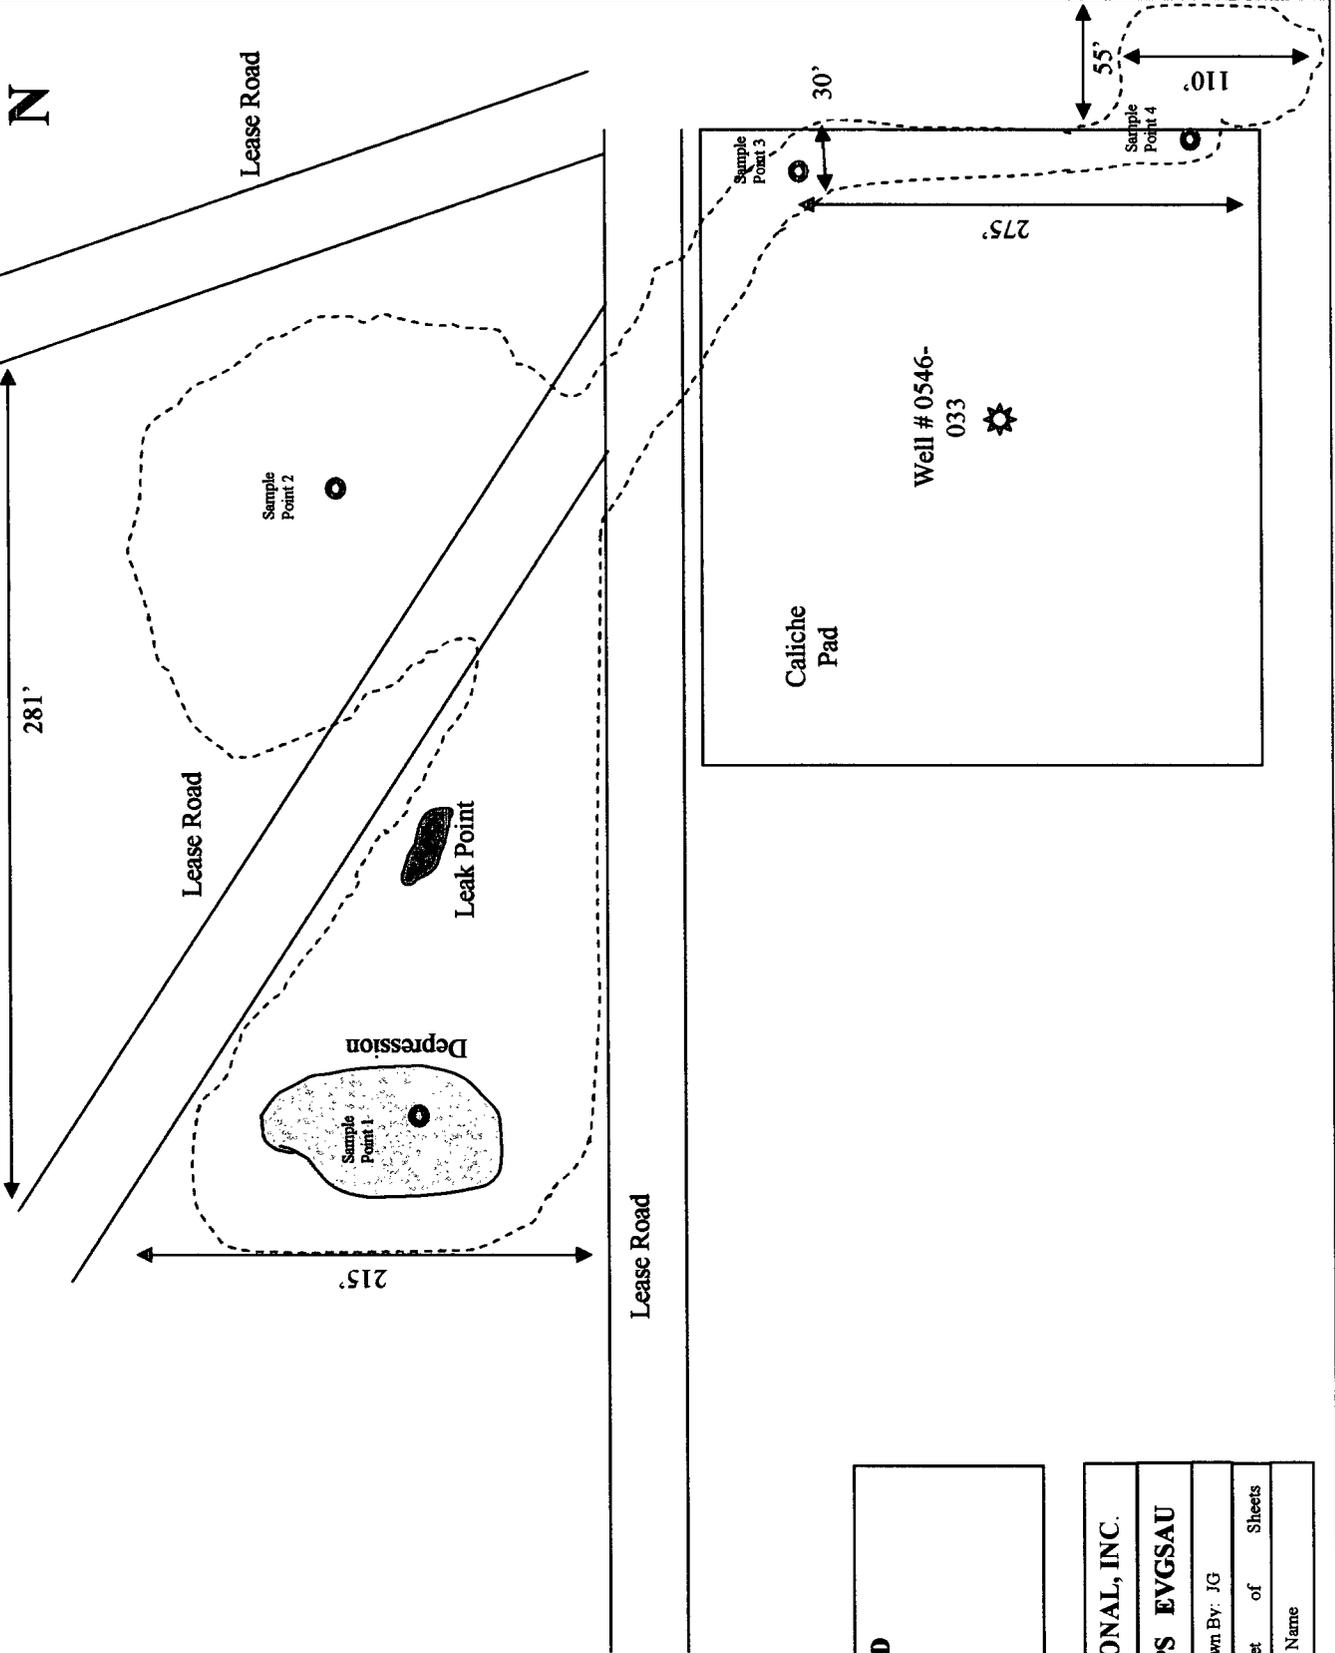
# ConocoPhillips EVGSAU 6" Injection Line Leak

On September 9, 2003 BBC personnel conducted an inspection of the site. Four sample points were dug at the site to varying depths, using a backhoe. Sample Point 1 was dug on the west side of the site in a depression where the fluid appeared to have collected. Sample Points 2 and 3 were dug at the approximate center of the north and south portions of the affected area. Sample Point 4 was dug on the south end of the leak site in a low spot where the fluid appeared to have collected. Sample Points 2, 3, and 4 were shallower than Sample Point 1 due to a very hard rock layer from 1 to 3 feet below surface. Field screening techniques were used to determine samples to be sent for laboratory analysis. Field screening consisted of field chloride titrations. Laboratory results are located in Appendix I. Pictures of the leak site and the investigation activities are located in Appendix III.
