## **Occidental Permian Limited Partnership**

RE: Final Closure Letter  
South Hobbs Unit 215 3" Fiberglass Injection Line  
UL 'F', Sec. 4, T-19-S, R-38-E

**Release Notification and Corrective Action**

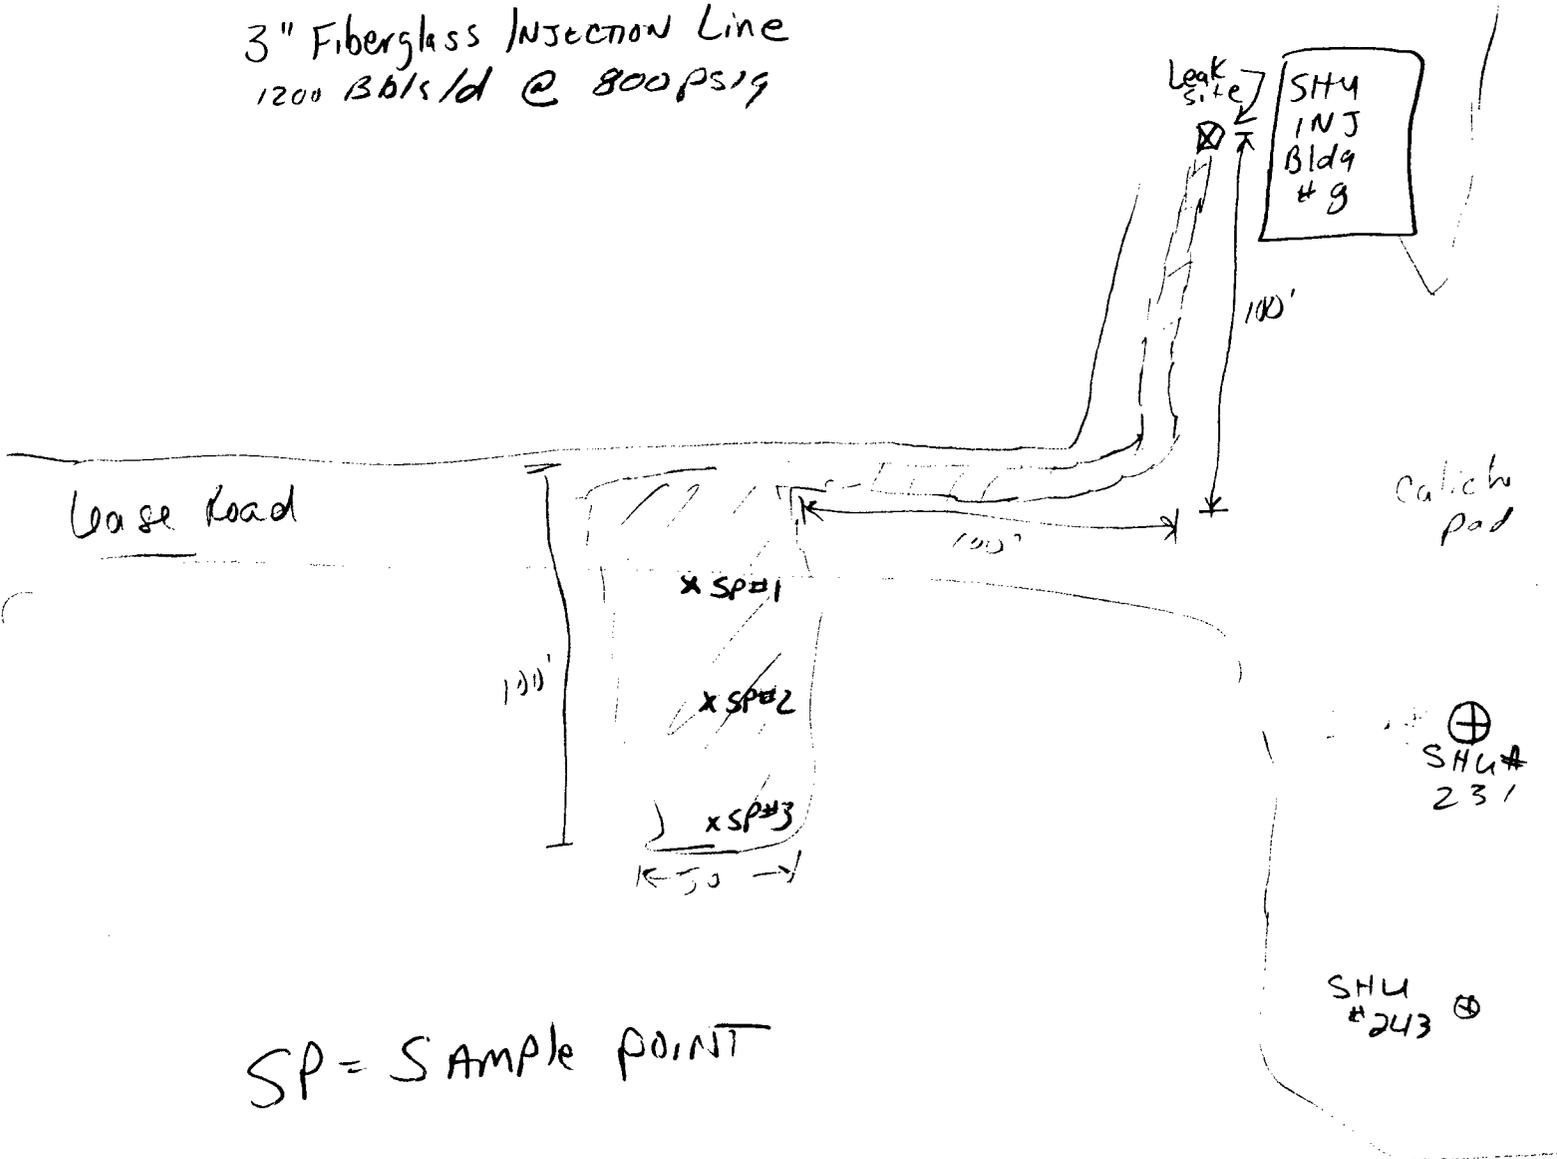
# SPILL MAP

12/13/05 SHU # 215 INJ Line leak  
West side of INJECTION Bldg # 9  
20 Bbls INJECTION WATER - Recovered  
N 32° 41' 33.80", W 103° 09' 19.90" UL'F, Sec 4, T-19-S, R-39-E  
3" Fiberglass INJECTION Line  
1200 Bbls/d @ 800 psig
