Incident Description

The West Artesia Grayburg Unit No. 4, an injection well, was being flowed back into a frac tank prior to well repairs. The tank overflowed sometime between the evening of 7/20/10 and the morning of 7/21/10. The water flow was immediately halted and the tank was drained. The resulting impacted area is located to the west of the location and onto the adjacent pasture. The release also had sufficient volume to cross County Road 231 and flow onto a local two-track road. The impacted area was measured to be approximately three hundred sixty feet (360') long by twenty feet (20') wide at the location, and it measures approximately one hundred ninety feet (190') by eight feet (8') across CR 231.

Project Number: 701358.003.01

Project Name: GIB Unit #4

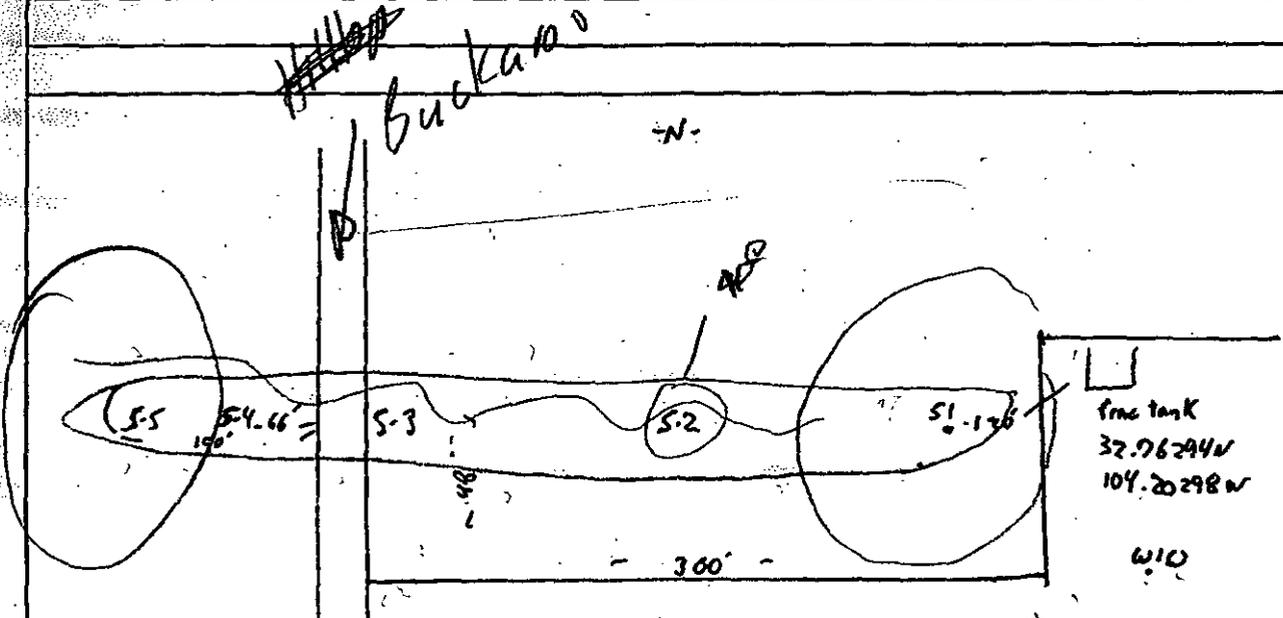
fuel tank
32.76244N
104.20298W

- S-1 32.76282N
104.20338W
- S-2 32.76252N
104.20361W
- S-3 32.76236N
104.20388W
- S-4 32.80085N
104.23465W
- S-5 32.76219N
104.20466W
