State G Com #1
(Located in UL-E of SEC 24, T19S, R27E of Eddy Co, NM)
(GPS Reading of 32°-38'-51.0"-N & 104°-14'-19.4"-W)
API # 30-015-22955

Spill Assessment Report

Basic Energy Services
PO Box 10460
Midland, Texas 79702

Phoenix Environmental, LLC.
P.O. Box 1856
Hobbs, New Mexico 88240

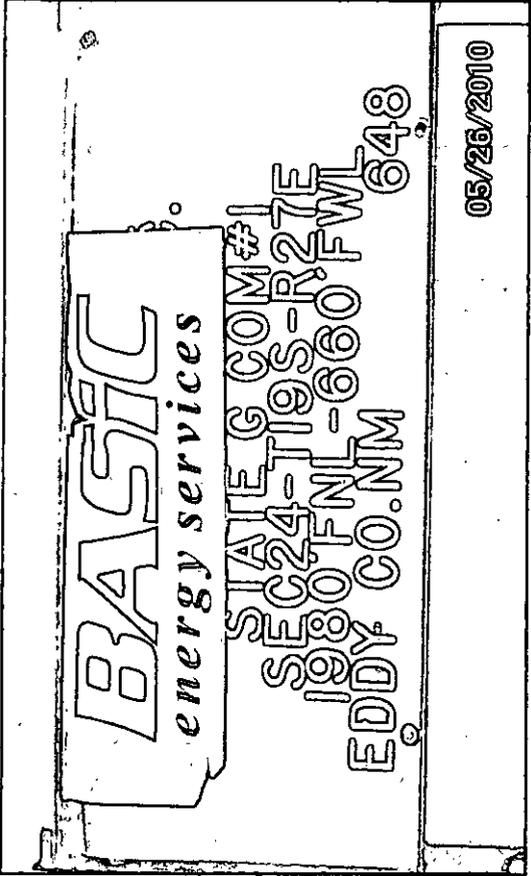
Photo # 1 Site sign and location
