**Release Notification and Corrective Action**

| Facility Name: FIELD #1 LEAK | Facility Type: Gas Processing | |

| Source of Release: 20" steel pipeline | Date and Hour of Occurrence:<br>9/6/2011 | Date and Hour of Discovery:<br>9/6/2011 |

**Remediation and Site Restoration Protocol  
Targa Midstream Services LLC  
Field #1 Leak  
1RP-2786**

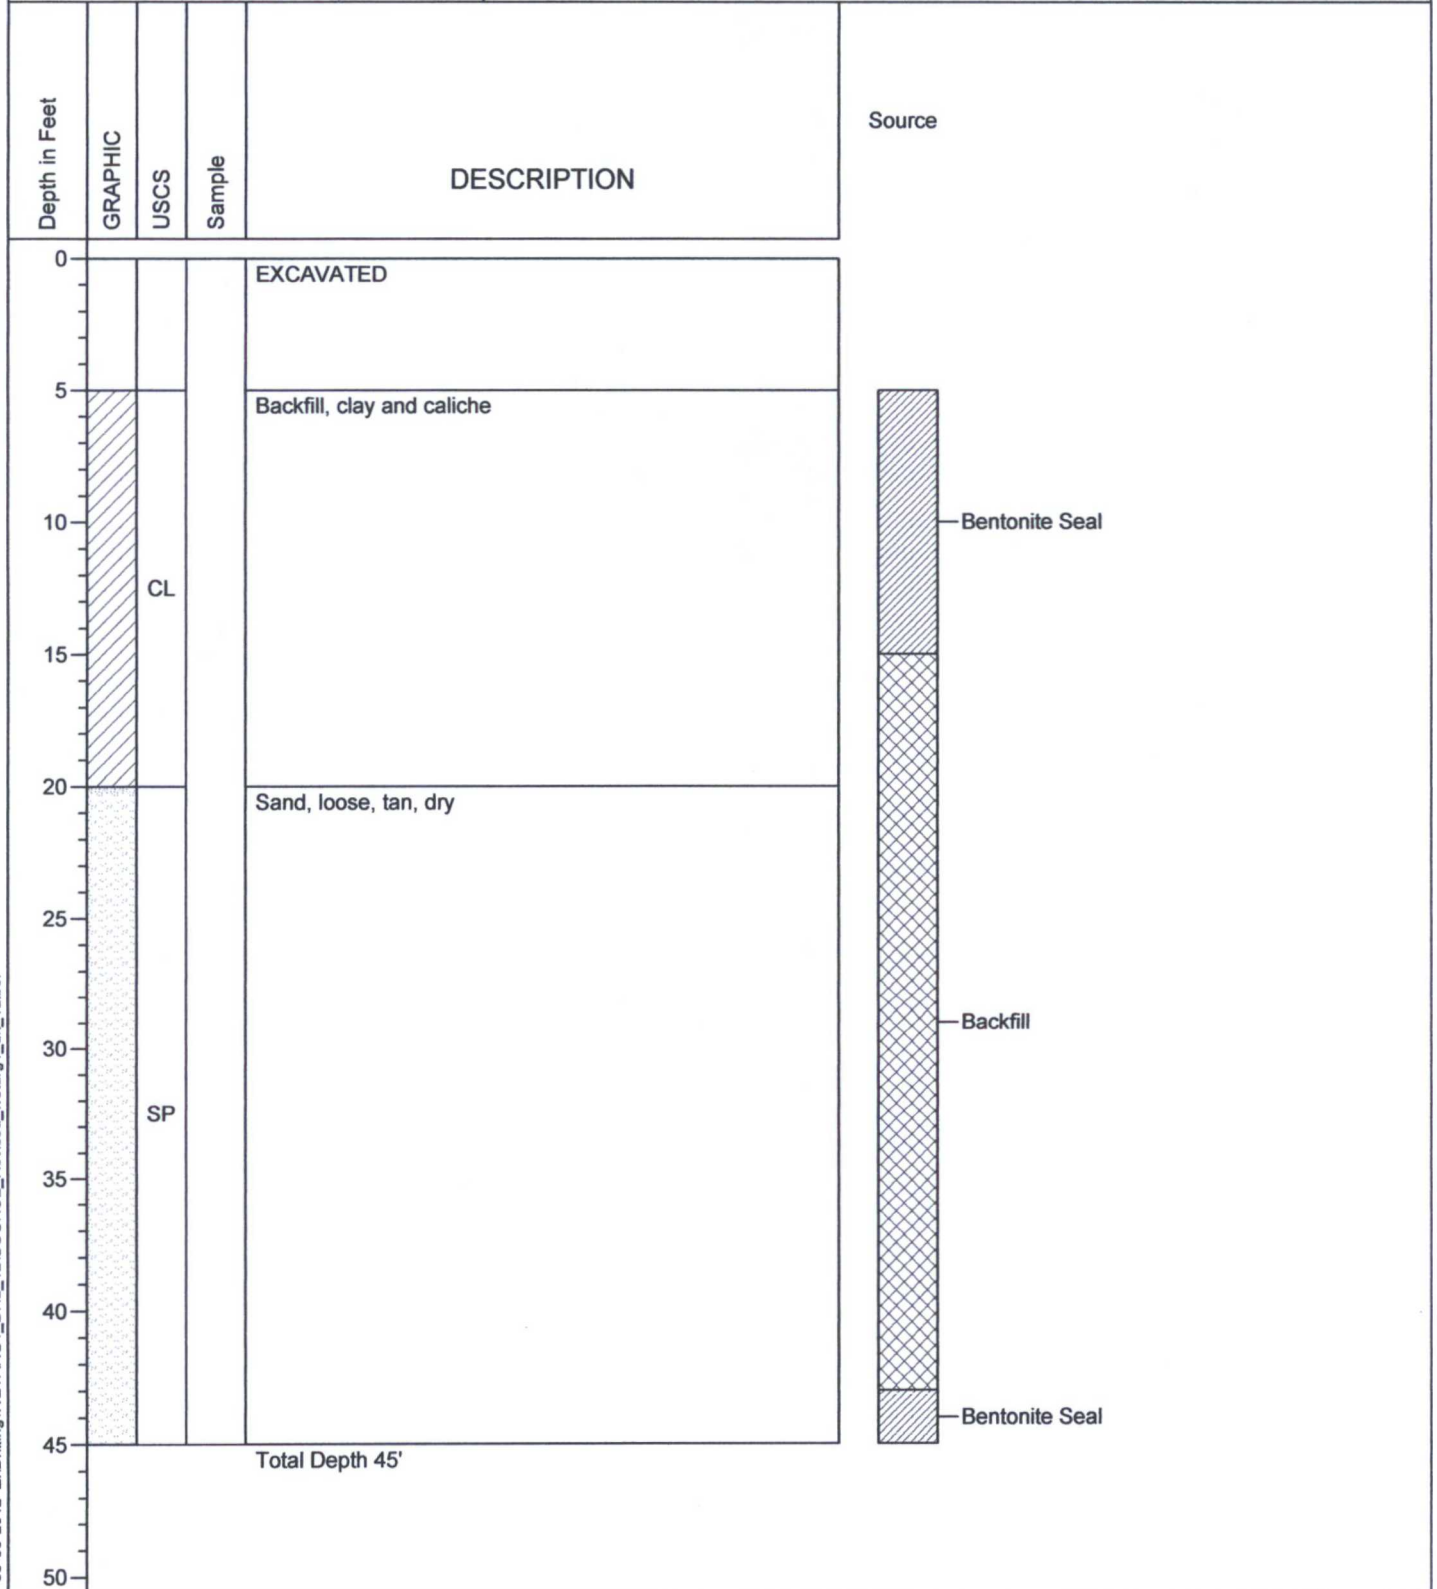
# Log of Boring: Targa Field 1 20" Leak SOURCE - Revised

| SOURCE<br>(N32.94690<br>W103.44845) | 830 | 15' | 10.6 | 25.7 | 2.42 | 0.05 | 242 | 1549.0 | 7.5YR-6/4 light brown sandy sand damp strong odor | | | | | | |
| | 838 | 20' | 0 | 0 | 0.00 | 0 | 0 | 1268.0 | 7.5YR-6/4 light brown sandy sand damp strong odor | | | | | | |
| | 848 | 25' | 10.3 | 25.6 | 2.49 | 0.01 | 50 | 1290.0 | 7.5YR-6/4 light brown sandy sand damp strong odor | | | | | | |
| | 900 | 30' | 0 | 0 | 0.00 | 0 | 0 | 724.0 | 5YR-7/2 pinkish gray sandy sand dry strong odor | <0.050 | <0.050 | <0.050 | <0.150 | <16.0 | 13.2 |
| | 908 | 35' | 10.2 | 27.9 | 2.74 | 0.02 | 109 | 349.0 | 5YR-8/3 pink sandy sand damp light odor | | | | | | |

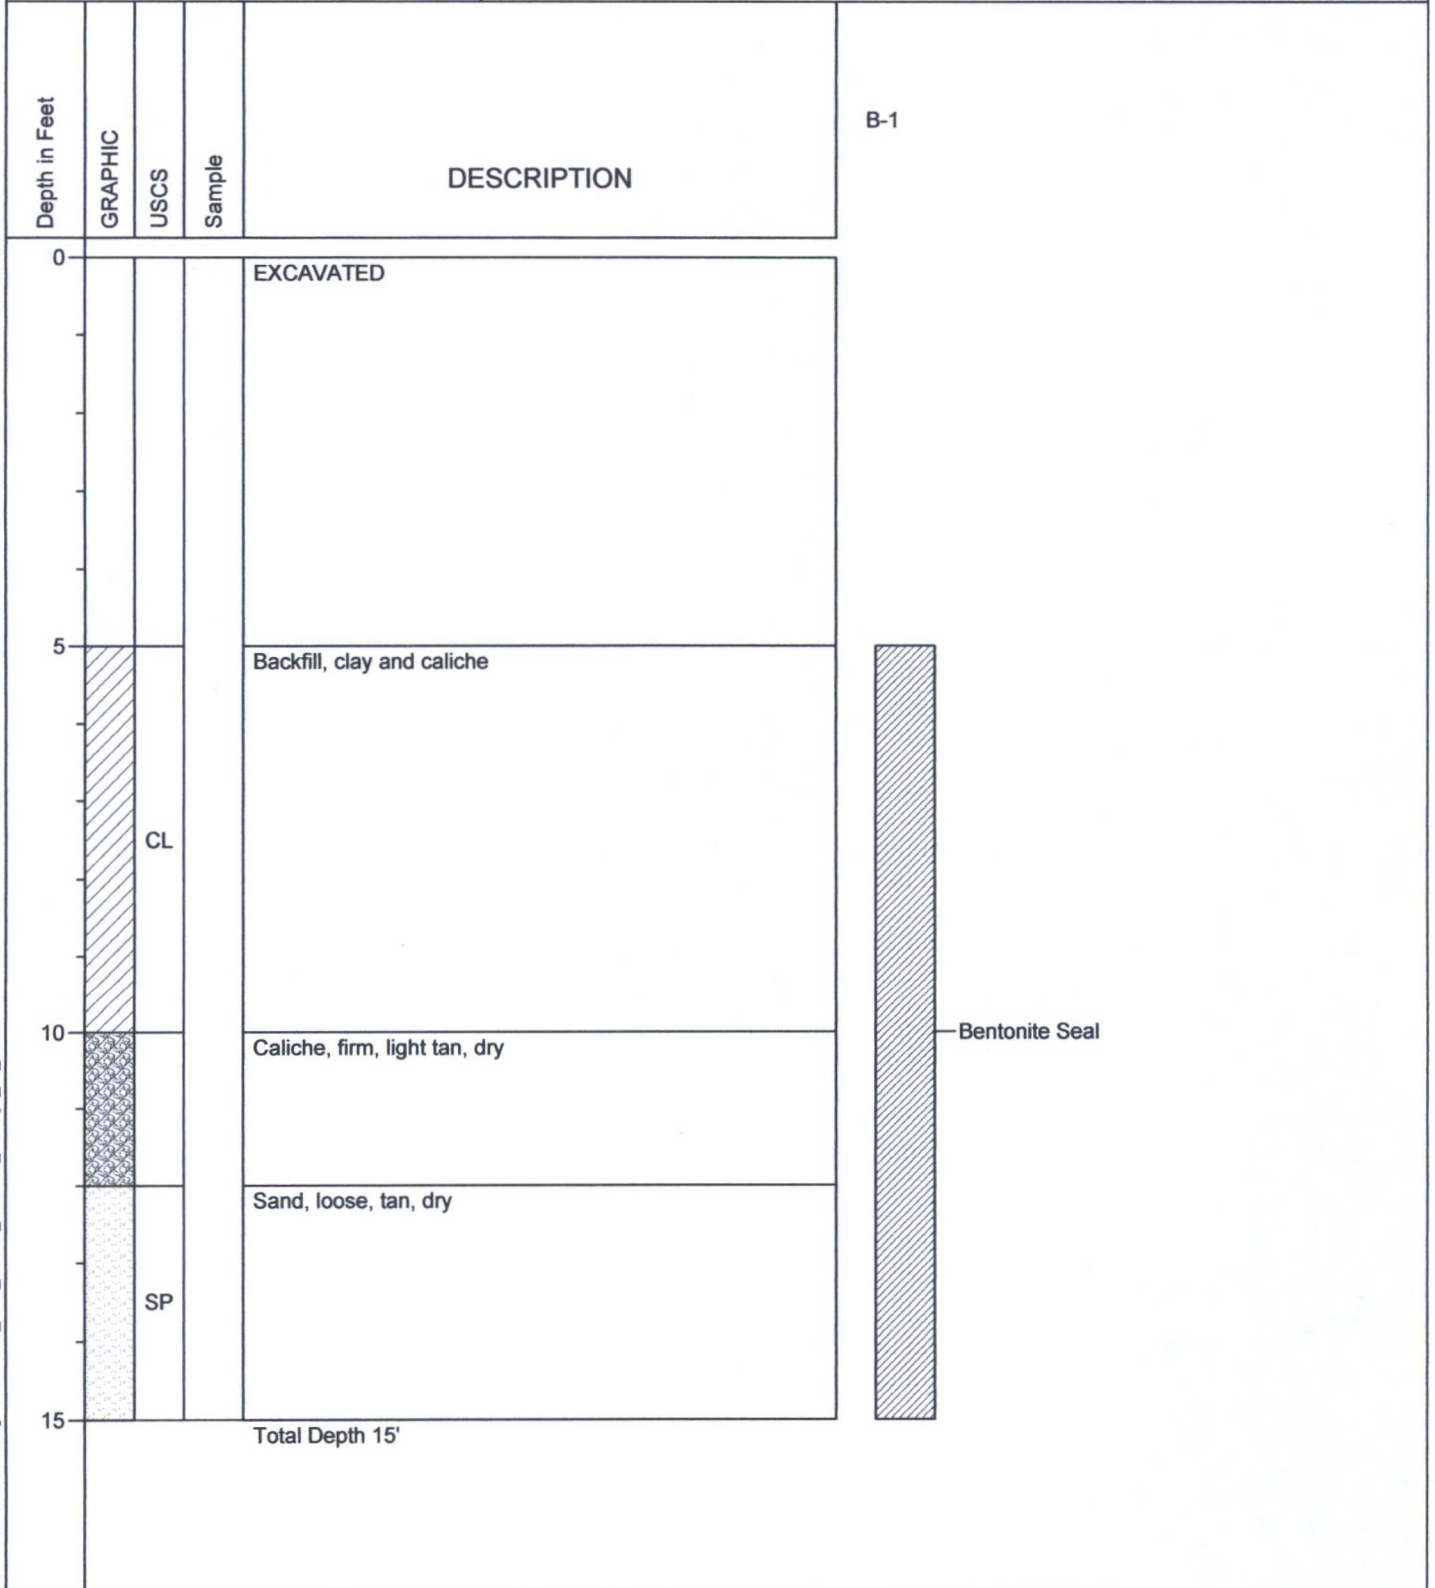
# Log of Boring: Targa Field 1 20" Leak B-1 - Revised

| B1<br>(N32.94695<br>W103.44846) | 918 | 40' | 0 | 0 | 0.00 | 0 | 0 | 129.0 | 5YR-8/3 pink sandy sand dry no odor | | | | | | |
| | 928 | 45' | 10.3 | 28.7 | 2.79 | 0.01 | 56 | 82.6 | 5YR-8/3 pink sandy sand dry no odor | <0.050 | <0.050 | <0.050 | <0.150 | <10.0 | <10.0 |

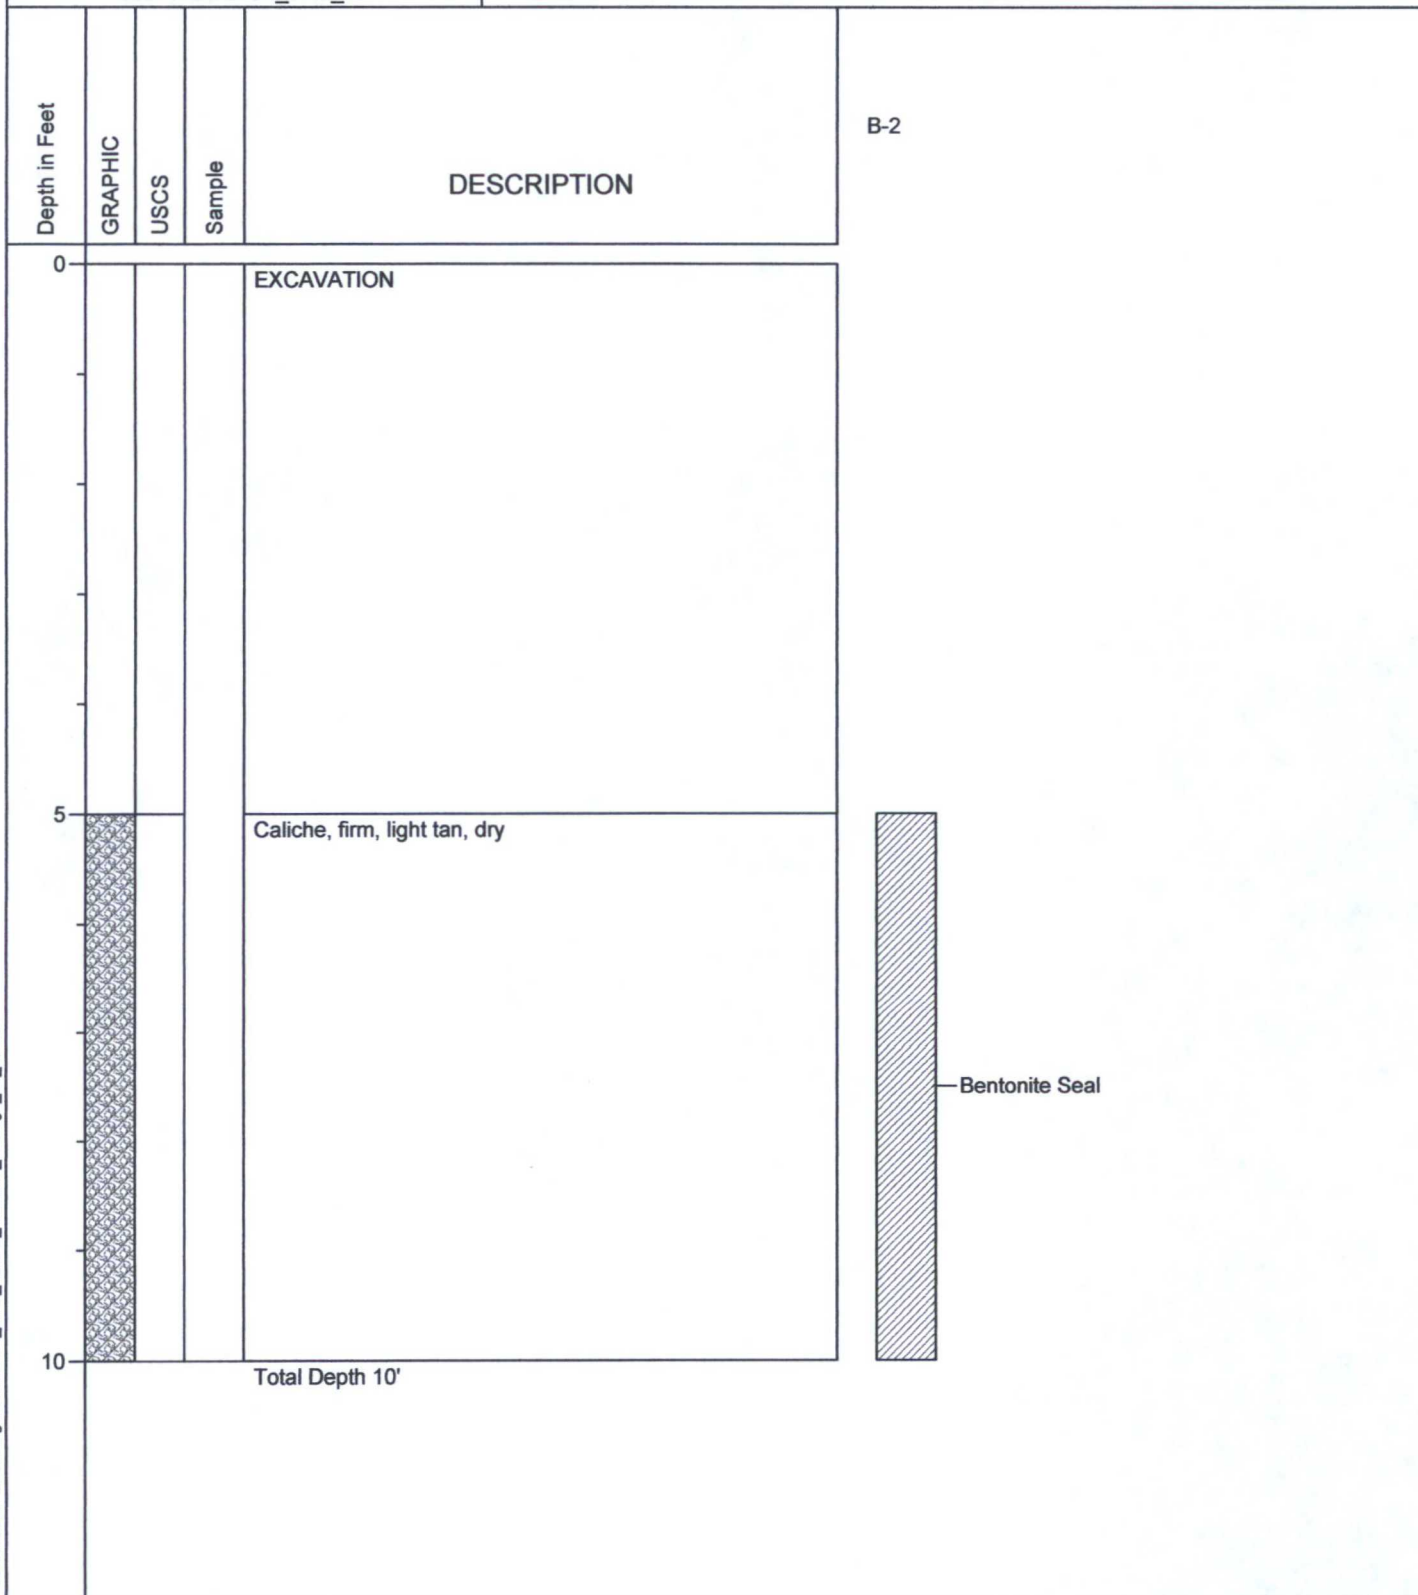
# Log of Boring: Targa Field 1 20" Leak B-2 - Revised

| B2<br>(N32.91693<br>W103.44846) | 15' | 1103 | 10 | 25.1 | 2.51 | 0.02 | 100 | 90.6 | 5YR-8/2 pinkish white sandy sand damp no odor | <0.050 | <0.050 | <0.050 | <0.150 | <10.0 | <10.0 |

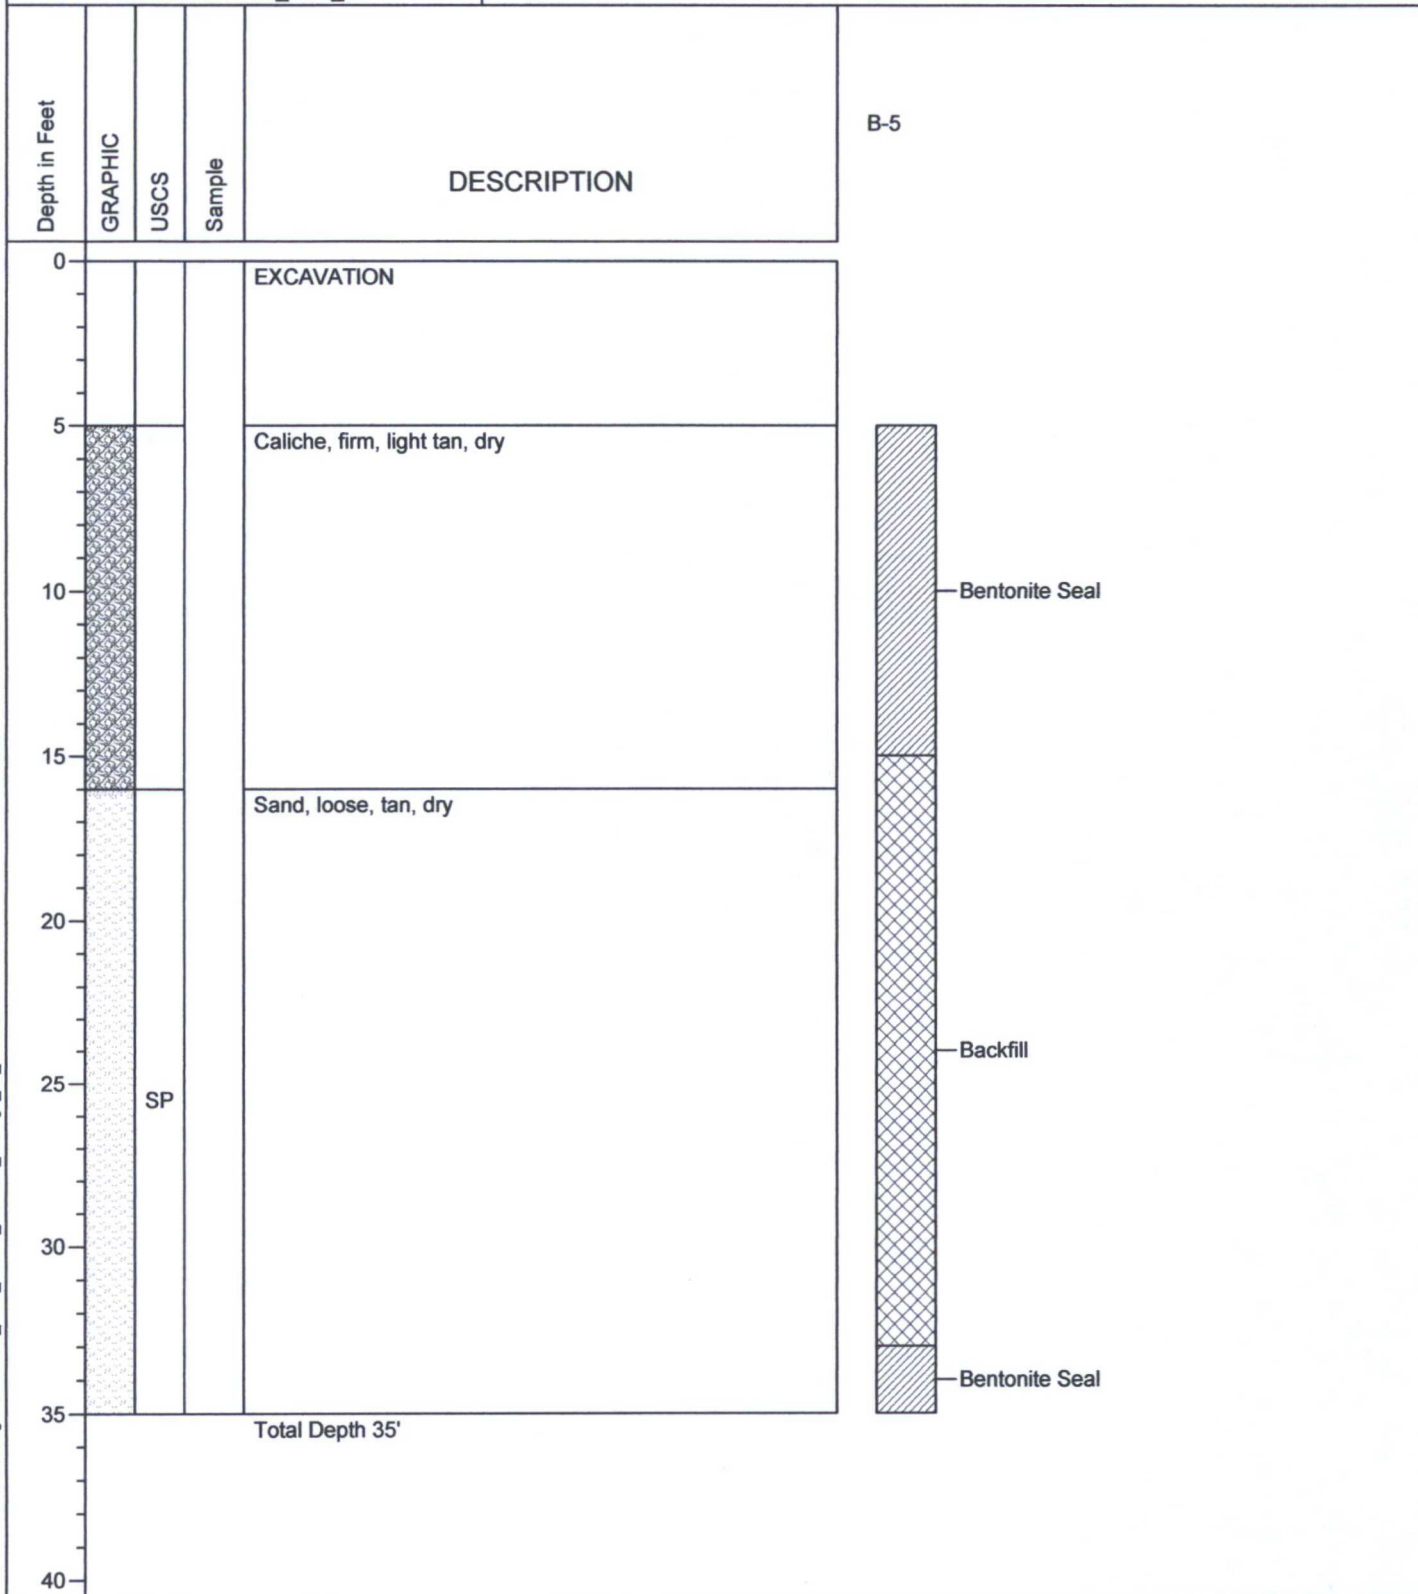
# Log of Boring: Targa Field 1 20" Leak B-5 - Revised

| Sample pt. | TIME | DEPTH | SOIL | WATER | CF | AGNO3 | CL- | PID | SOIL LITHOLOGY | LAB RESULTS | | | | | | |
|---|---|---|---|---|---|---|---|---|---|---|---|---|---|---|---|---|
| B5<br>(N32.94693<br>W103.44848) | 10' | 1237 | 10.1 | 27.3 | 2.70 | 0.03 | 162 | 27.6 | 5YR-8/2 pinkish white sandy sand damp no odor | | | | | | | |
| | 15' | 1244 | 0 | 0 | 0.00 | 0 | 0 | 84.1 | 5YR-8/3 pink sandy sand damp light odor | | | | | | | |
| | 20' | 1254 | 0 | 0 | 0.00 | 0 | 0 | 136.0 | 5YR-8/3 pink sandy sand damp light odor | <0.050 | <0.050 | <0.050 | <0.150 | | <10.0 | <10.0 |

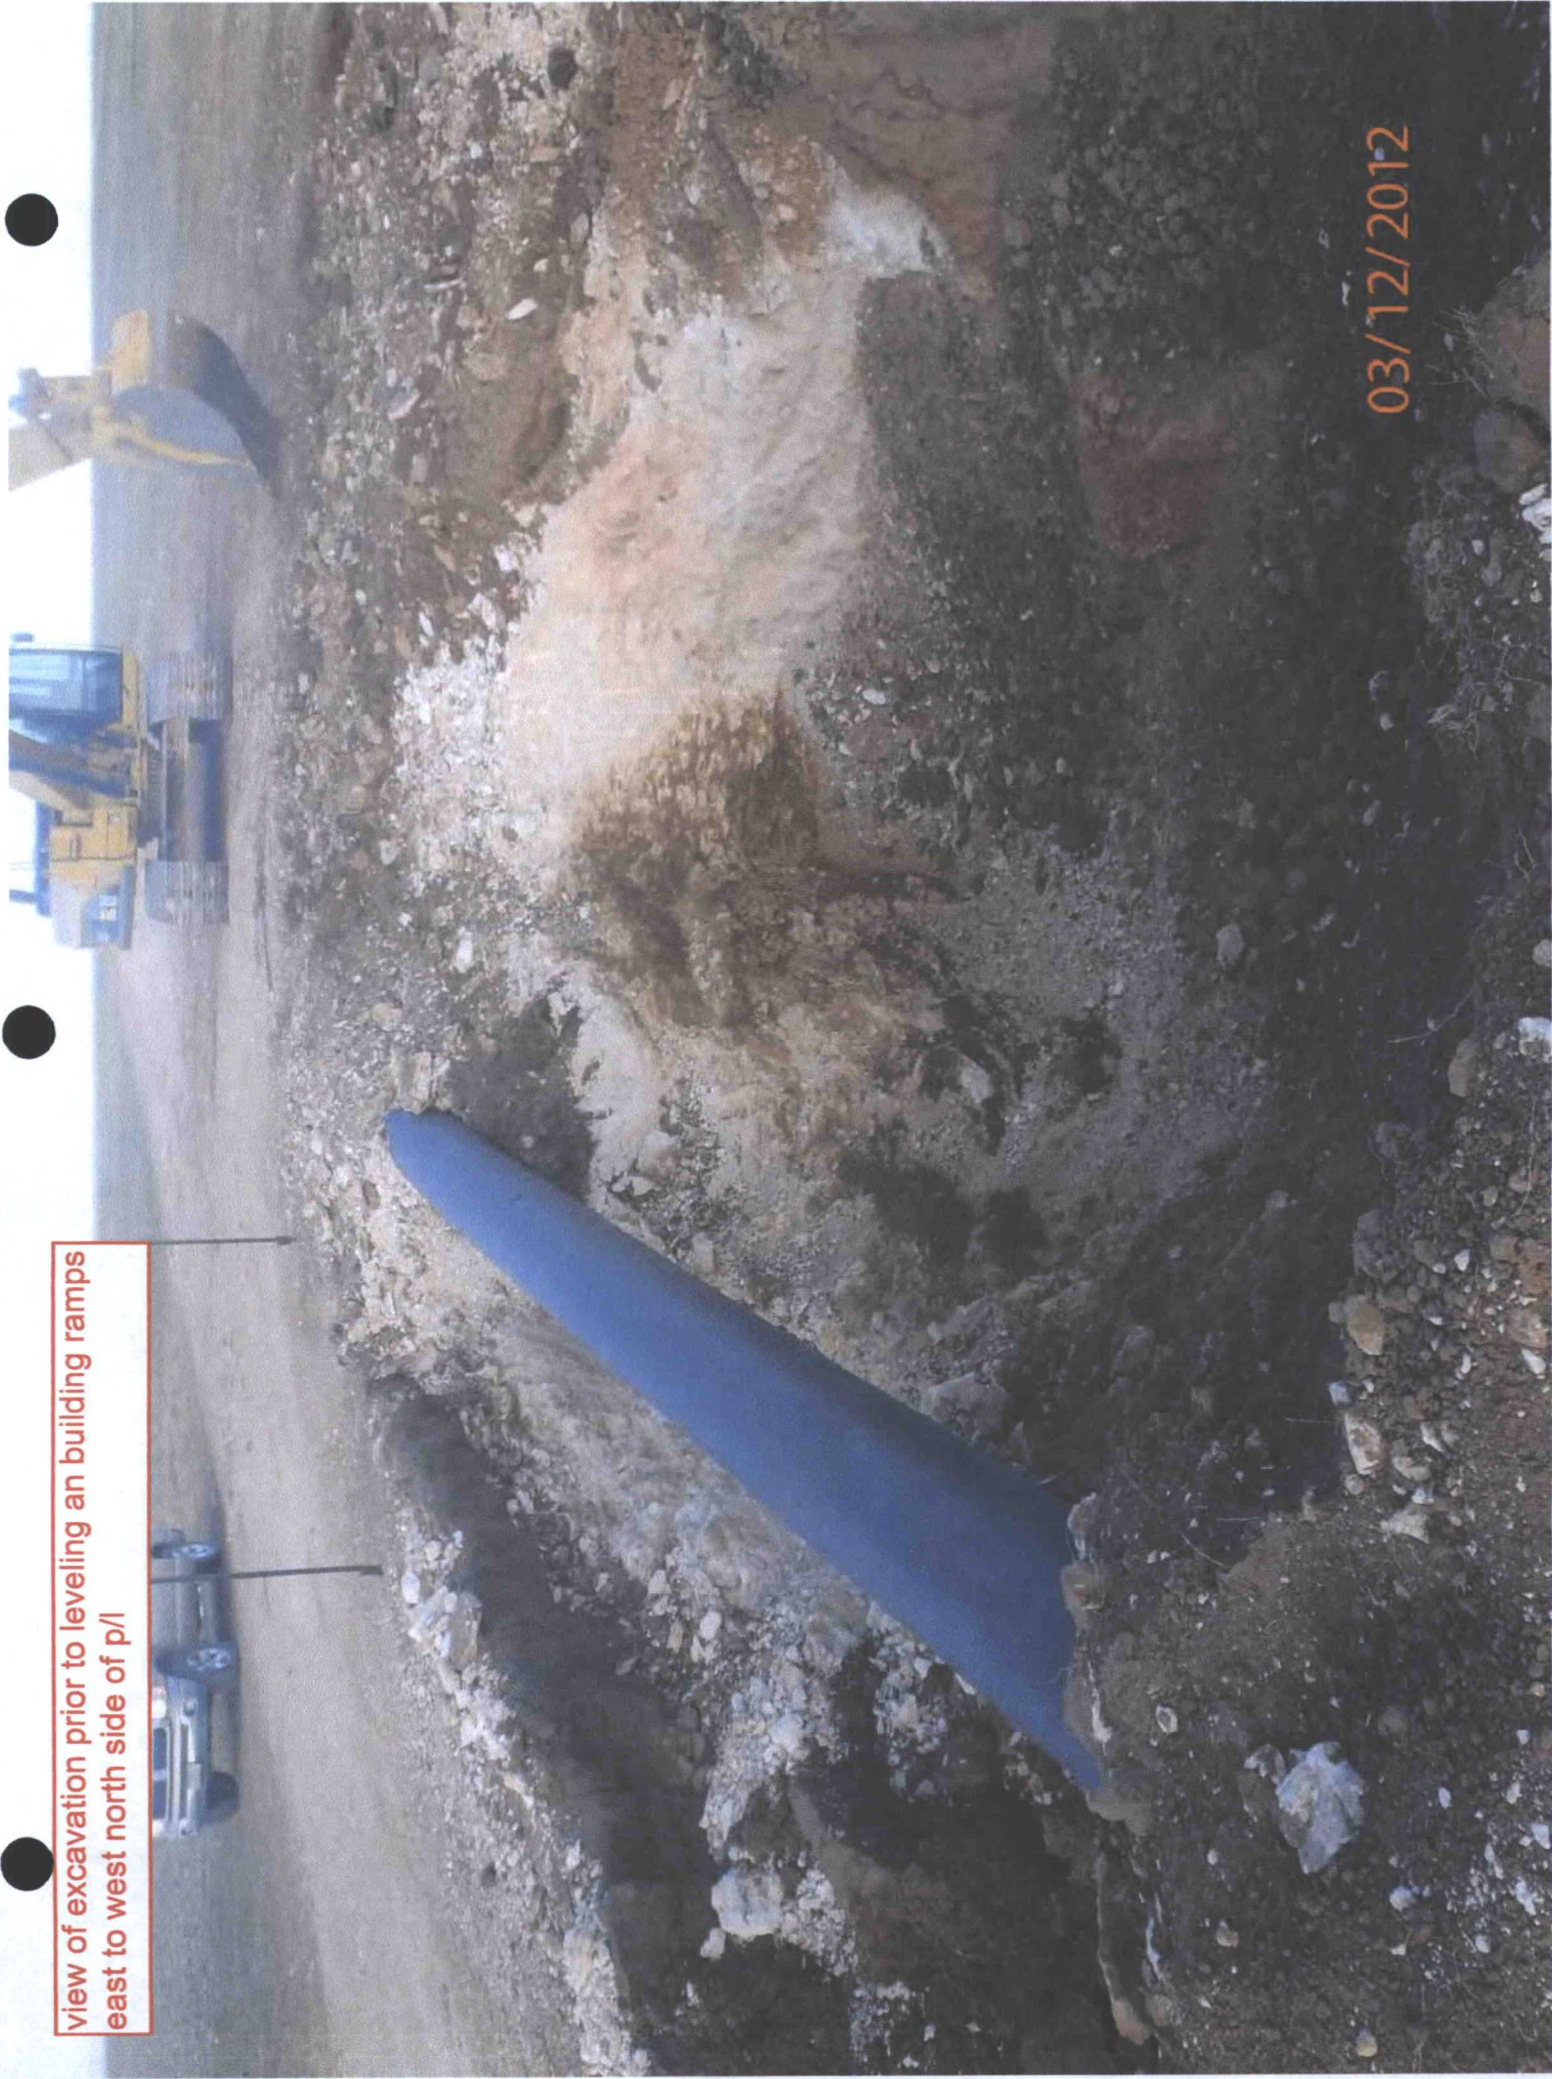
view of excavation prior to leveling an building ramps  
east to west north side of p/i

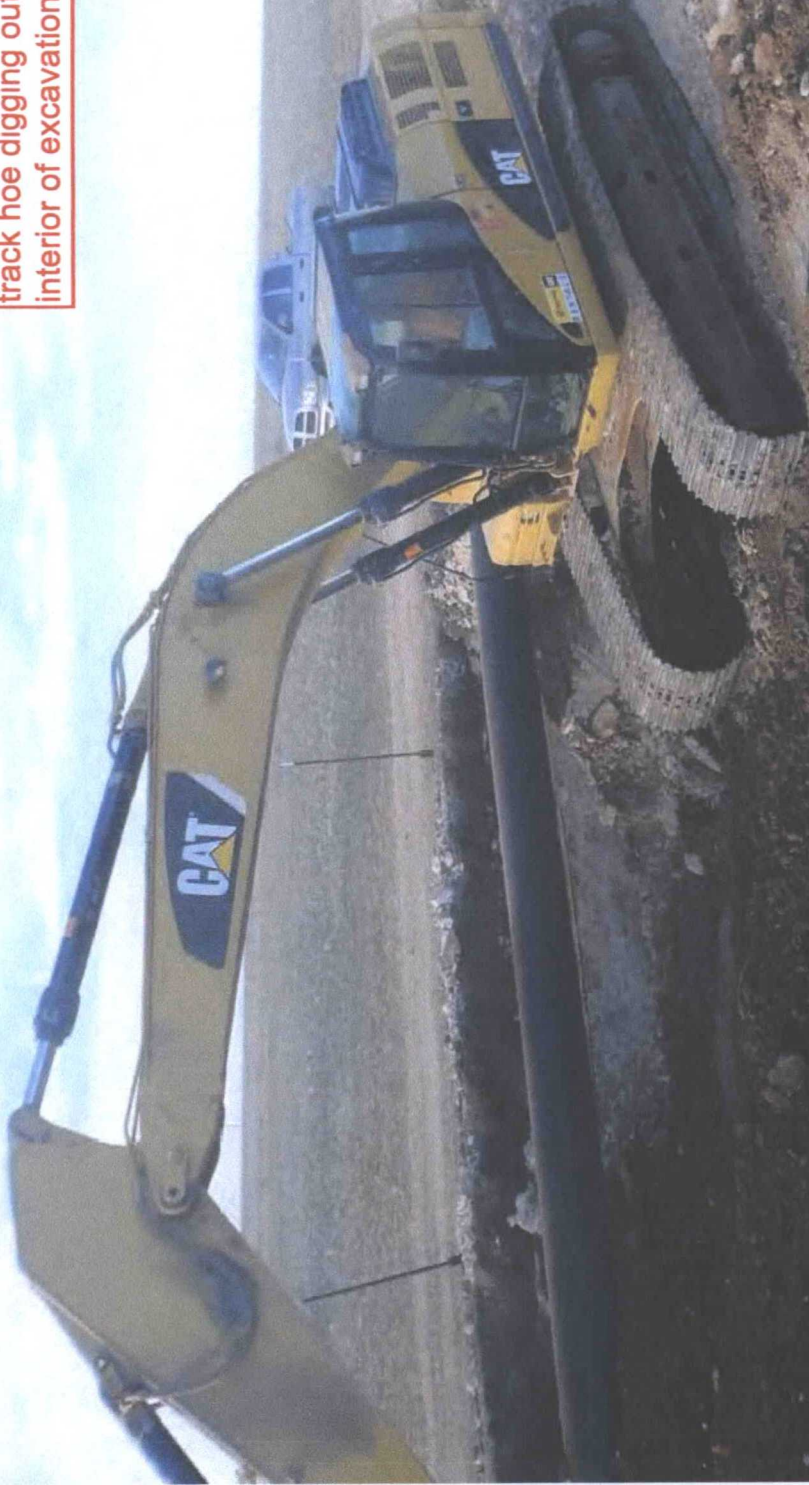
track hoe digging out ramps and using material to level  
interior of excavation viewing from north to south

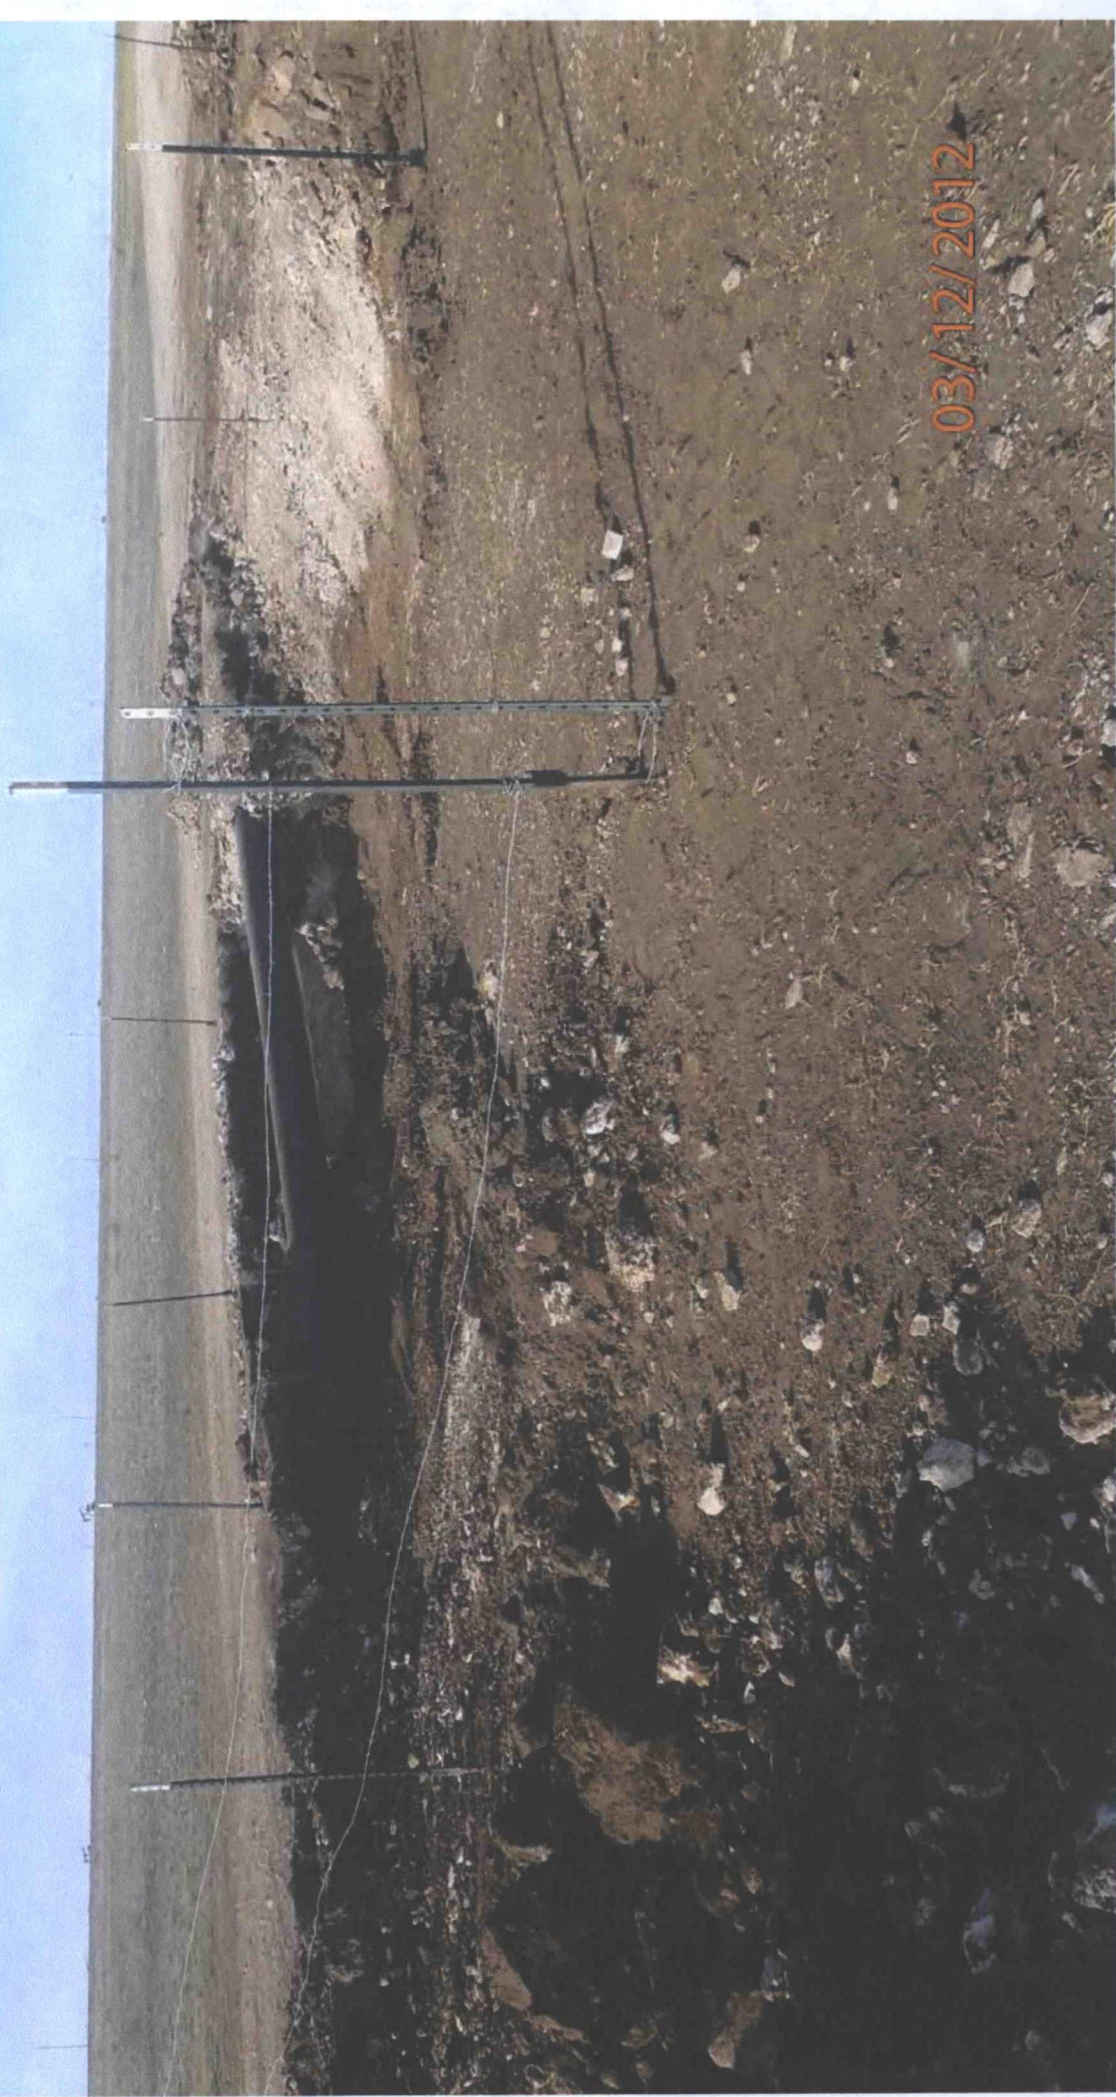
viewing excavation leveled, access ramps built, fence around  
excavation northeast to southwest

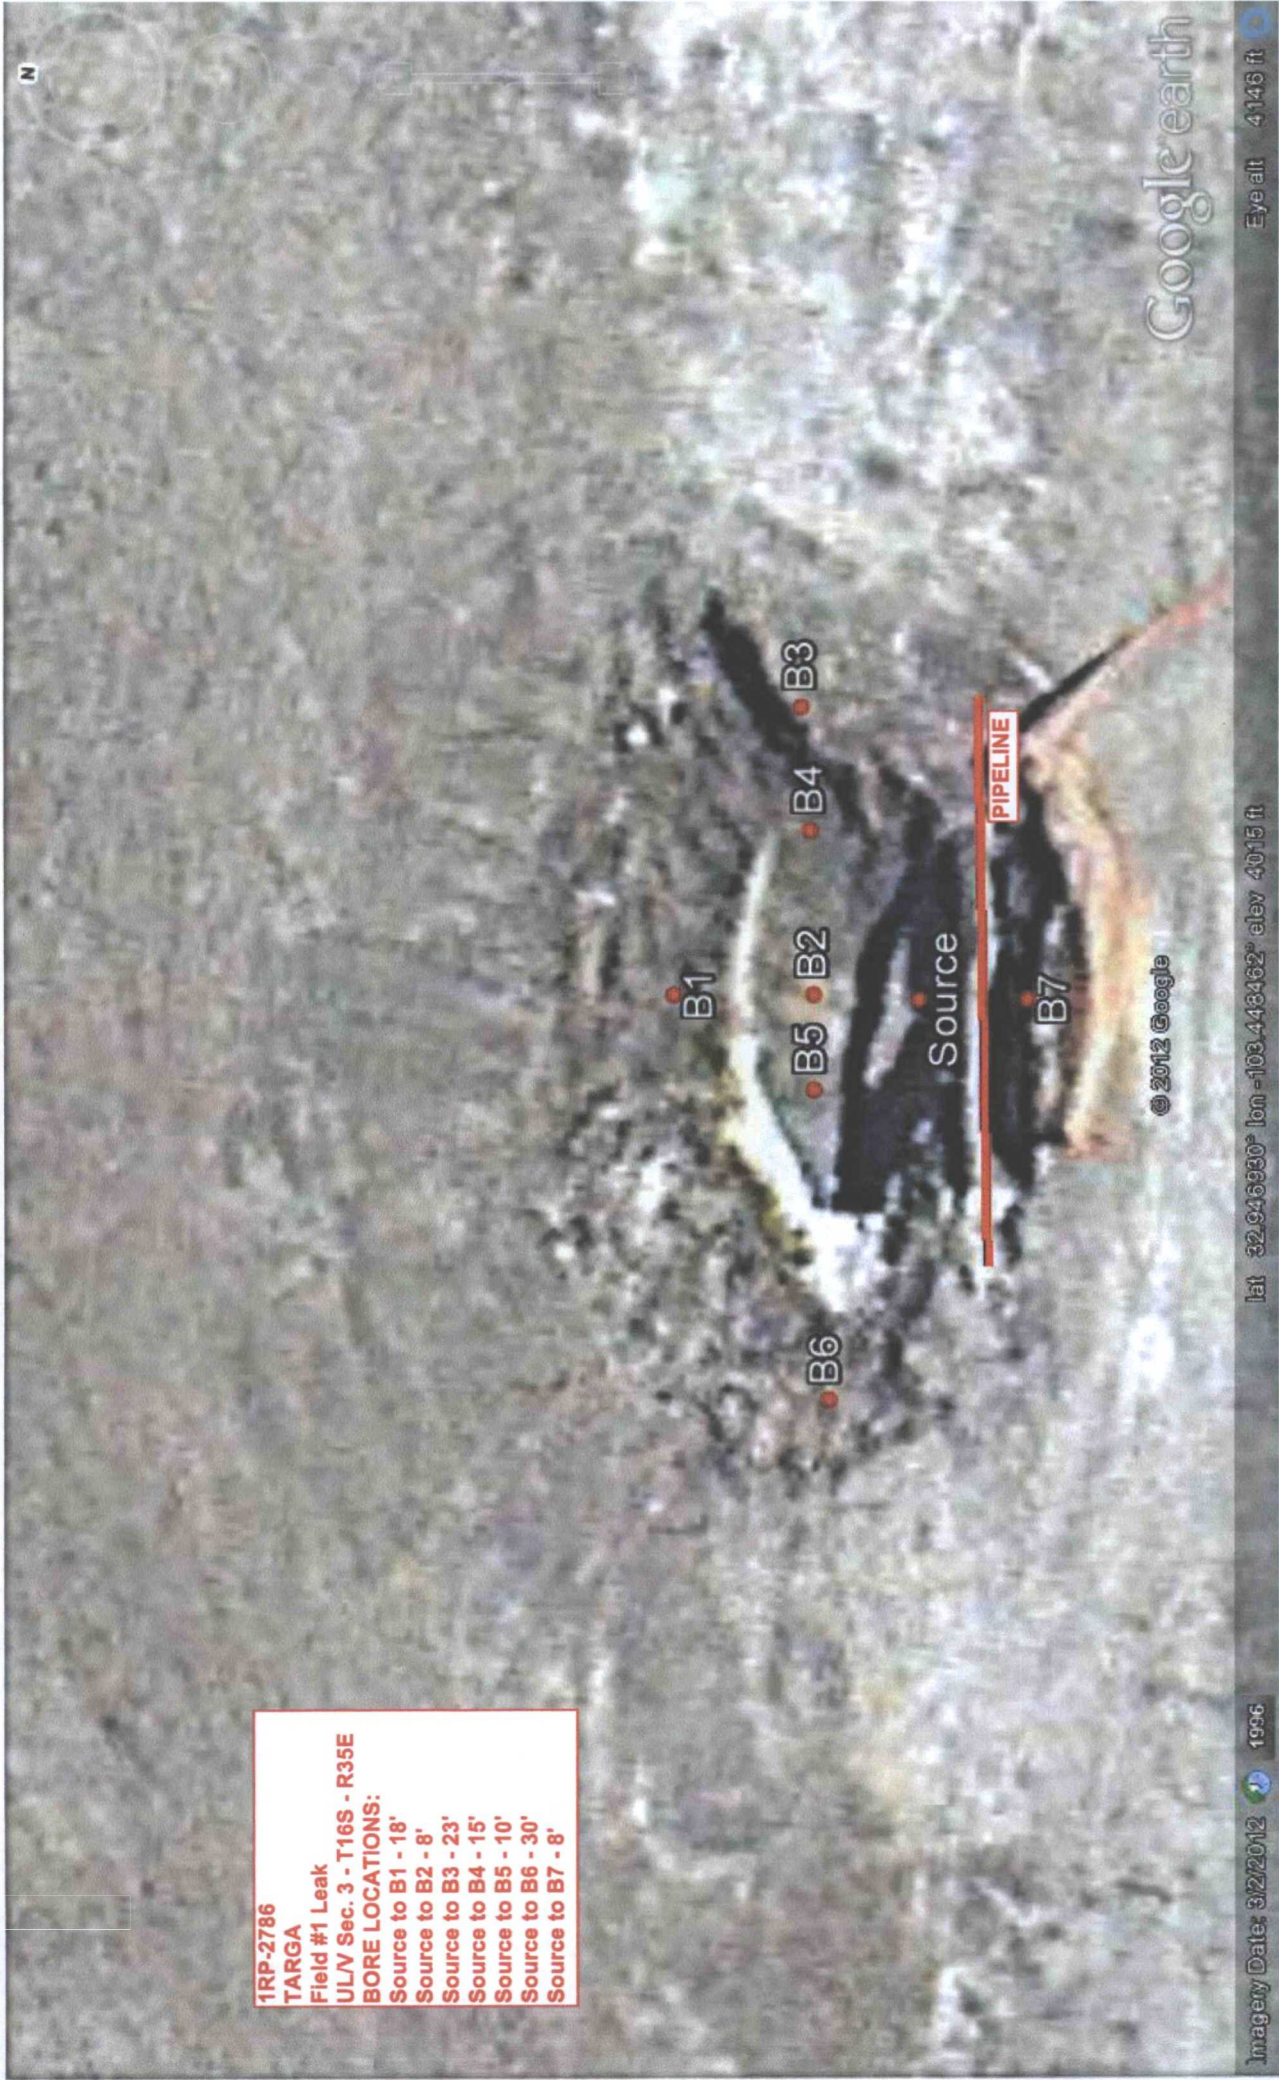
1RP-2786  
TARGA  
Field #1 Leak  
UL/V Sec. 3 - T16S - R35E  
BORE LOCATIONS:  
Source to B1 - 18'  
Source to B2 - 8'  
Source to B3 - 23'  
Source to B4 - 15'  
Source to B5 - 10'  
Source to B6 - 30'  
Source to B7 - 8'

5.1 The area impacted by the gas and hydrocarbon leak will be excavated to depth of 10' below ground surface within the boundaries of the bore #2, 4, 5 & 7. The approximate dimension of the excavation will be 20'L x 20'W. The bottom of the excavation will be sampled using a 5pt composite, along with a 5pt composite of each wall. Samples will be sent to Cardinal Labs in Hobbs, NM for confirmation in accordance to NMOCD sampling procedure. Photos of the sampling event will be taken. Upon confirmation of Lab results a Geo-Synthetic liner will be placed at the bottom of the excavation.
