**1RP - 4168**

Release Notification and Corrective Action

**Chevron USA  
Lea County, New Mexico  
214 Leak Site**

**Remediation/Cleanup Work Plan**

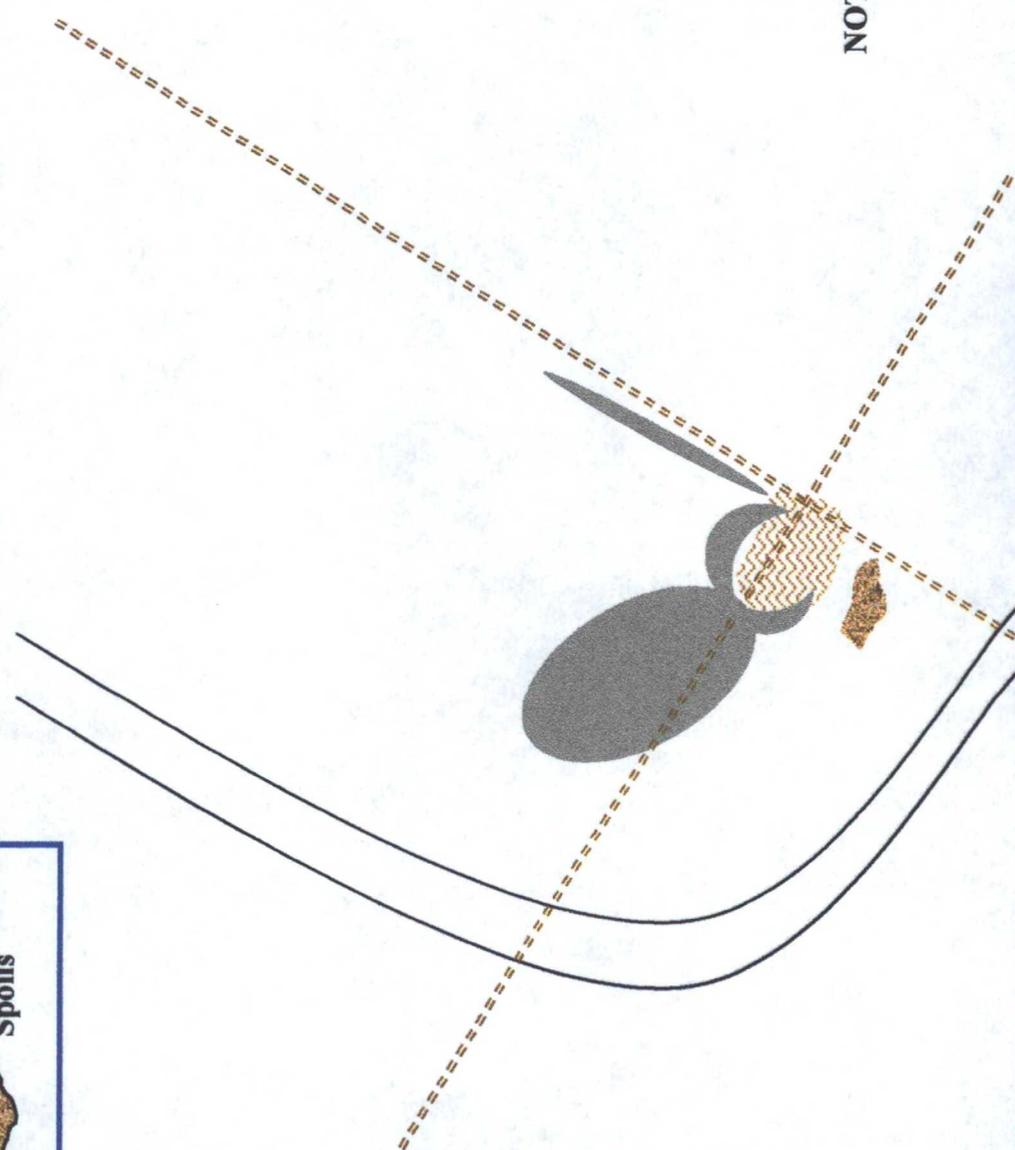
**#214 Leak  
Site Plan**

The leak in the pipeline resulted in crude oil being discharged up to six feet underground and spreading over a surface area approximately 75 feet in length and 4 feet wide in the stream pooling into an area 70 feet by 20 feet. (Site Plan) Chevron USA has received notification from the Oil Conservation Division that the crude oil in this pipeline does not have to be subjected to the Toxic Leaching Characteristic Procedure (TCLP) for toxicity. No evidence of other contaminants was observed.

The leak site will be excavated both horizontally and vertically for the removal of contaminated soils. Field-testing will be conducted to ensure the removal of said soils to below the NMOCD requirements for TPH levels. The bottom and side of the hole will be sampled at the final excavation depths. The samples will be tested for BTEX, TPH and Chlorides with a third laboratory for confirmation of the contamination levels present. Upon receipt of these test results, the appropriate reports will be filed with the NMOCD in the closure report.

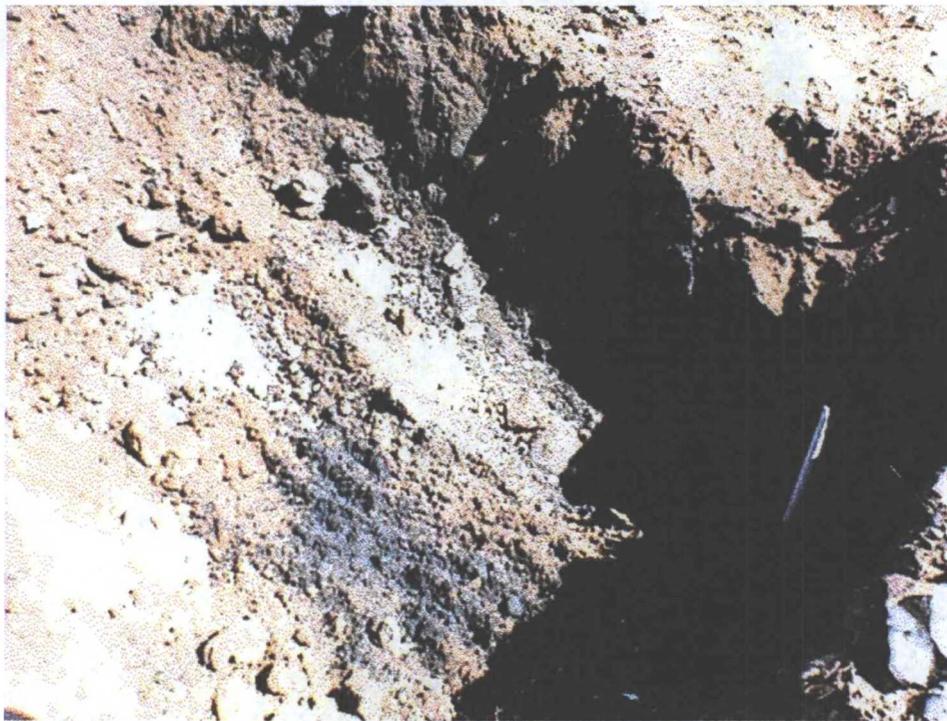
Chevron #214 Leak Site - Excavated Leak Area

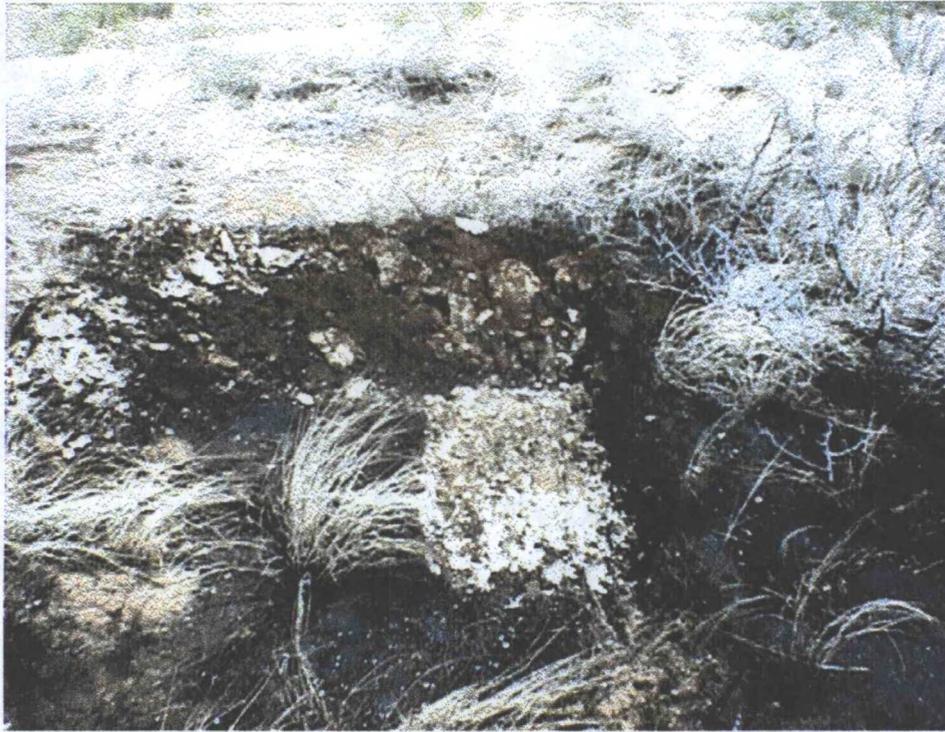
Chevron #214 Leak Site - Spill Area
