LINN OPERATING, INC.

Release Notification and Corrective Action

Remediation Summary
Report Form

Site Name: Hale State #4

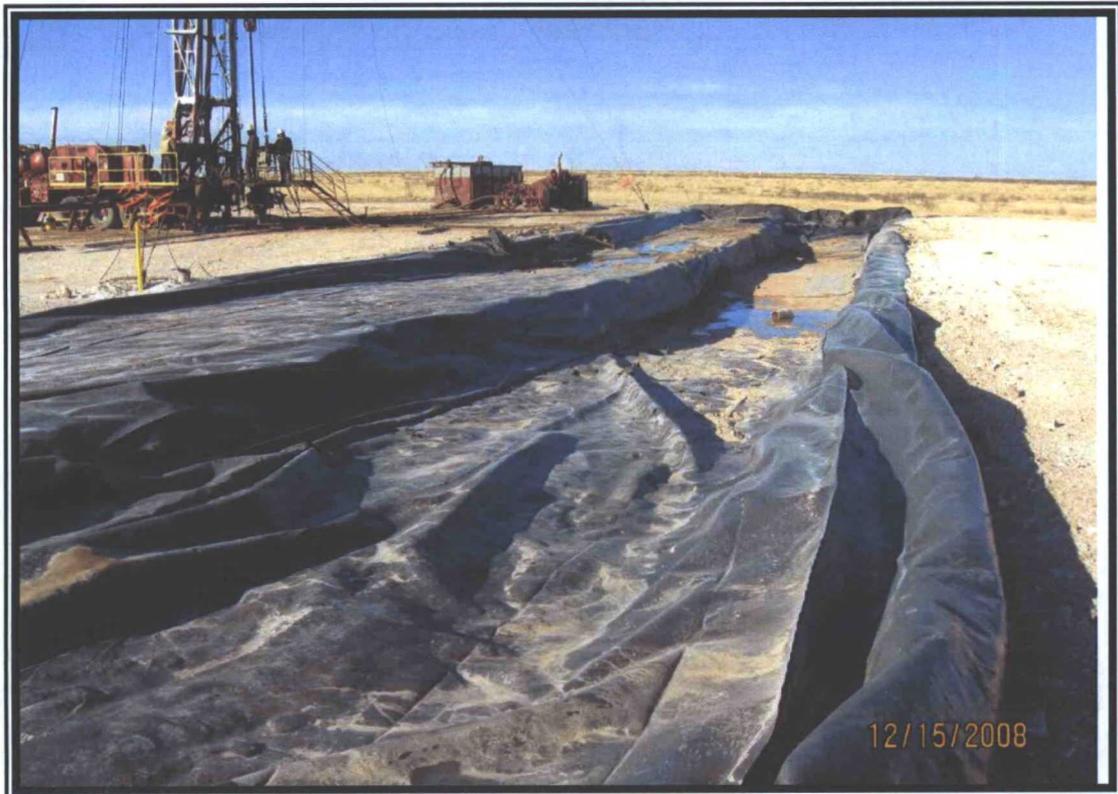
The Hale State #4 was drilled using a closed-loop mud system. The drilling contractor placed roll-off boxes in a two-tier trench to accumulate drill solids. After the rig was removed from the site, some drilling fluids and soil residuals were observed in the trenches. Visual inspection found several penetrations of the liner. After the liner was removed (see Photo #1), initial sampling found chloride levels ranging from 56,000 mg/kg (upper NE trench) to 1820 mg/kg (upper SW trench) and TPH levels ranged from 1,010 ppm (Upper C trench) to below action levels. The initial form C-141 was submitted to NMOCD on March 11, 2009.

#1 Initial View -- Upper and Lower Trenches

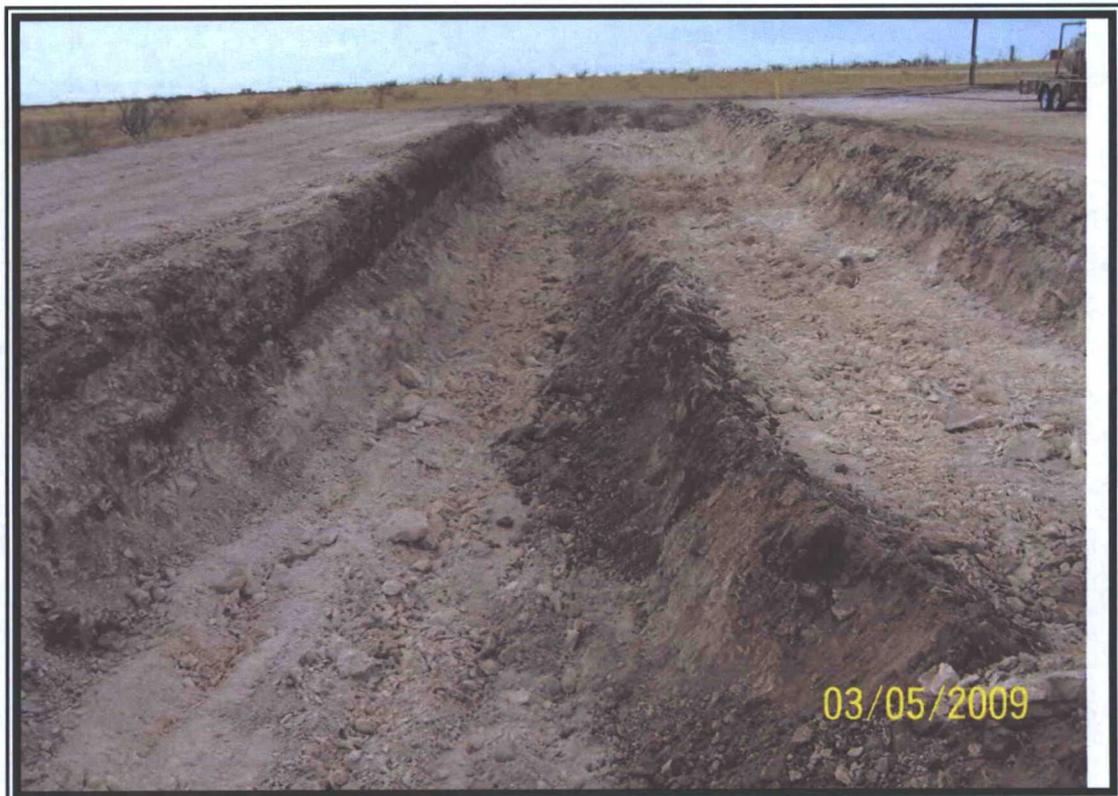
#2 Excavation in progress

About 1092 cubic yards of impacted soils were excavated and staged onto plastic prior to being manifested offsite. Soils were sampled at various depth intervals to evaluate the progress of the remediation (see Photo #2). Excavation was terminated when chloride concentrations were below action levels (see Photo #3). The excavation was backfilled with new soil that had been stockpiled at other sites. Soil was added in lifts and compacted to bring the excavation area to grade (see Photo #4). Final form C-141 has been prepared and is attached.

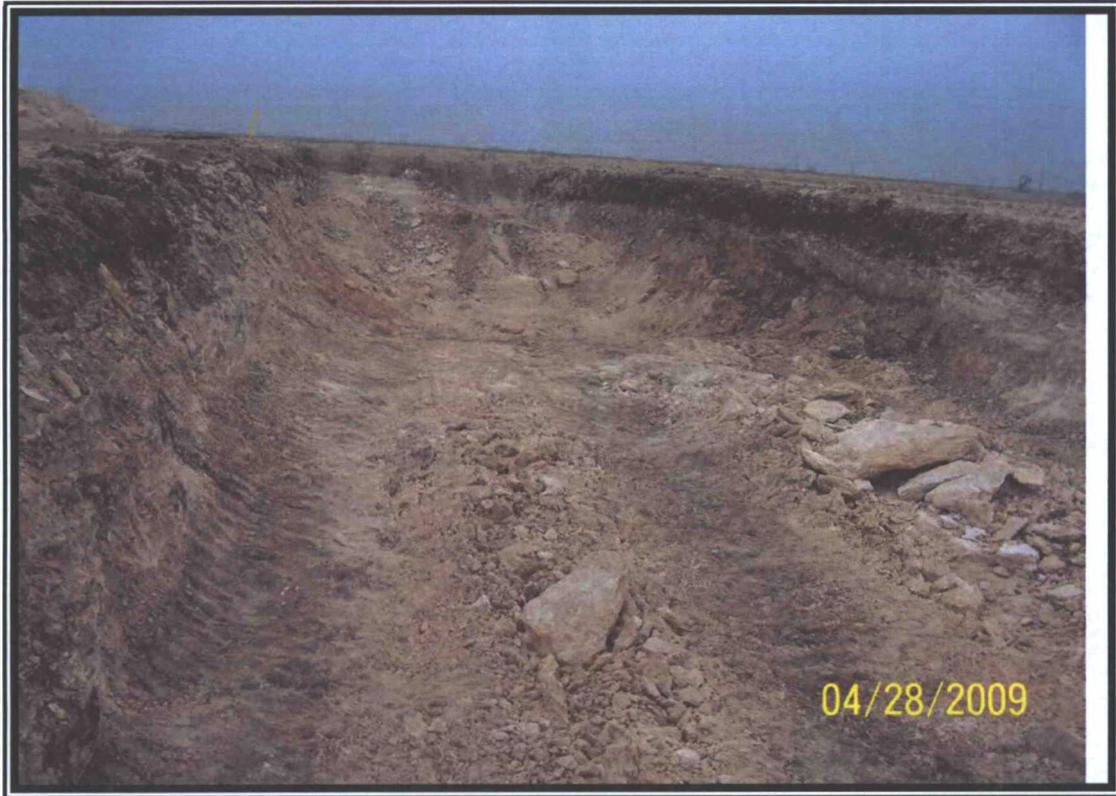
#3 Excavation completed

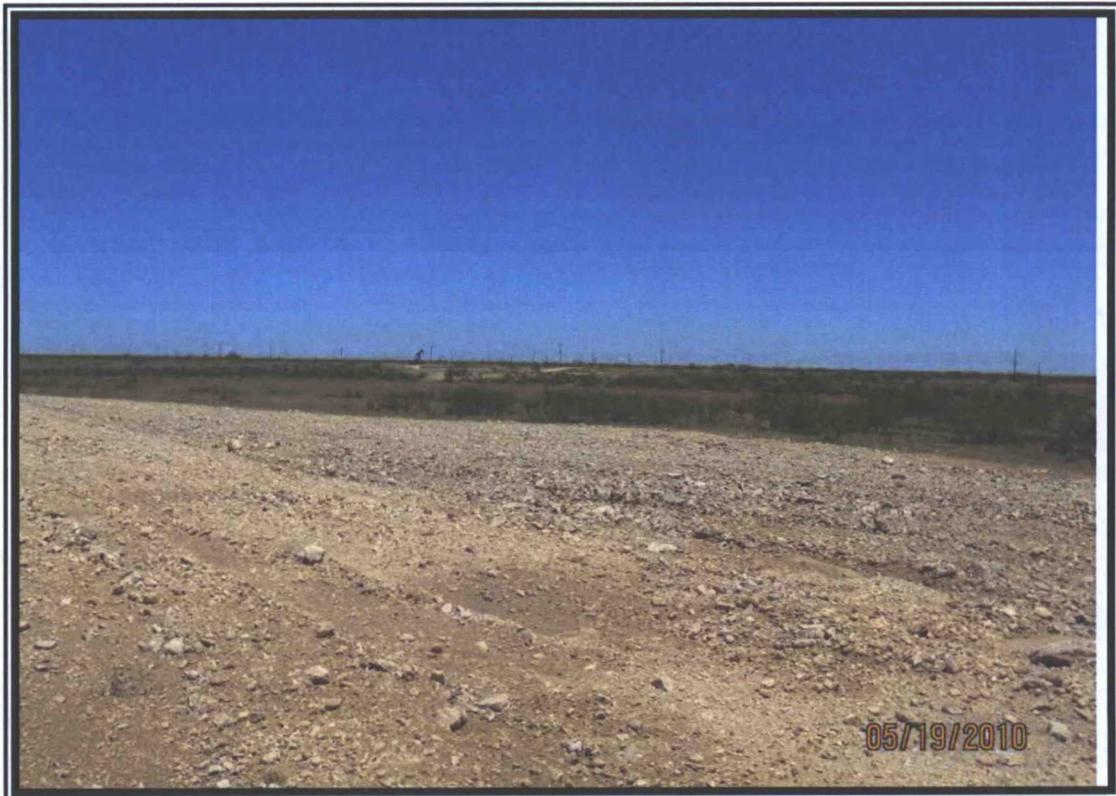
#4 Site After Backfilling.
