### Report Type: Work Plan

<b>Site:</b>	Pronghorn SWD Facility		
<b>Company:</b>	COG Operating LLC		
<b>Section, Township and Range</b>	Unit B	Sec 24	T19S R32E
<b>Lease Number:</b>	API 30-025-32735		
<b>County:</b>	Lea County		
<b>GPS:</b>	32.65218° N	103.71698° W	
<b>Surface Owner:</b>	Federal		
<b>Mineral Owner:</b>			
<b>Directions:</b>	From the intersection of 529 and CR-126, travel south on 126 for 9.9 miles, turn left and travel 4.5 miles, turn right (at tin horn) and travel 0.6 miles to location

**Re: Work Plan and Assessment Report for the COG Operating LLC,  
Pronghorn SWD Facility Spills, Unit B, Section 24, Township 19 South,  
Range 32 East, Lea County, New Mexico.**

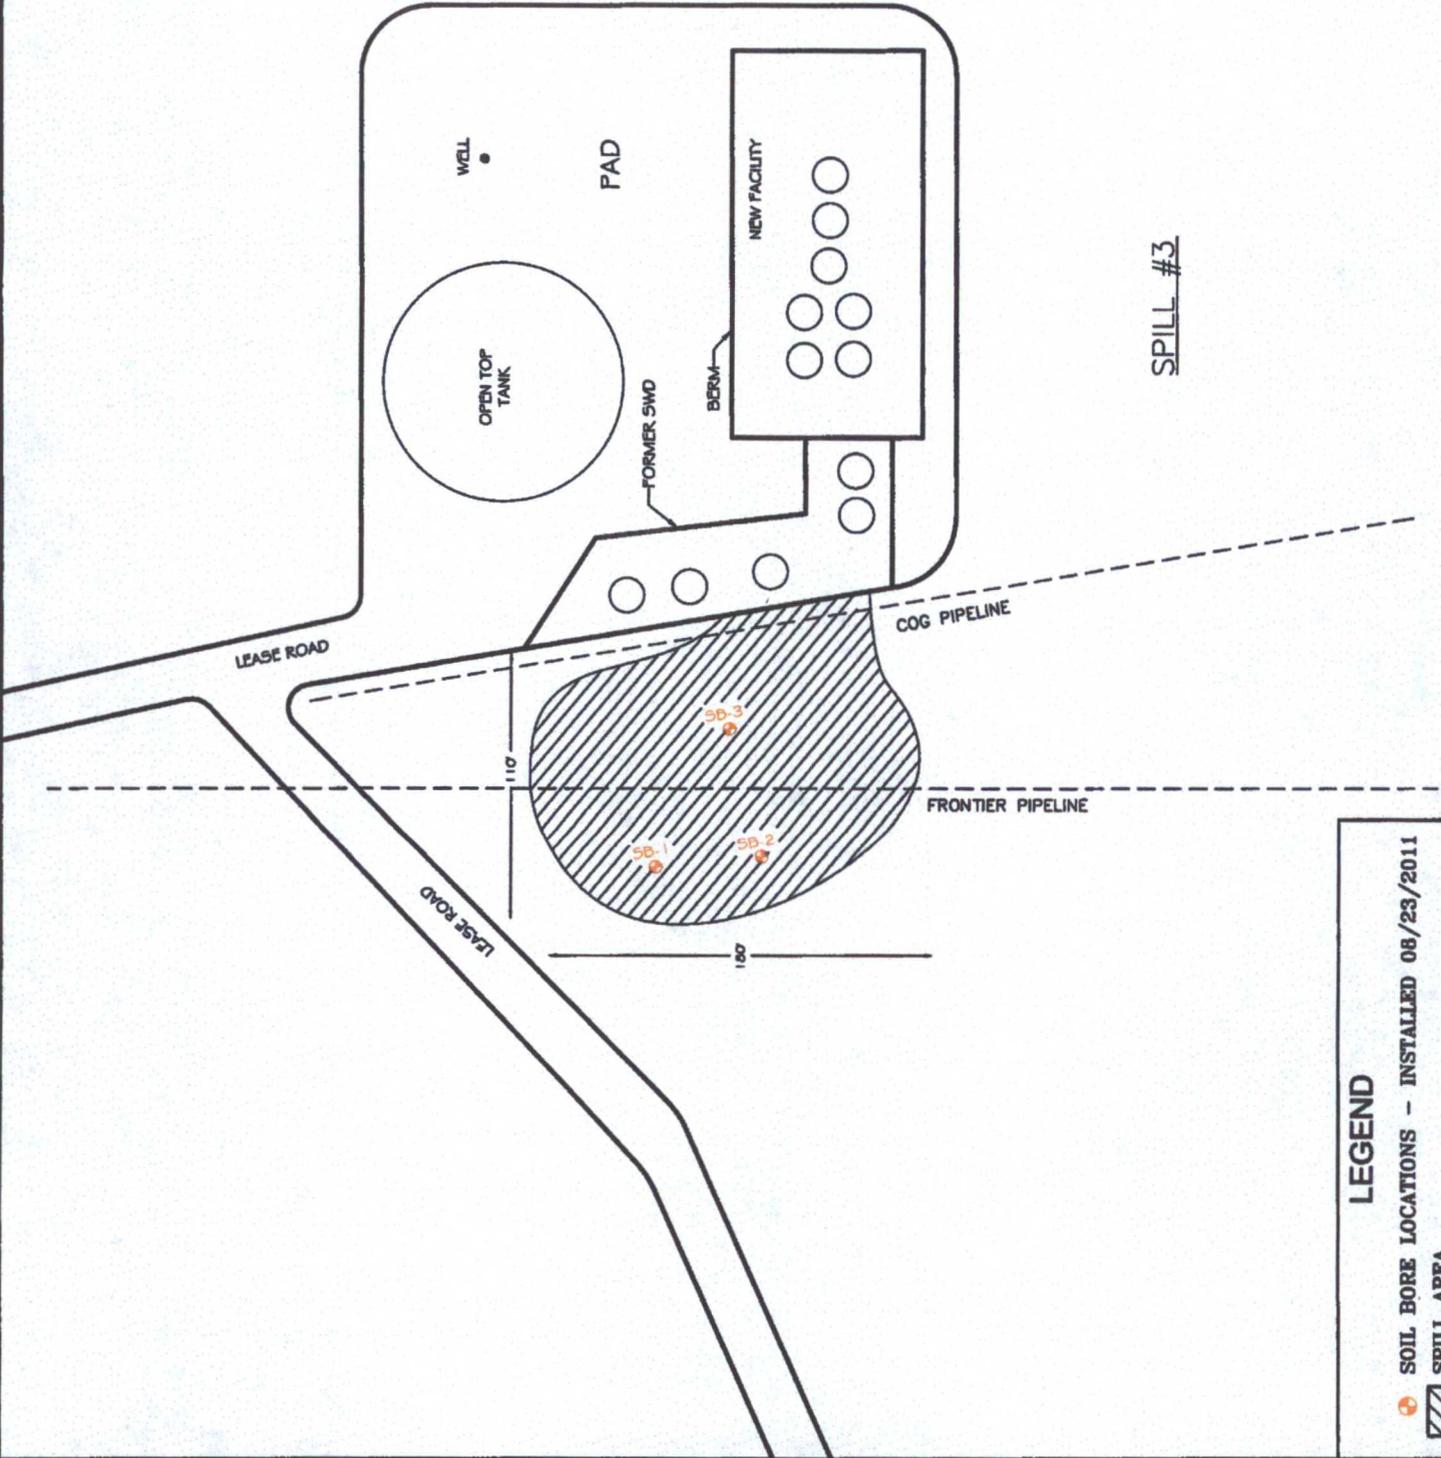
Figure 4

According to the State of New Mexico C-141 Initial Report, the leak was discovered on July 20, 2011 and released approximately 100 barrels of produced water. The check valve on the transfer pump failed, the standing fluid has been removed and 95 bbls were recovered. The spill area released to the west of the facility and encompassed the area of the first and second spills. The initial C-141 is enclosed in Appendix A. The spill area is shown on Figure 4.

A total of three (3) soil borings (SB-1, SB-2 and SB-3) were installed to assess the third spill in the pasture. The soil boring locations are shown on Figure 4. The boring logs are shown in Appendix B. Selected samples were analyzed for TPH analysis by EPA method 8015 modified, BTEX by EPA Method 8021B and chloride by EPA method 300.0. Copies of laboratory analysis and chain-of-custody documentation are included in Appendix C. The results of the sampling are summarized in Table 2.

Referring to Table 2, all of the samples selected for TPH and BTEX were below the RRAL. The chloride impact greater than 1,000 mg/kg extends down to approximately 25.0' below the excavated bottom. All three of the soil borings showed chloride concentrations decreased with depth and were vertically defined. The areas of SB-1 and SB-2 showed a deeper impact to the soils to approximately 25' and shallow impact down to approximately 10' in the area of SB-2.

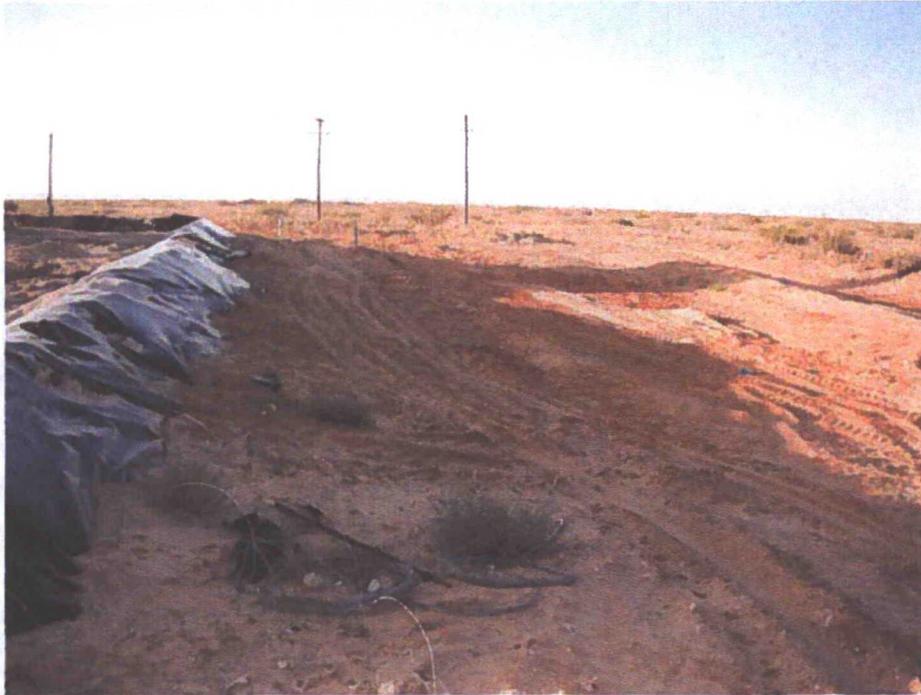
**Excavated Area West of Facility**

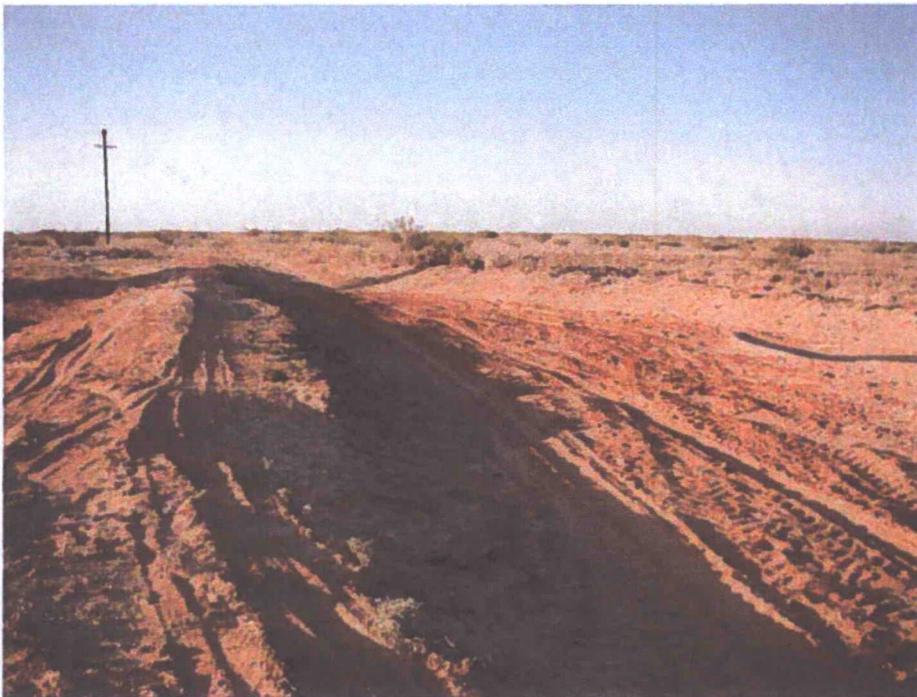
**Excavated Area West of the Facility**

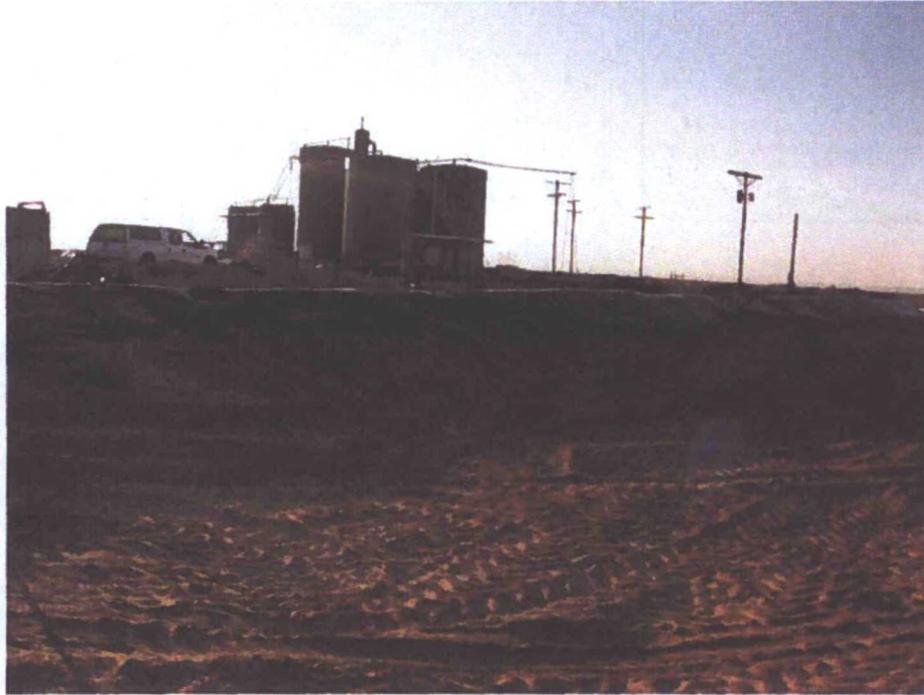
Excavated Area West of Facility

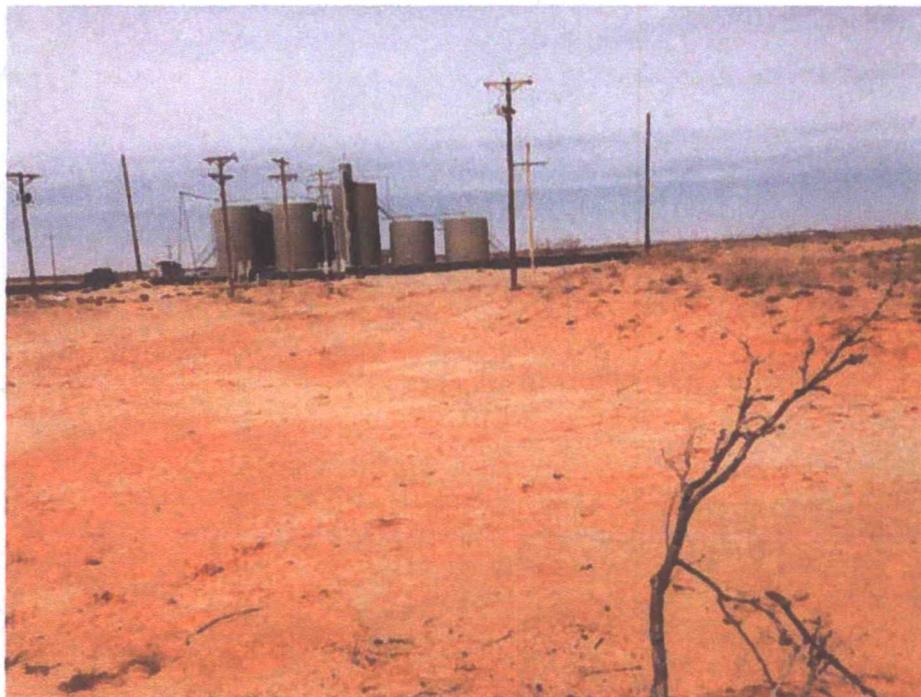
Excavated Area South of the Facility

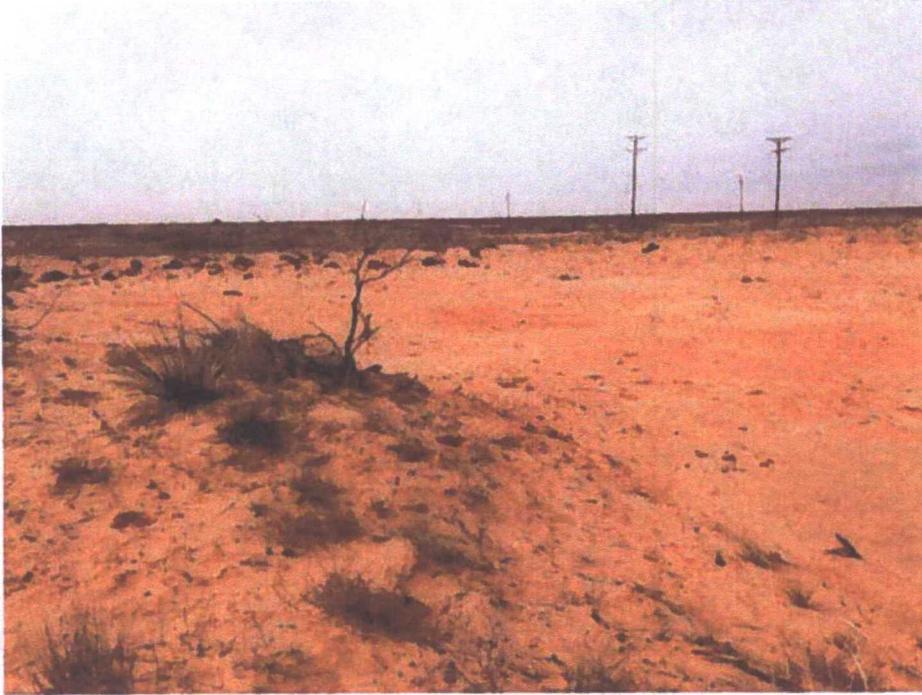
**Excavated Area South of Facility**

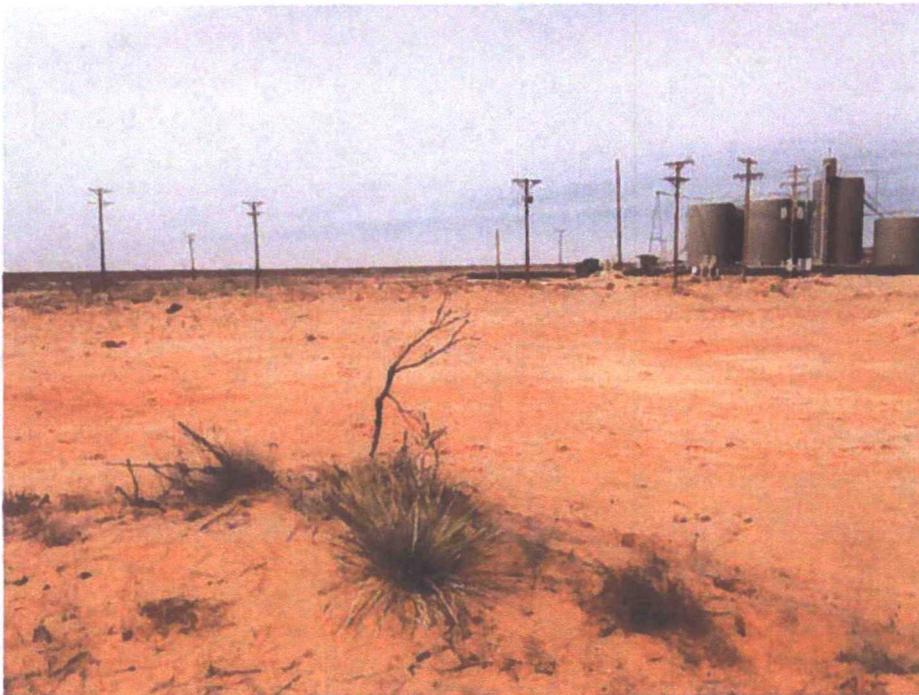
**Excavated Area South of the Facility**

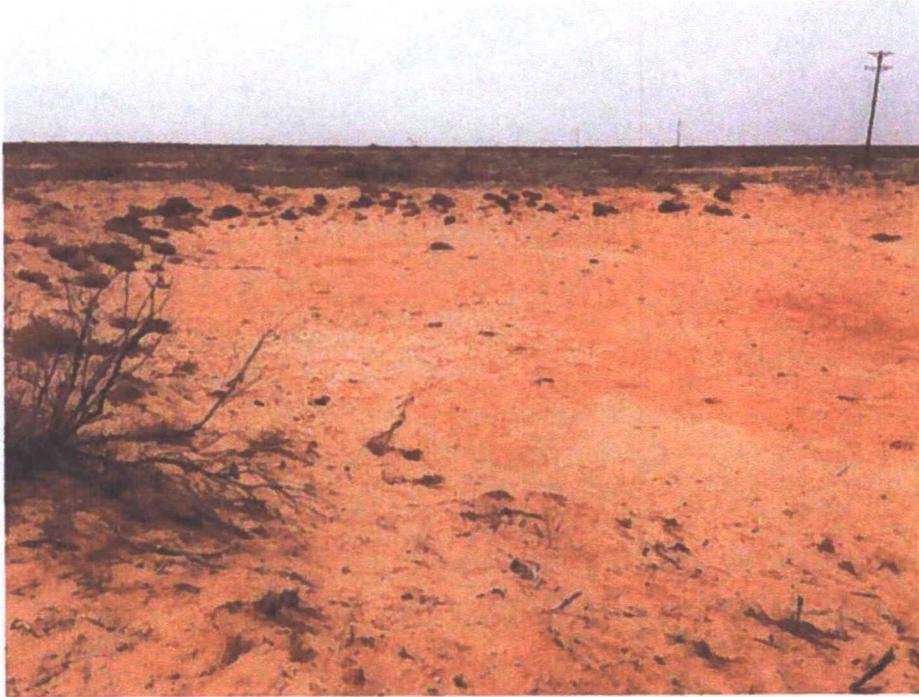
**View West - Excavated Area South of Facility**

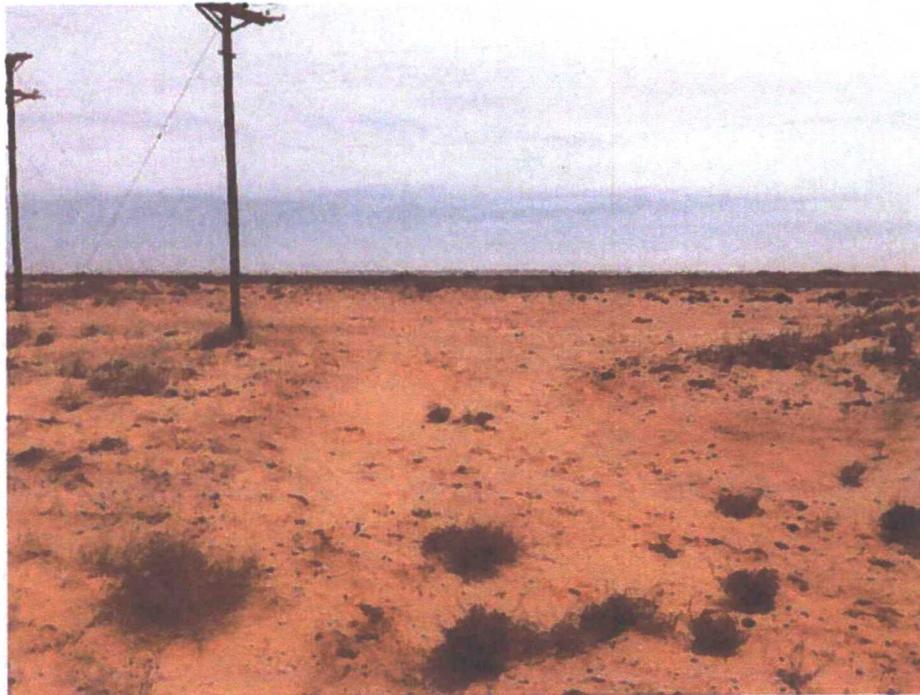
**View South - Excavated Area South of the Facility**
