MERIT ENERGY CORPORATION

INITIAL C-141 AND WORK PLAN WB-94 INJECTION LINE RELEASE

PROJECT REF: MER-WB94-041305

April 15, 2005

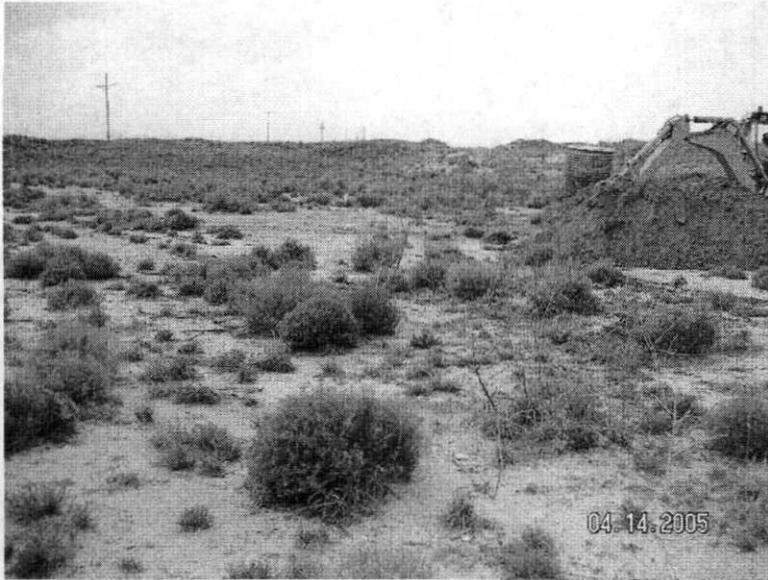
Surface contamination in immediate area of the injection line release

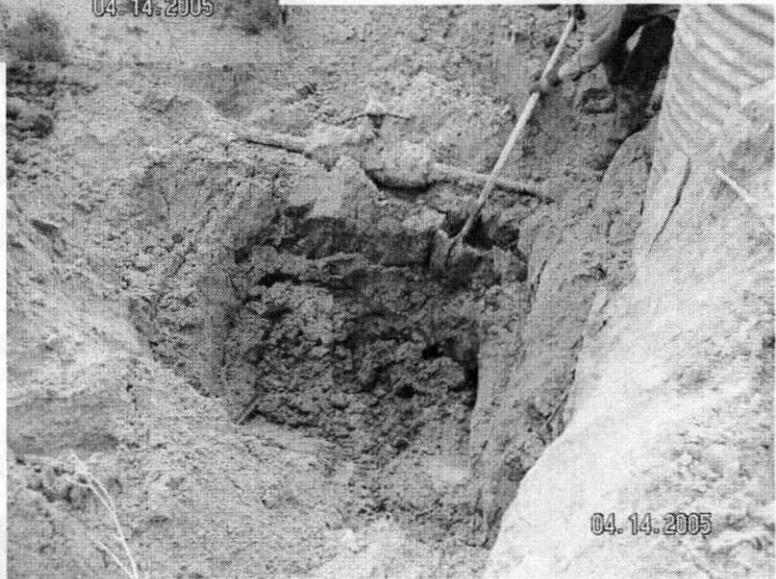
Obvious hydrocarbon contamination beneath the line leak

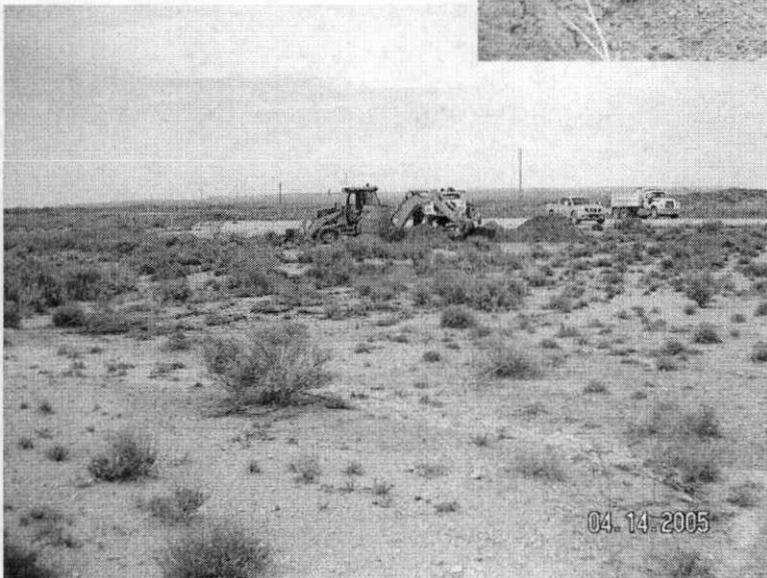
Surface flow path from southern terminus looking north toward WB94 well pad.
