Pit Closure Proposal (Revised)

**Lotsa Luck 29 Fed #3
Section 29, T16S, R27E
Eddy County, New Mexico**

May 26, 2009

**Merit Energy Company
13727 Noel Rd. Ste 500
Dallas, Texas 75240**

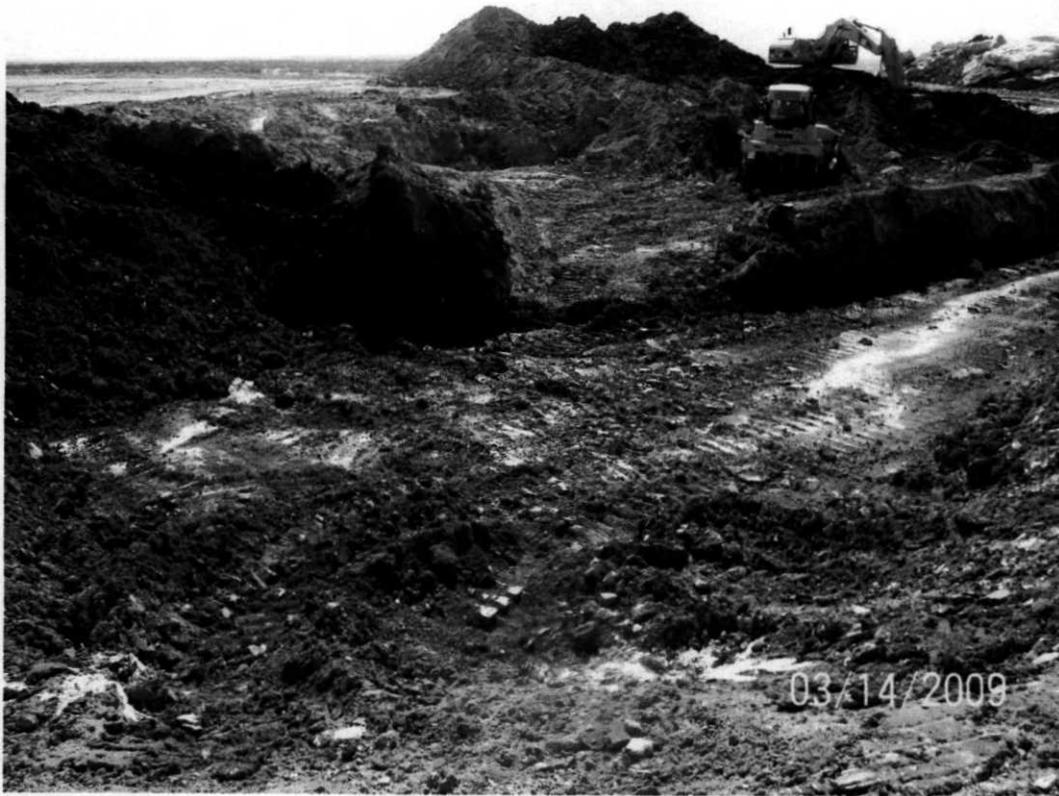
Figure 1: Pit bottom during excavation

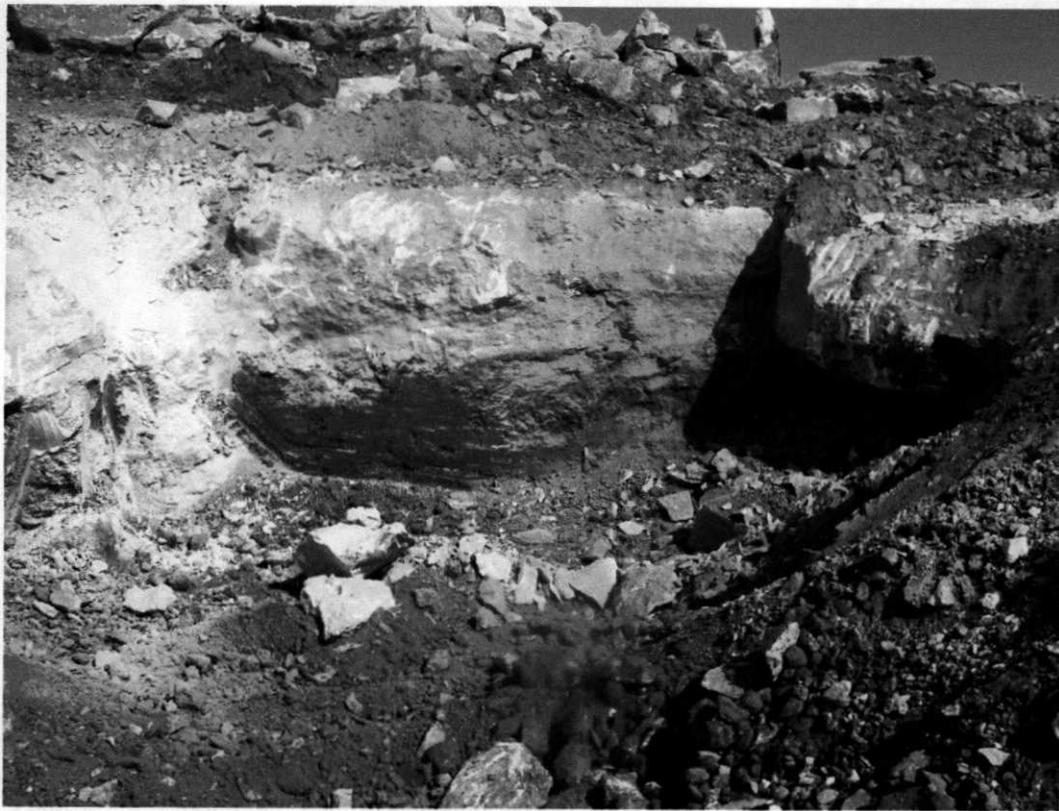
Figure 2: Northeast corner trench, approximately 4 feet beyond pit sidewall

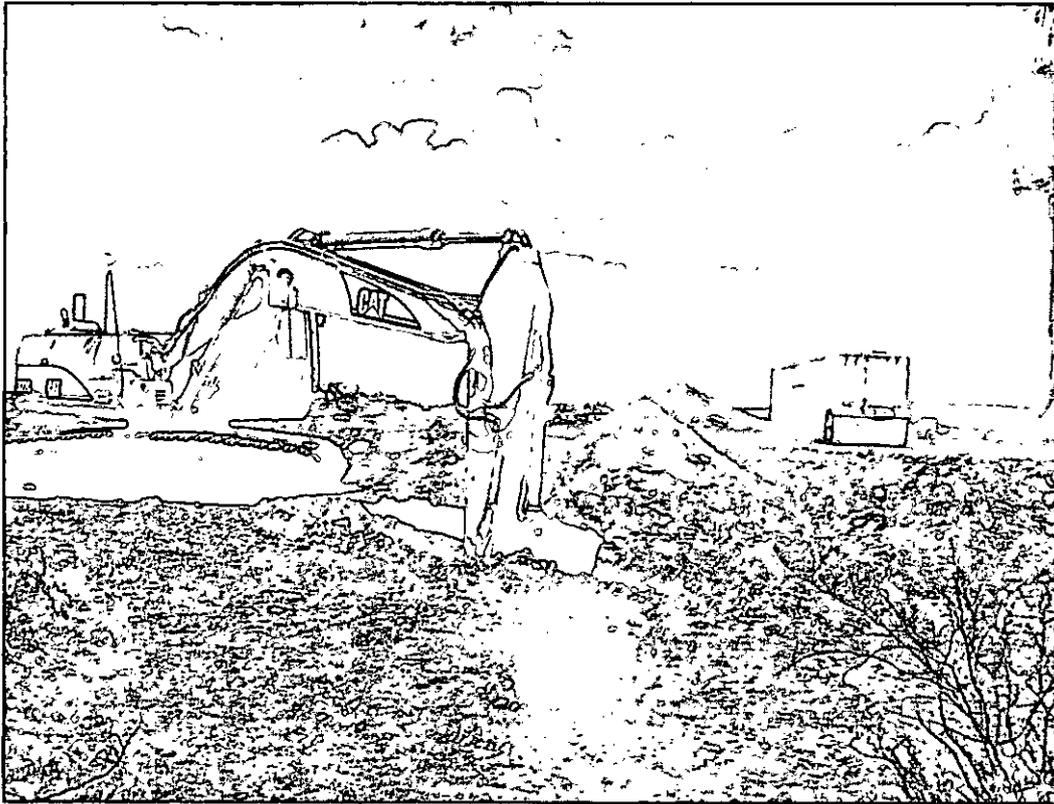
Figure 3: Excavating the south background trench
