Release Notification and Corrective Action

Name of Company ExxonMobil	Contact Toni Collier	
Address P.O. Box 4358, Houston, TX 77210	Telephone No. 281-654-1133	
Facility Name Greenwood 15	Facility Type Flowline	
Surface Owner Charlie Bettis	Mineral Owner	Lease No. N/A

RE: Remediation Proposal

Exxon Mobil – J. L. Greenwood #15 Release Area
UL-M (SW ¼ of the SW ¼) of Section 09, T 22 S, R 37 E
Longitude: N 32° 24' 07.87"; Latitude: W 103° 10' 19.62"
Lea County, New Mexico
EPI Ref. #190036

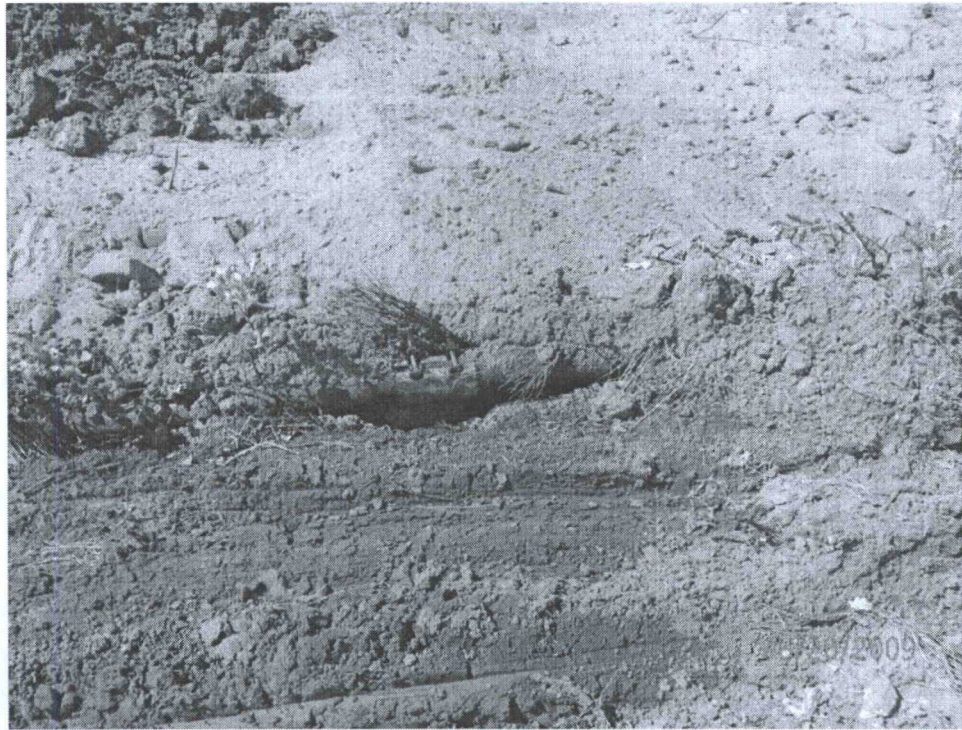
Leak on 2.5" steel flowline due to corrosion. Flowline has been isolated and will be inspected for replacement.

Photograph No. 1 – Point of release with circular clamp on surface flow line

Care will be exercised when backfilling around the existing surface flow line. Preliminary information indicates the surface flow line has been isolated and will be inspected for possible replacement.

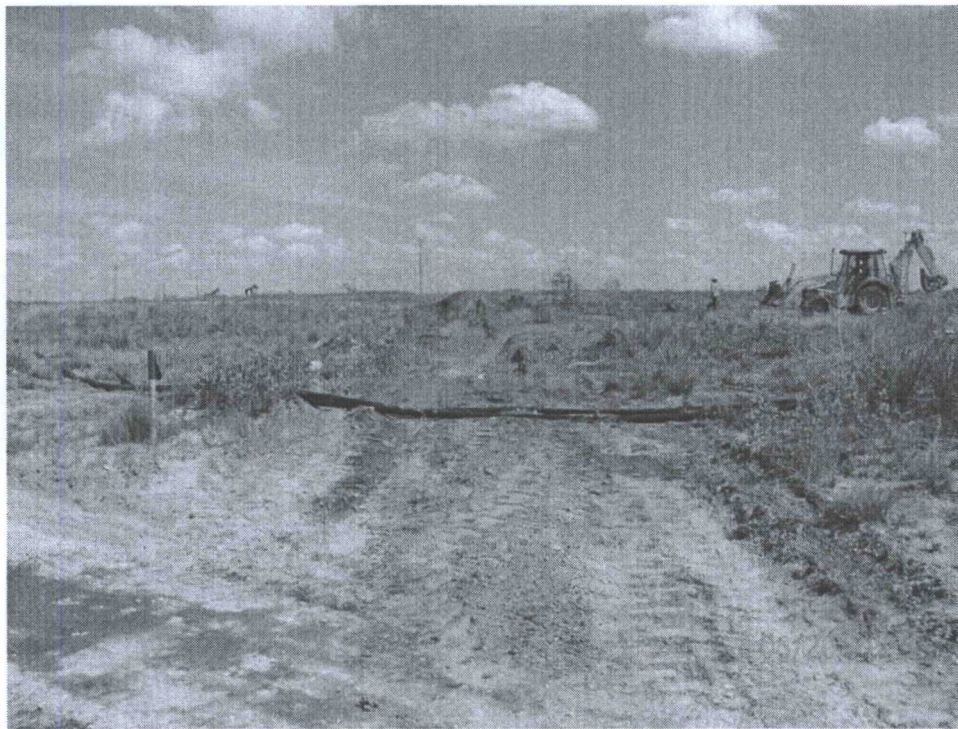
Photograph No. 2 – Looking southeast at release area extension

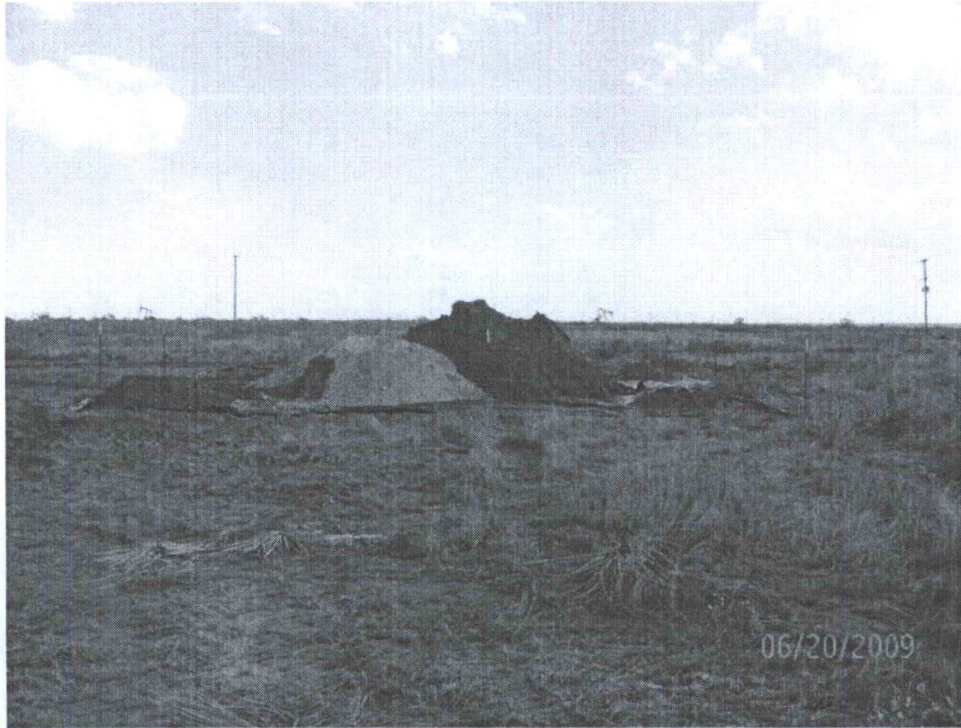
Photograph No. 3 – Impacted material stockpiled on plastic liners

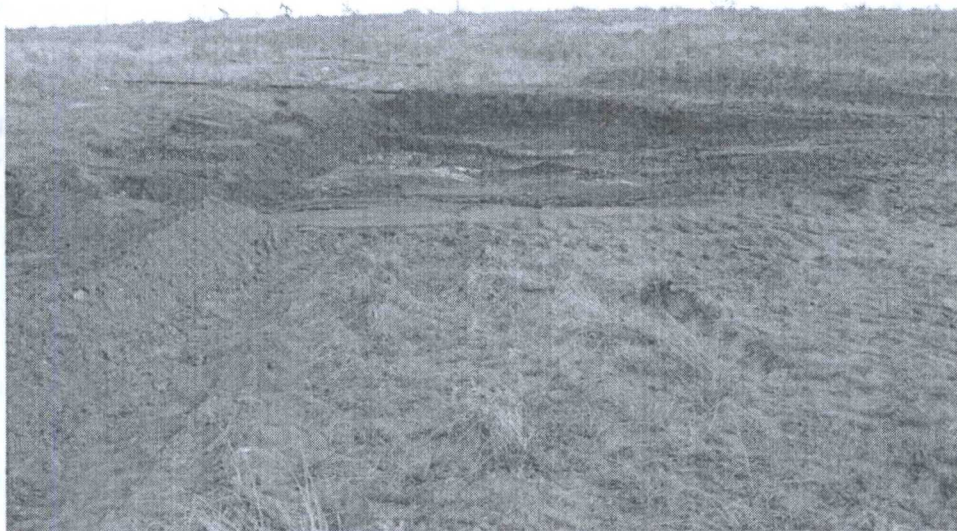
Photograph No. 4 – Excavation of impacted material around point of release

EPI proposes continuing delineation of the release area via use of a backhoe or track hoe. Surface area and depth of excavation will be determined by extent of impacted material. Sidewalls and bottom of the excavation will be field analyzed primarily for chloride concentrations interspersed with random tests for TPH constituents. Upon satisfactory field analyses results, soil samples collected will be sent to an independent laboratory for analytical verification. With receipt of laboratory analytical results indicating sidewalls and bottom of excavation are below NMOCD parameters for chloride and TPH concentrations, EPI will complete remedial activities.

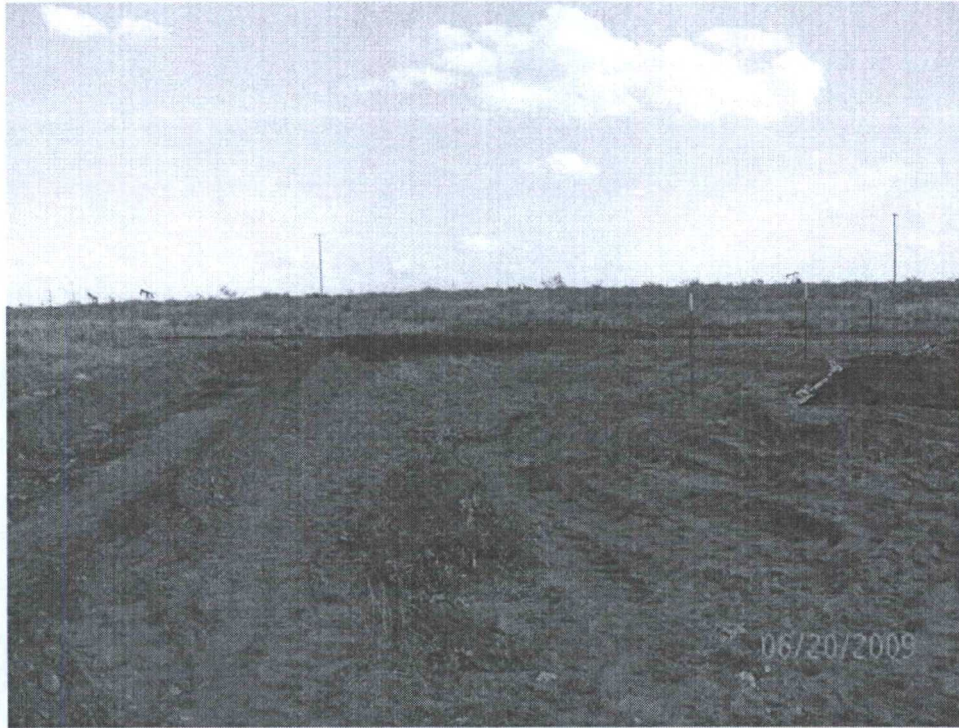
Photograph No. 5 – Stockpiled impacted material within barb wire fence enclosure

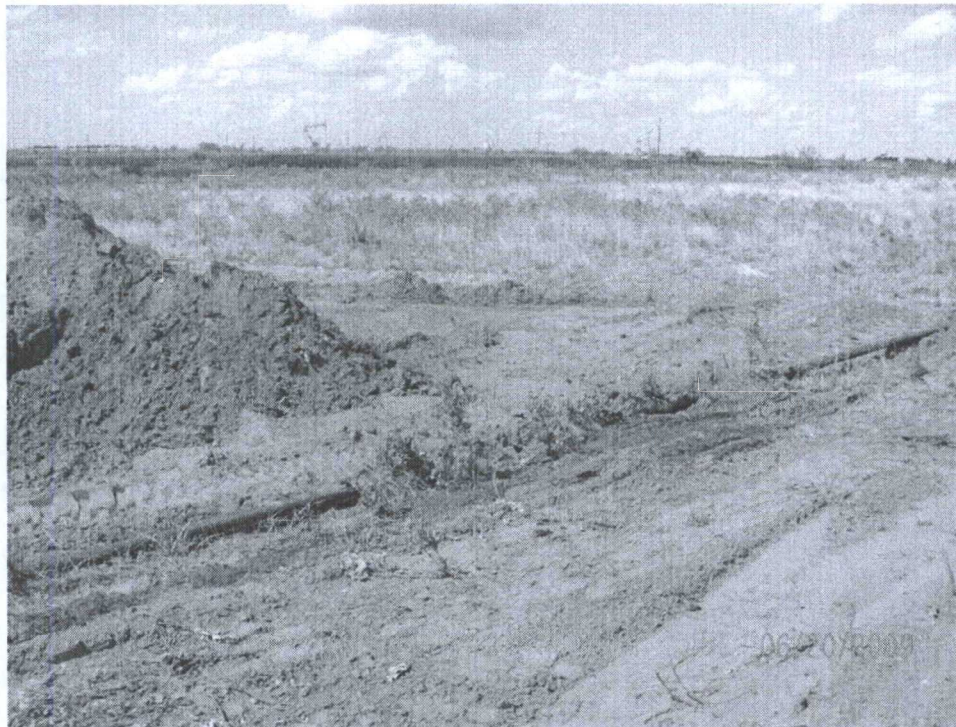
Photograph No. 6 – Flow line near point of release with impacted material temporarily stockpiled
