Report Type: Work Plan

Site:	Texaco State BE Tank Battery				
Company:	COG Operating LLC				
Section, Township and Range	Unit B	Sec 16	T17S	R30E	
Lease Number:	(API#) 30-015-04181				
County:	Eddy County				
GPS:	32.83891° N			103.97546° W	
Surface Owner:	State				
Mineral Owner:					
Directions:	In Loco Hills at the intersection of Goat Roper Road and Hwy. 82 travel 1.39 miles to north on Goat Roper Road. Turn right traveling east approximately 0.10 miles to the location on the right.

Re: Work Plan for the COG Operating LLC., Texaco State BE Tank Battery, Section 16, Township 17 South, Range 30 East, Eddy County, New Mexico.

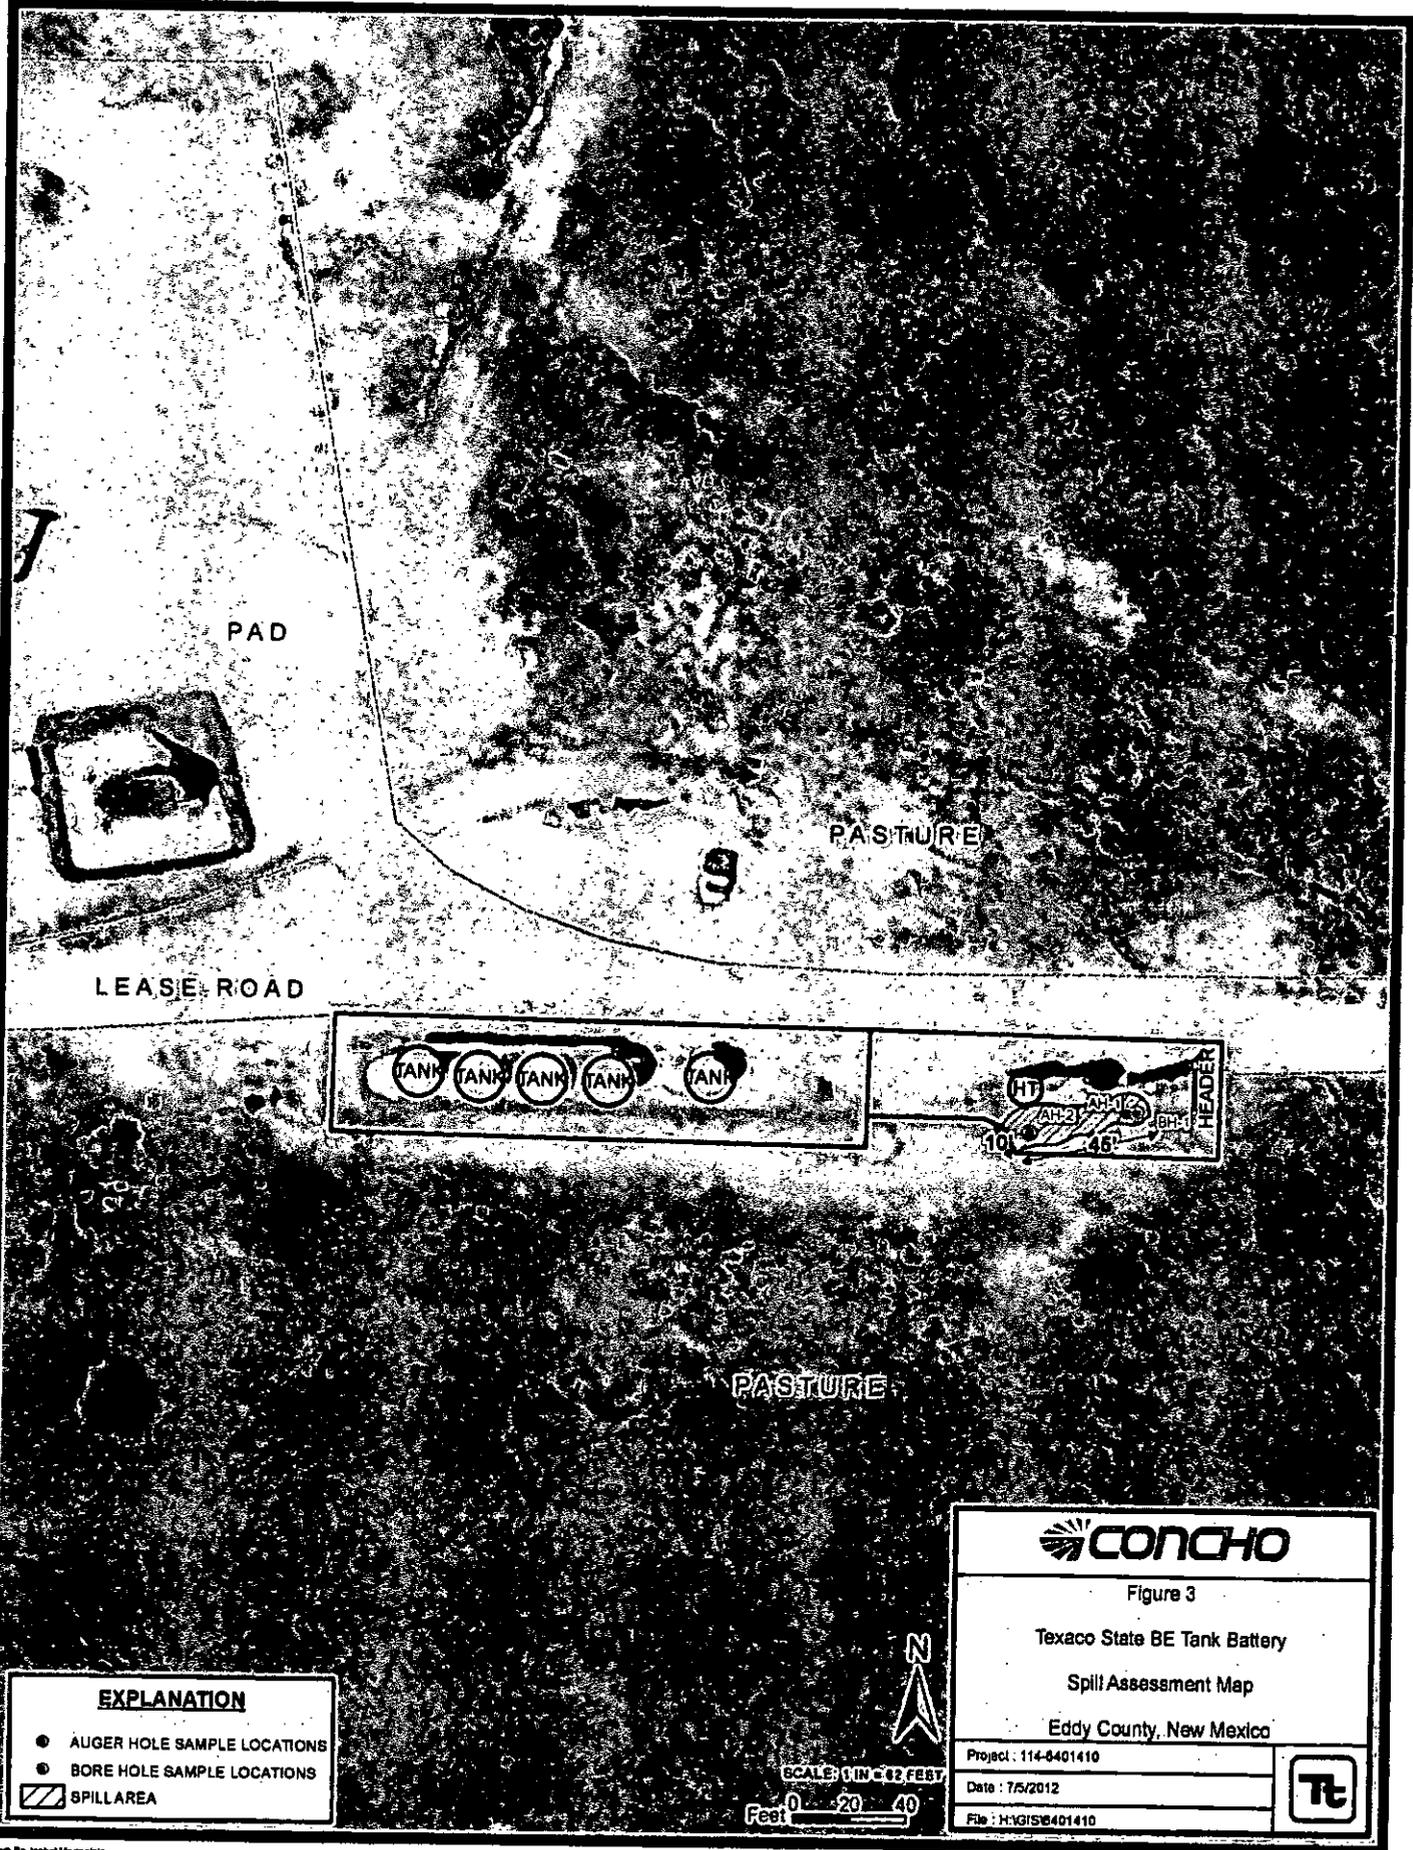
Figure 3

On June 6, 2012, Tetra Tech personnel inspected and sampled the spill area. Two (2) auger holes (AH-1 and AH-2) were installed using a stainless steel hand auger to assess the impacted soils. The auger holes were installed within the berm of the tank battery. The spill area measured approximately 10' x 45' located behind the heater treater and separator. Selected samples were analyzed for TPH analysis by EPA method 8015 modified, BTEX by EPA Method 8021B and chloride by EPA method 300.0. Copies of laboratory analysis and chain-of-custody documentation are included in Appendix C. The sampling results are summarized in Table 1. The auger hole locations are shown on Figure 3.

Referring to Table 1, AH-2 exceeded the RRAL for TPH and BTEX. AH-2 had a maximum TPH concentration of 12,520 mg/kg and a total BTEX of 163 mg/kg at 1-1.5' and declined below the RRAL at 2-2.5' to 4,070 mg/kg and 38.2 mg/kg, respectively.

A chloride impact was detected in both auger holes with maximum chloride concentration detected in the area of AH-1 of 9,180 mg/kg at 0-1.0'. At AH-1, the chloride concentrations declined with depth, but spiked at 5-5.5' below surface showing a bottom auger hole of 5,660 mg/kg at 8-8.5' below surface. Auger hole (AH-2) showed elevated chlorides throughout the auger hole. The chloride concentrations in both auger holes were not vertically defined in both auger holes.

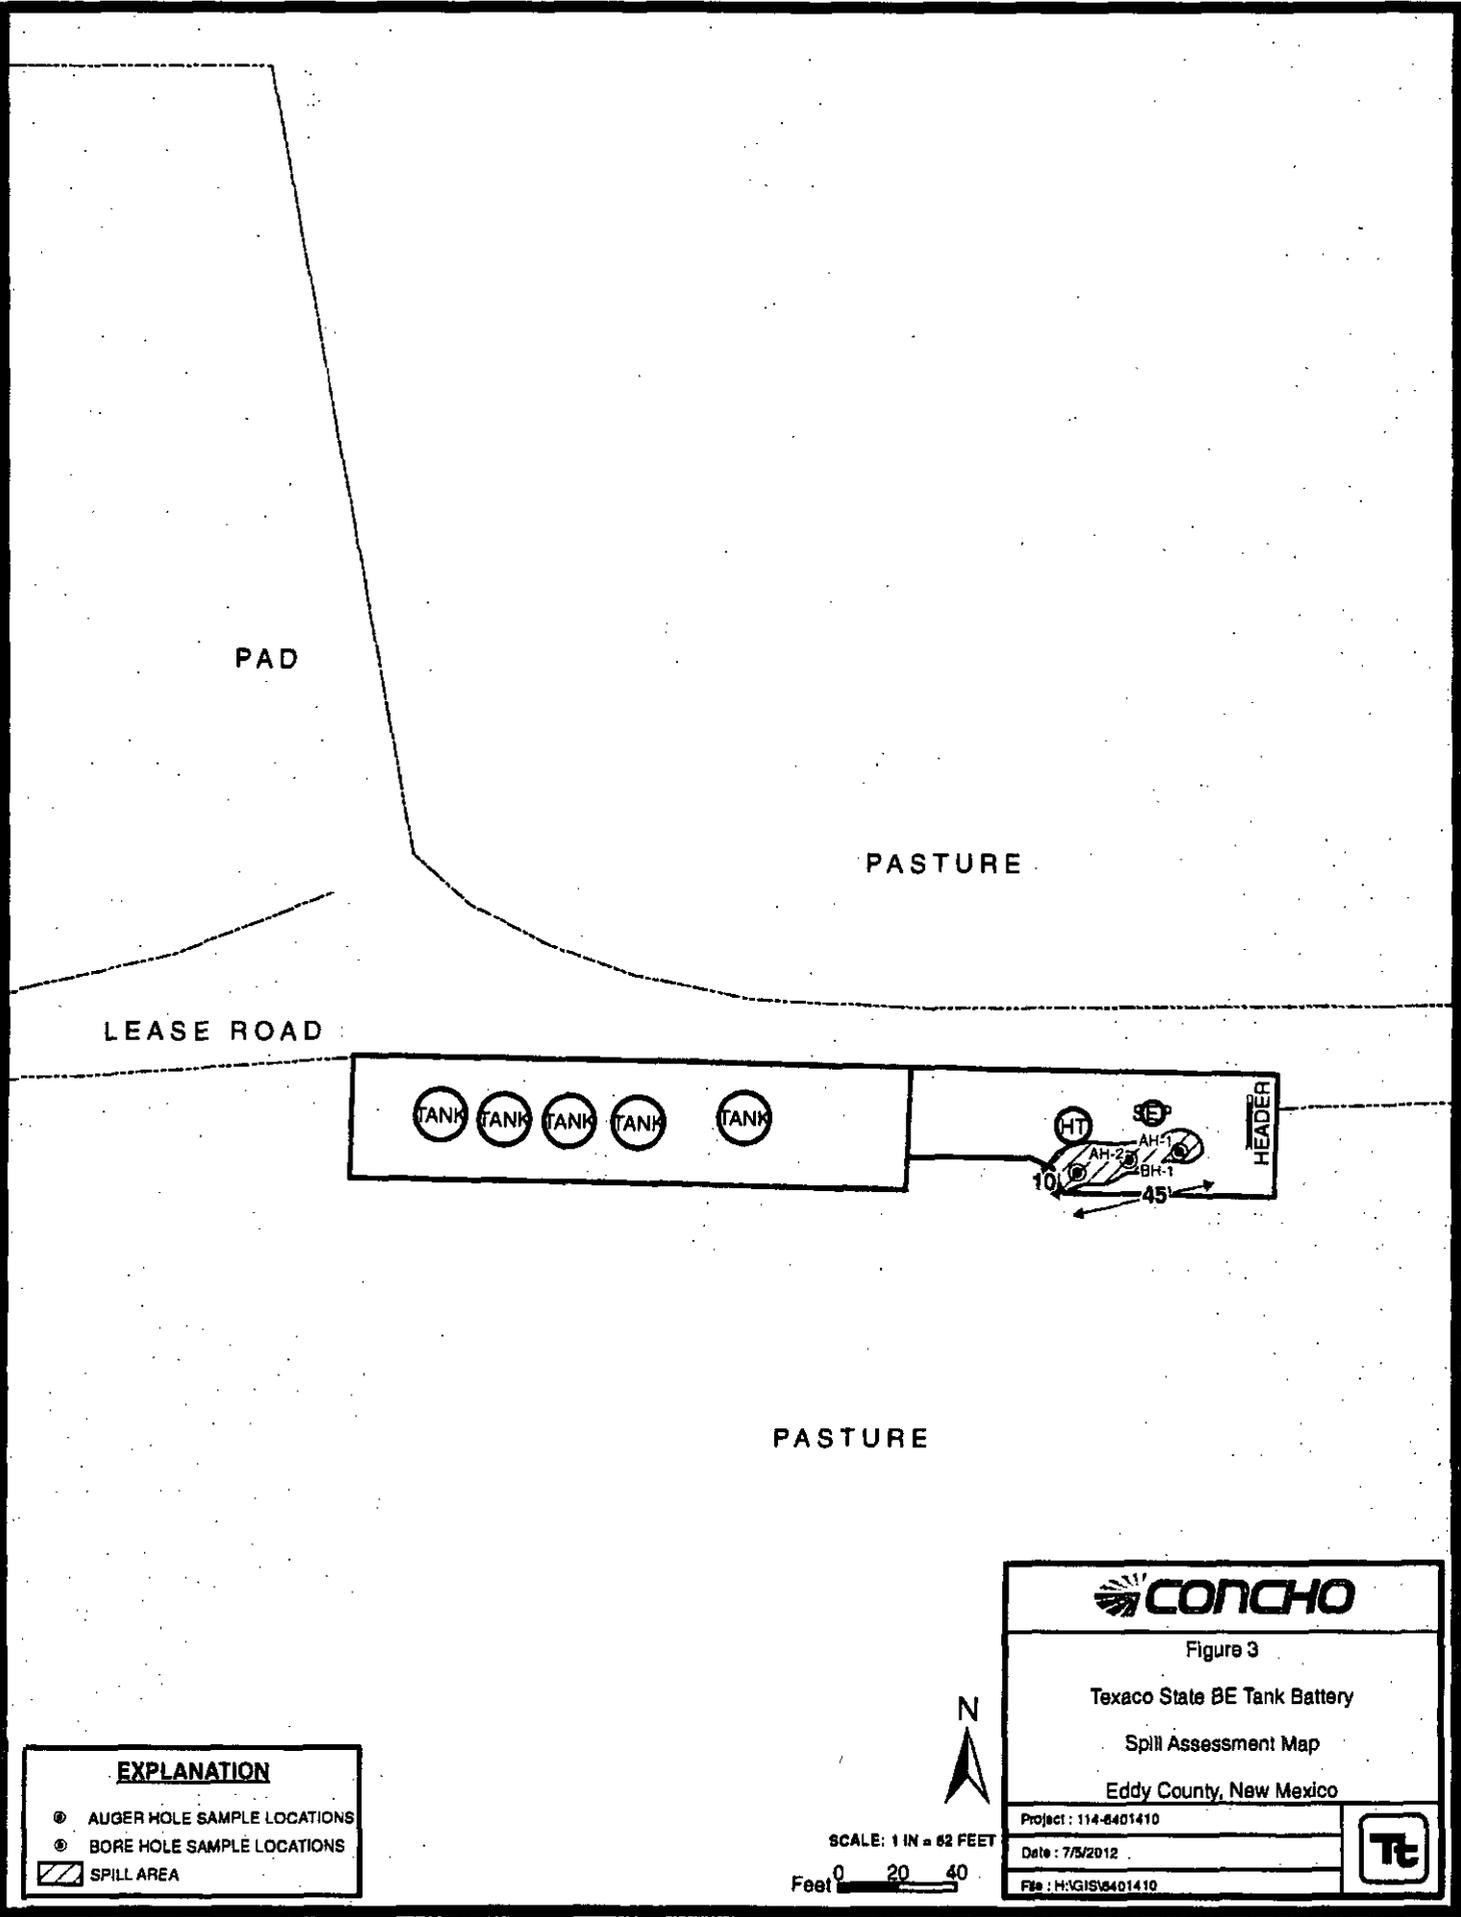
Figure 3	
Texaco State BE Tank Battery	
Spill Assessment Map	
Eddy County, New Mexico	
Project : 114-6401410	
Date : 7/5/2012	
File : H:\GIS\6401410

On September 12, 2012, Tetra Tech supervised the installation of a bore hole (BH-1) between the two the two auger points previously installed (AH-1 and AH-2) using an air rotary drilling rig to attempt to define the chloride impacted soils. The borehole was installed to a maximum depth of 70.0' below surface. At approximately 70.0' below surface the subsurface soils (flowing sands) began to collapse the borehole and drilling with air rotary could not be continued. Referring to the Table 1, the chloride concentrations were not vertically defined and showed a bottom boreholes of 3,840 mg/kg at 69-70' below surface and appears to be a historical impact.

On June 6, 2013, Tetra Tech supervised the installation of a soil boring (SB-1) near the location on the previously installed borehole (BH-1) using a hollow stem auger drilling rig. The soil boring was installed to a maximum depth of 110.0' below surface. At approximately 110.0' below surface, the subsurface soils (*flowing sands*) began to collapse in the borehole and drilling with a hollow stem auger could not be continued. The soil boring results are summarized in Table 1 and the location is shown on Figure 3. Copies of laboratory analysis chain-of-custody documentation are included in Appendix C.

Referring to Table 1, chloride concentrations did show declining chlorides with depth, but spiked at 69-70' of 2,920 mg/kg and at 89-90' of 3,560 mg/kg. The bottom hole sample at 109-110' showed a chloride of 6,140 mg/kg, which may be cross-contaminated from the upper soils.
