**NMSWD JENKINS STA. 13 S. LEAK
PROTOCOL 153**

Release Notification and Corrective Action

**Remediation and Site Restoration Protocol
New Mexico Salt Water Disposal Jenkins Sta. 13 S. Leak
1RP- 2611**

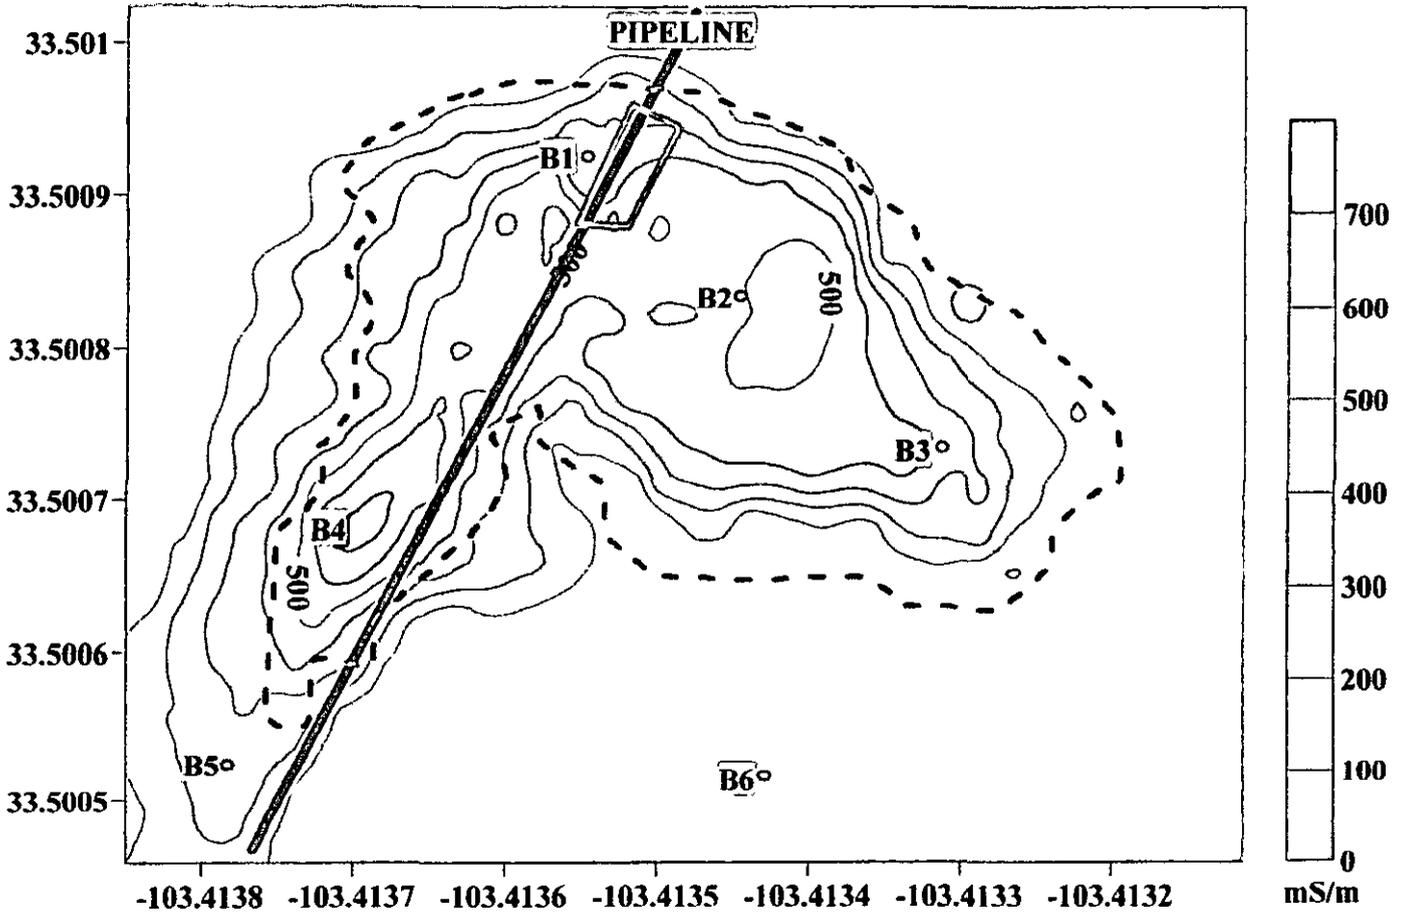
NMSWD JENKINS STA. #13 S. LEAK
SW/SE 1/4 UL/O SEC 25 - T9S - R34E
1451' FEL & 1067' FSL
EM38 SURVEY AREA 218' E&W X 200' N&S= 1.0 ACRE
GPS: WGS84 (DECIMAL)
N33.500906950 / W103.413513200
