1RP - 1523

SOUTHERN UNION GAS COMPANY

Environmental Site Summary

Project Name: Trunk "O" #5 (RP-1523)

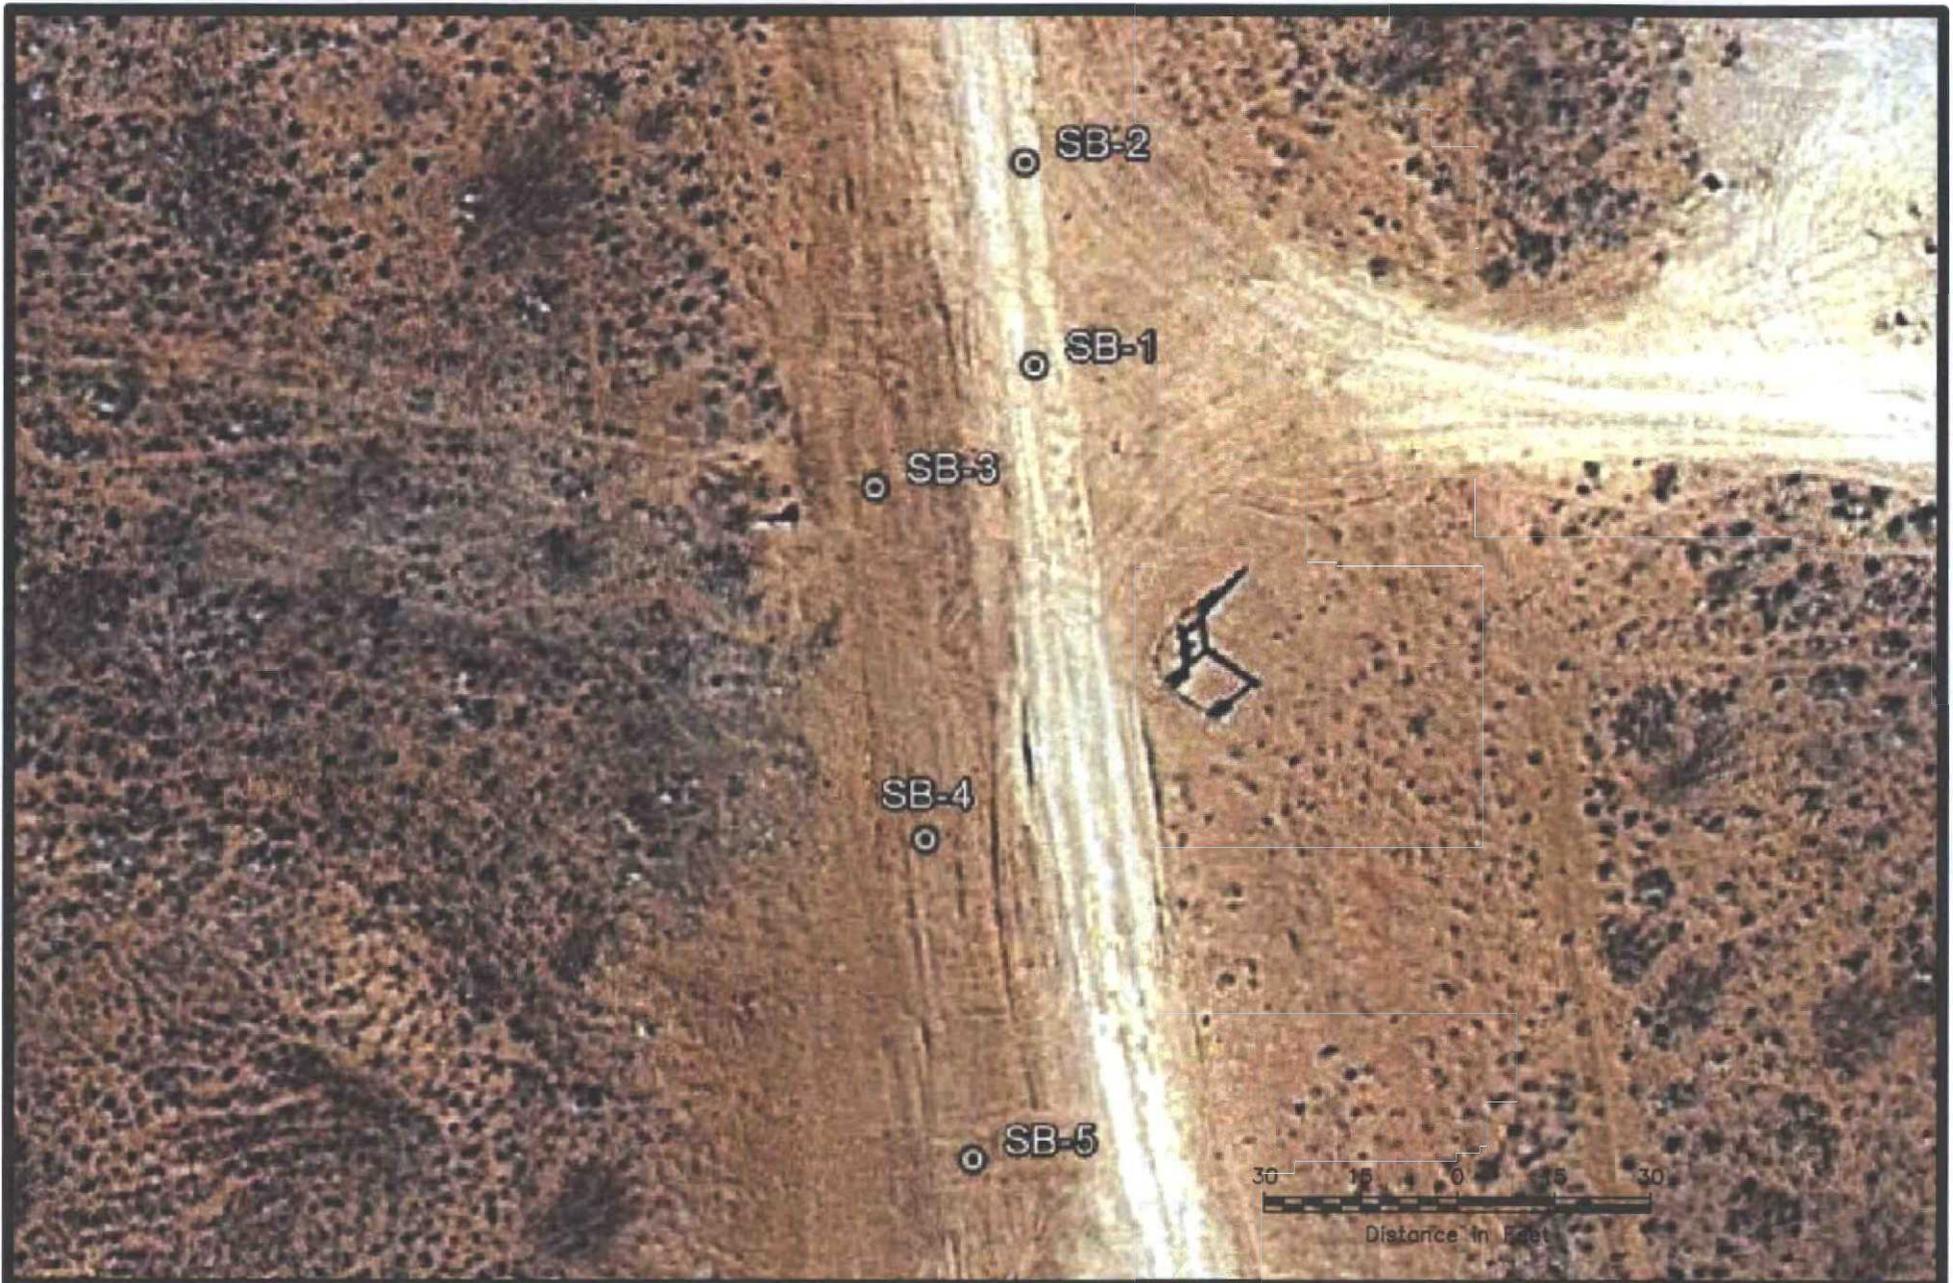
Figure 2
 Proposed Soil Boring Location Map
 Southern Union Gas Services
 Trunk "O" #5
 NMOCD Ref RP-1523
 Lea County, New Mexico

<u>SB-1 (Inferred center of impacted area)</u>
<u>SB-2 (North of inferred center of impacted area)</u>
<u>SB-3 (Southwest of inferred center of impacted area)</u>
<u>SB-4 (Inferred center of release flowpath)</u>
<u>SB-5 (Southern terminus of release flowpath)</u>
