1RP - 2366

R. T. HICKS CONSULTANTS, LTD.

September 25, 2009

RE: Gladiola SWD Section 26 Release Site T-12-S R-37-E Section 26 Unit Letter J
NMOCD # Not Assigned

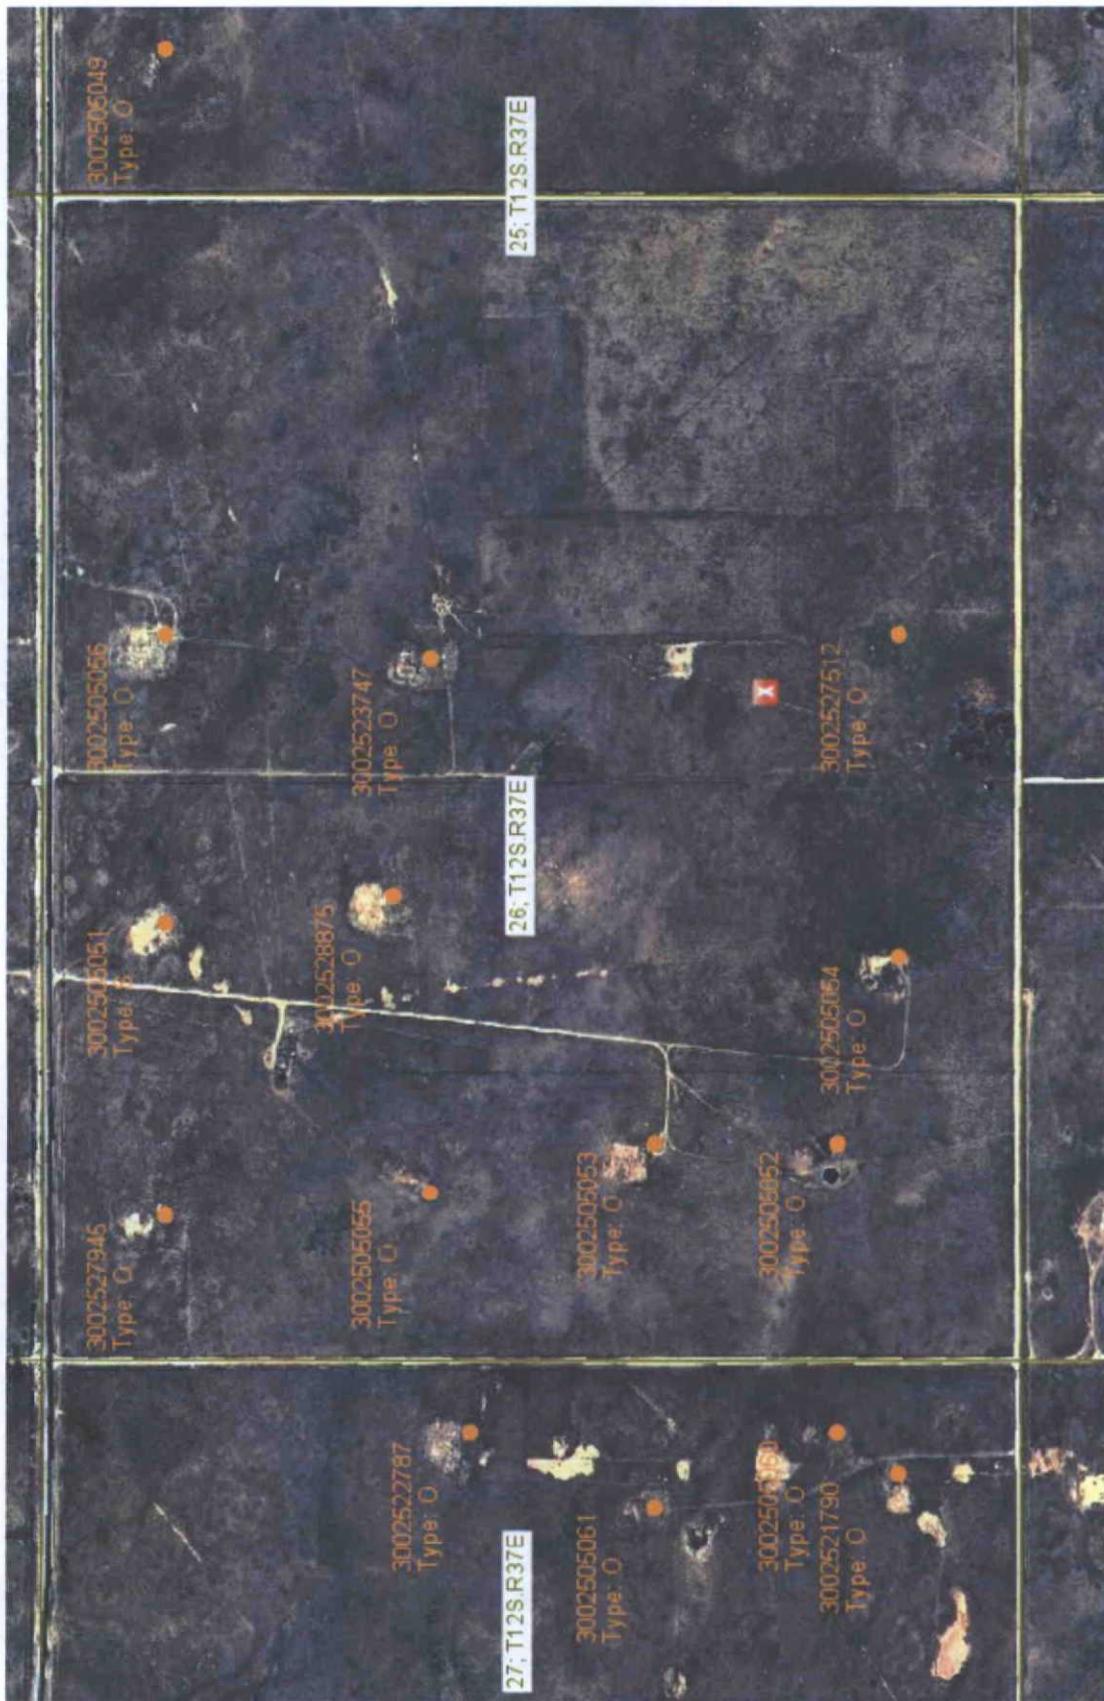
Figure: 2

Recent Air Photo Showing E&P Activities

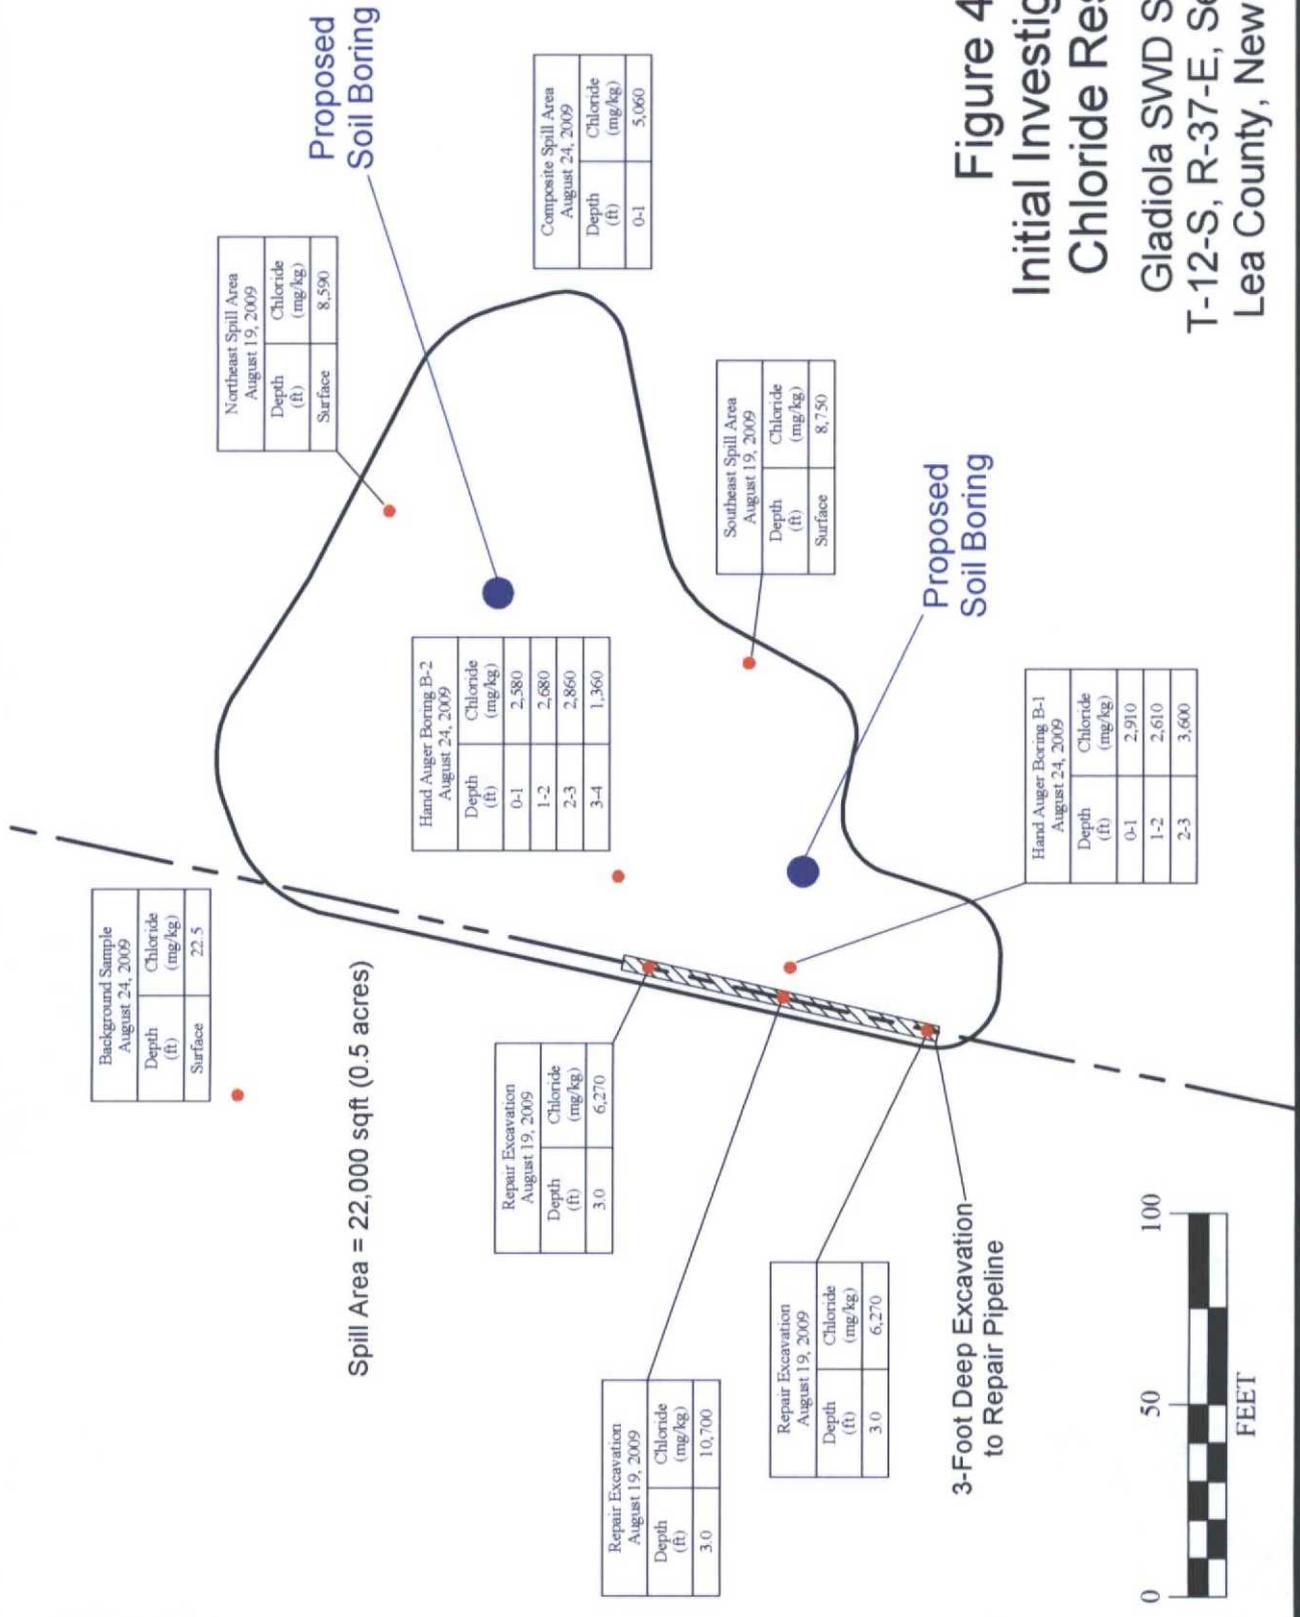
Figure 4
Initial Investigation
Chloride Results
 Gladiola SWD System
 T-12-S, R-37-E, Sec 26 (J)
 Lea County, New Mexico

Figure 4 is a site map that indicates the locations of the soil samples and the associated laboratory results

The horizontal extent of the spill (22,000 ft²) is defined by the damaged vegetation as verified by the spill footprint and background samples. The highest sample chloride concentration (10,700

mg/kg) is at the pipeline depth near the source of the leak. High chloride concentrations in samples (8,590 to 8,750 mg/kg) are also in the top few inches of the spill footprint area. Chloride concentrations in the topsoil within most of the spill area range from 2,500 to 5,000 mg/kg.

Hicks Consultants proposes two soil borings at approximately 30 feet down gradient from the release source area and approximately 100 feet to the northeast (see Figure 4) in order to define the depth of chloride-impacted soil. The soil boring that encounters the highest chloride concentrations from 10 to 20 feet below grade, based on field titrations, will penetrate ground water depth and be completed as a monitoring well according to the August 13, 1993 *Guidelines for Remediation of Leaks, Spills and Releases* in order to evaluate the ground water quality relative to background conditions.
