PURVIS OPERATING CO

R. T. HICKS CONSULTANTS, LTD.

February 16, 2010

RE: Gladiola SWD No. 2 Release Site T-12-S R-38-E Section 30 Unit Letter D
NMOCD # Not Assigned

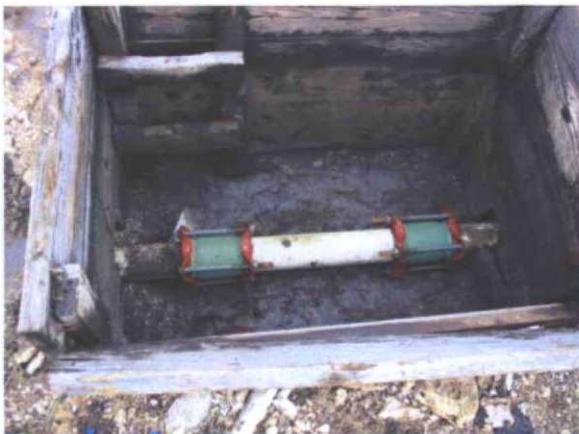
The main release occurred from a valve box (see photo on left below) on the Gladiola SWD pipeline and flowed out to and along a dirt road that is located adjacent to the north side of the pipeline. Soil in this area exists as a thin (1 to 1.5-foot thick) clay loam over the caliche bedrock. The pipeline rests on top of, or just within the caliche. A perched ground water zone is believed to be present at a depth of approximately 24 feet.

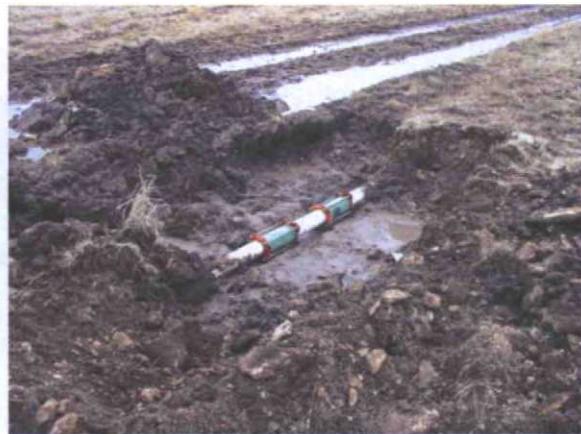
Repair operations occurred during a significant rainfall event. As a result, a second pipeline break occurred approximately 240 feet to the east when the wheel of one of the vehicles slid off the dirt road and likely pushed a rock through the shallow soil and into the PVC pipeline.

The pipeline was shut off when this occurred and the release was believed to be contained within a few feet of the damaged line (see photo on right above).

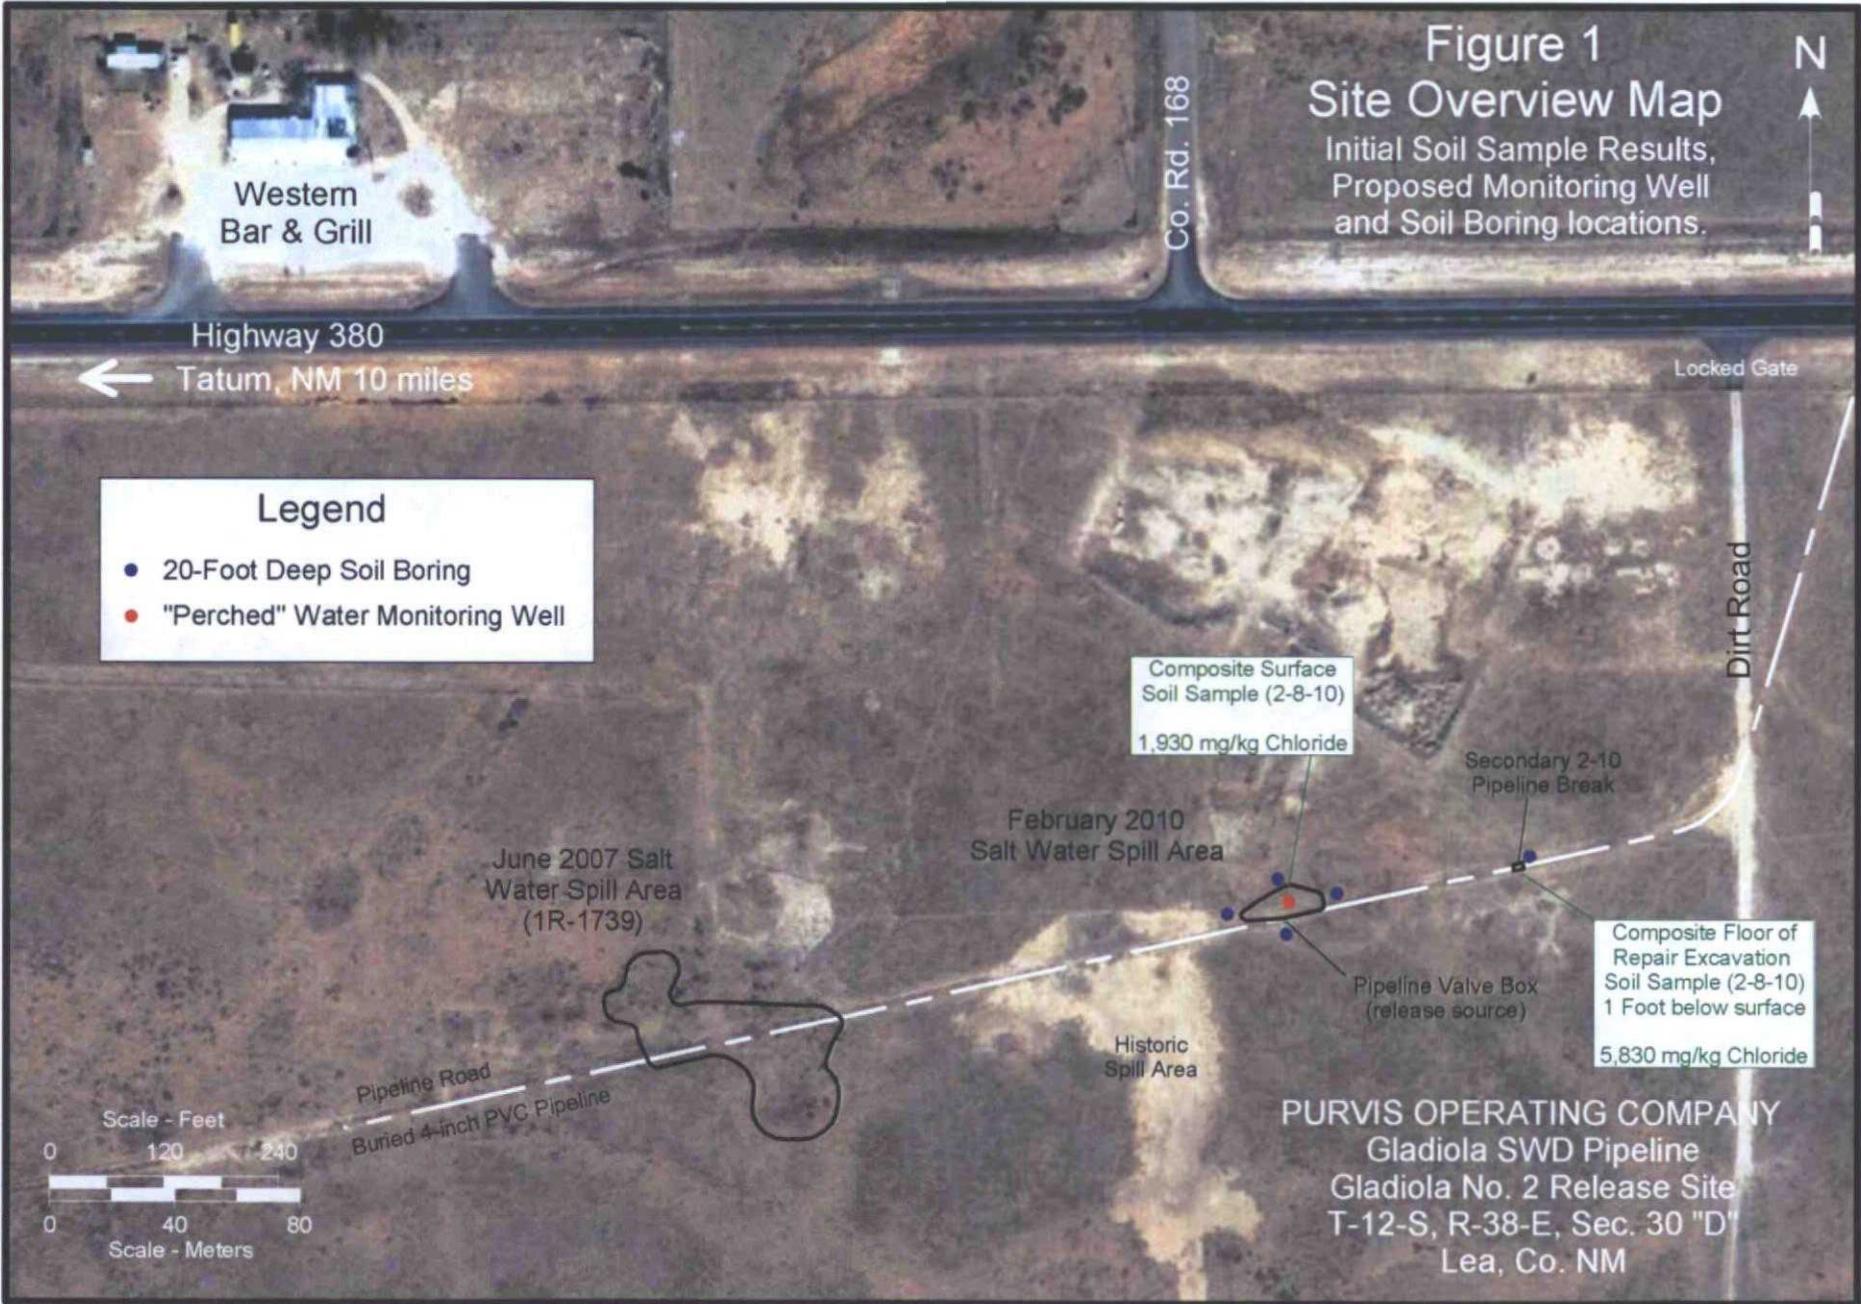
Figure 1 is a site overview map that indicates the locations of the release areas, soil sample laboratory results, proposed monitoring well and soil boring locations, and the proximity to the June 2007 Gladiola SWD spill site (1R-1739).

The horizontal extent of the spill (approximately 4,000 ft²) is not well defined due the saturated and highly disturbed condition of the shallow soil. Once the soil has completely dried the horizontal extent of the chloride impact should be more apparent.

Hicks Consultants proposes that one 4-inch monitoring well be installed to the shallow perched ground water zone within the spill footprint and at least four 20-foot soil borings installed adjacent to the footprint in order to delineate the vertical and horizontal extent of the chloride-impacted soil at the main spill. In addition, a 20-foot soil boring will be installed adjacent to the excavation at the secondary spill area.
