CML EXPLORATION, LLC

R. T. HICKS CONSULTANTS, LTD.

April 18, 2011

RE: CML Exploration, Paddy 19 State #3, Unit F, Section 19, T17S, R33E
API #:30-025-38591
Ground Water Monitoring Report and Request for Closure

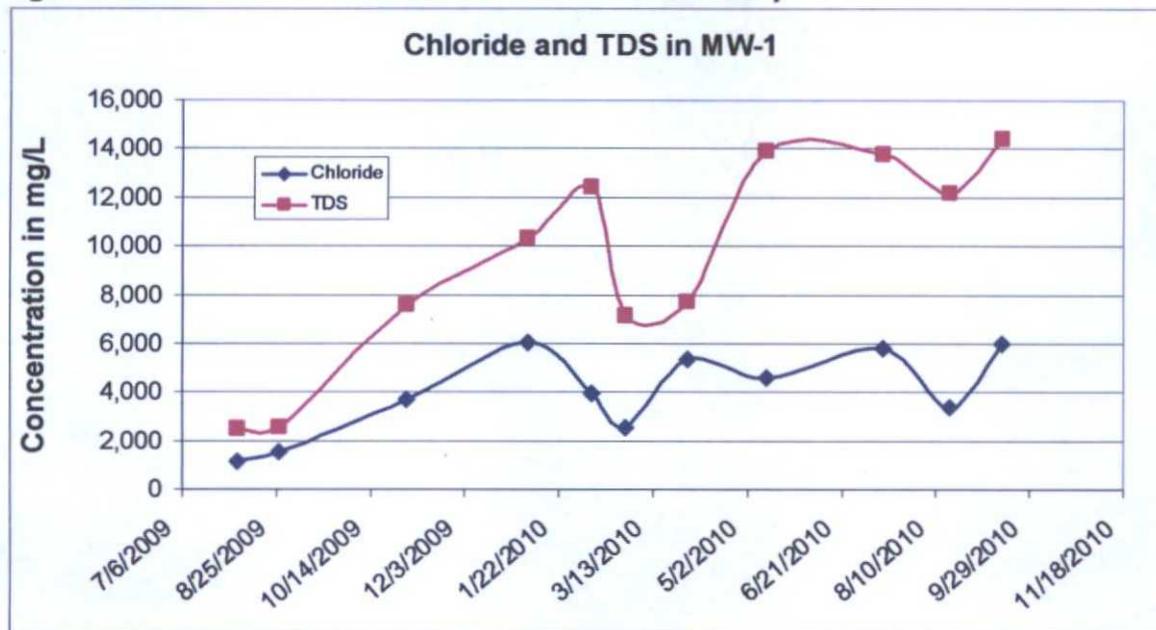
Figure 1. Concentrations of Chloride and TDS at Paddy 19 #3

MW-1 was installed in July 2009. Ground water sampling data for chloride and TDS concentrations are summarized in Figure 1 below and Table 1.

- Initial chloride concentrations in ground water observed in MW-1 were 1,160 and 1,500 mg/L in August 2009.
- Pumping of MW-1 caused significant drawdown in the well and localized westward

migration of chloride from the main portion of the ground water plume to the well. This migration is evidenced in the increasing chloride concentration observed in MW-1 during 2009 and 2010.

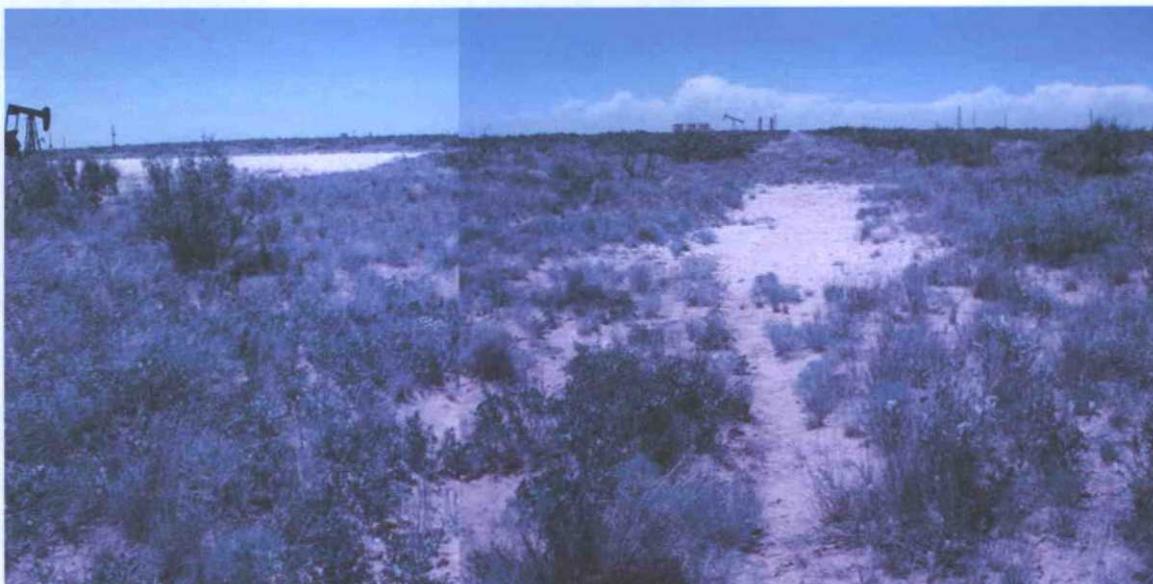
Figure 2: Vegetation scar along pipeline north of Paddy 19#3

1. Ground water gradient in the area flows to the southeast at a gradient of 0.005 ft/ft as shown on Plate 2.
2. This direction of flow and gradient is consistent with regional data (see regional ground water flow map in Appendix A).
3. Background chloride concentrations in ground water are less than 50 mg/L (MW-2).
4. Ground water chloride concentration up-gradient from the former pit exceeds 10,000 mg/L.
5. Between 1996 and 2006, damage to vegetation occurred along the pipeline right-of-way north of the Paddy 19 #3 reserve pit area.

- A historic release from the pipeline north of the former Paddy 19 #3 reserve pit created saturated flow of produced water from the pipeline to ground water. This release caused chloride concentrations in ground water quality beneath the pipeline to exceed 10,000 mg/L.

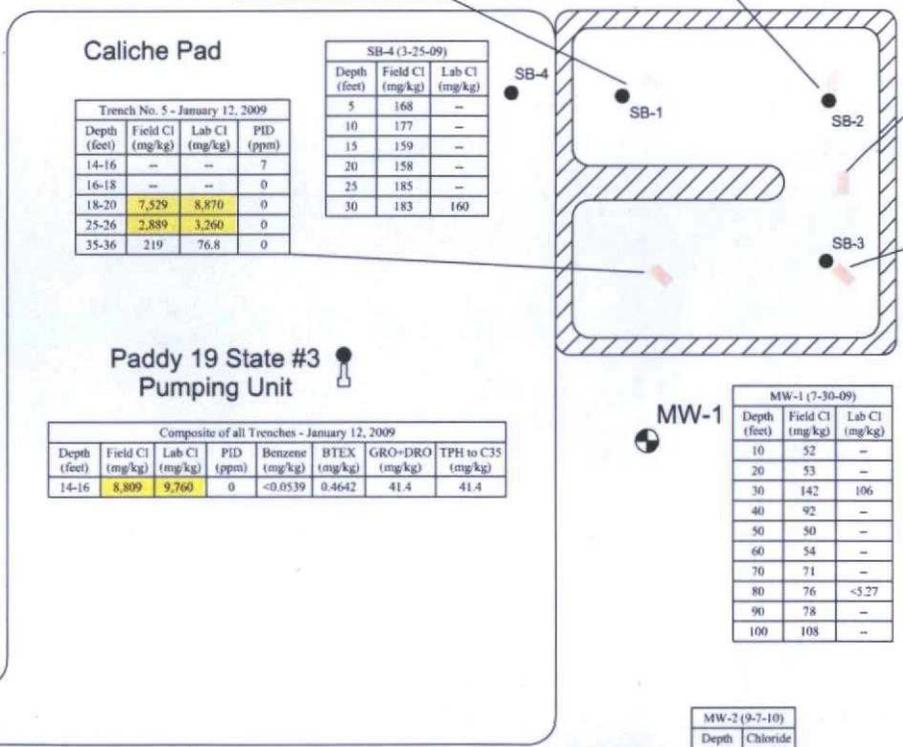
Plate 1
 Soil Sample Results

- Chloride released from the former Paddy 19 #3 drilling pit did not enter ground water via saturated flow as evidenced by chloride in soil boring data that show relatively low levels of chloride in soil in the 5-10 feet above ground water at the site.

- Soil boring data at the site indicate a very small mass of chloride released from the pit entered ground water near SB-1.
- When originally drilled in 2009, MW-1 was at the western edge of a ground water chloride plume caused by the release of produced water from the pipeline.

Lab Concentrations Exceeds
 Regulatory Protection Levels

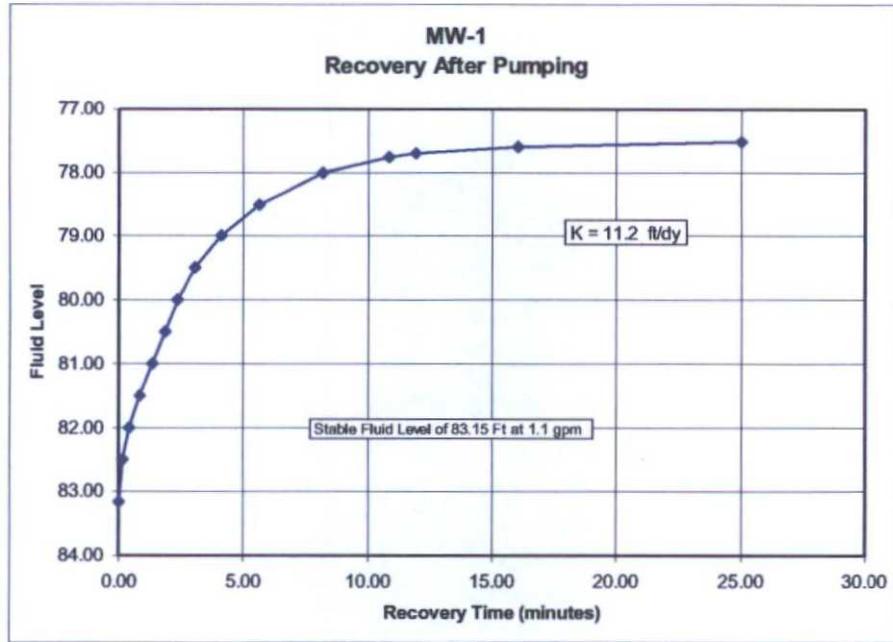
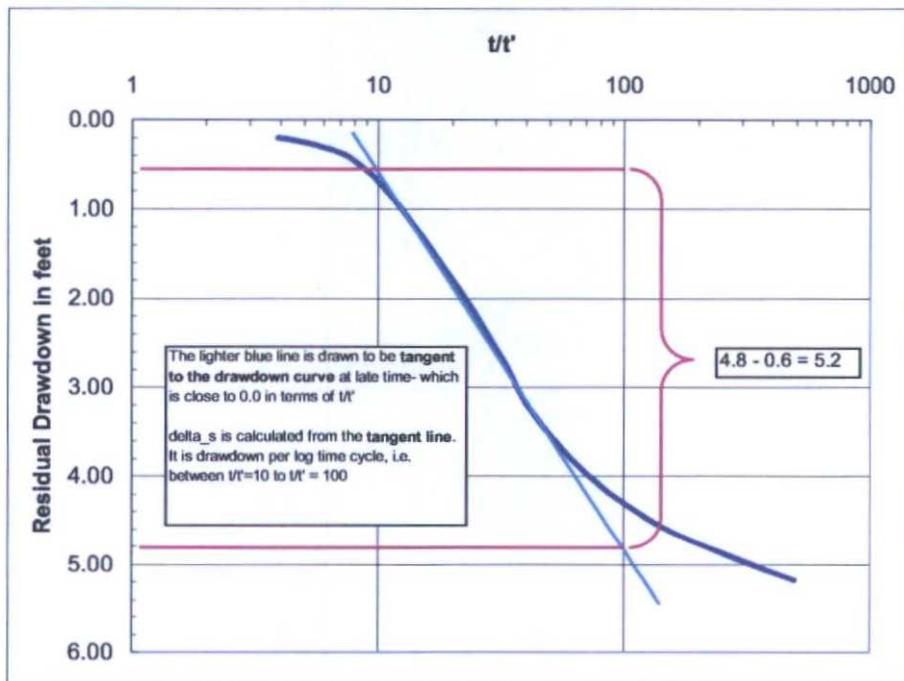
**CML Paddy 19 State #3 Reserve Pit
Attachment A – Residual Drawdown Test Results**

Input	Pumping Rate	1.10	[gal/min]	delta_s is calculated from graph
Input				5.2 [feet]
$T = (264 \cdot Q) / \text{delta}_s$				delta_s is
residual drawdown in feet per log time cycle (Page 256, Groundwater and Wells)

Output	T =	55.84615	[feet^2/day]
Input	Aquifer thickness	5	[feet]
Output	Resultant K	11.16923	[feet/day]

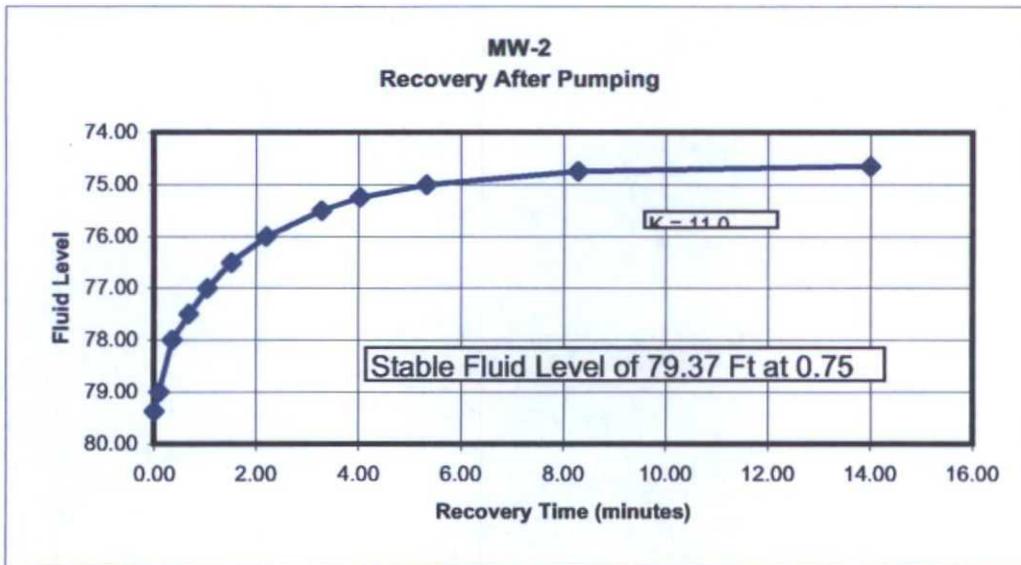
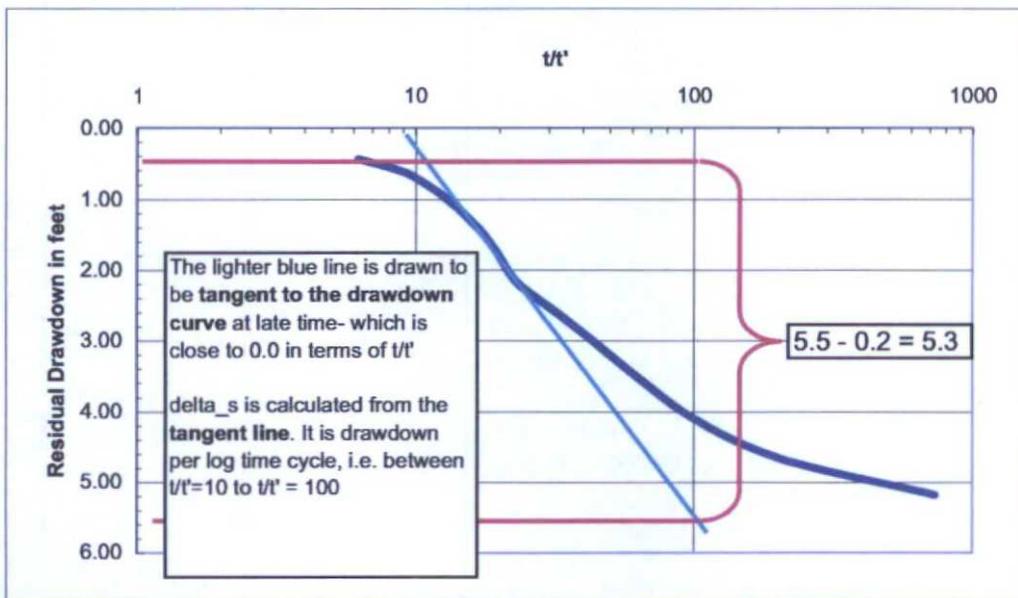
delta_s is calculated from graph			
Input	Pumping Rate	1.10	[gal/min]	Input	5.3	[feet]
$T = (264 \cdot Q) / \text{delta}_s$ residual drawdown in feet per log time cycle (Page 256, Groundwater and Wells)				delta_s is

Output	T =	54.79245	[feet ² /day]
Input	Aquifer thickness	5	[feet]
Output	Resultant K	10.95849	[feet/day]
