Release Notification and Corrective Action

NAB 1800555402

Name of Company	Devon Energy Production Company <i>0137</i>	Contact	Stephen Richards, Devon Completions Foreman
Address	6488 Seven Rivers Hwy Artesia, NM 88210	Telephone No.	575-252-3717
Facility Name	Cotton Draw Unit 294H (near the Cotton Draw Unit 113H API# 30-015-39517)	Facility Type	Oil

CDU 294H Spill 12.21.17

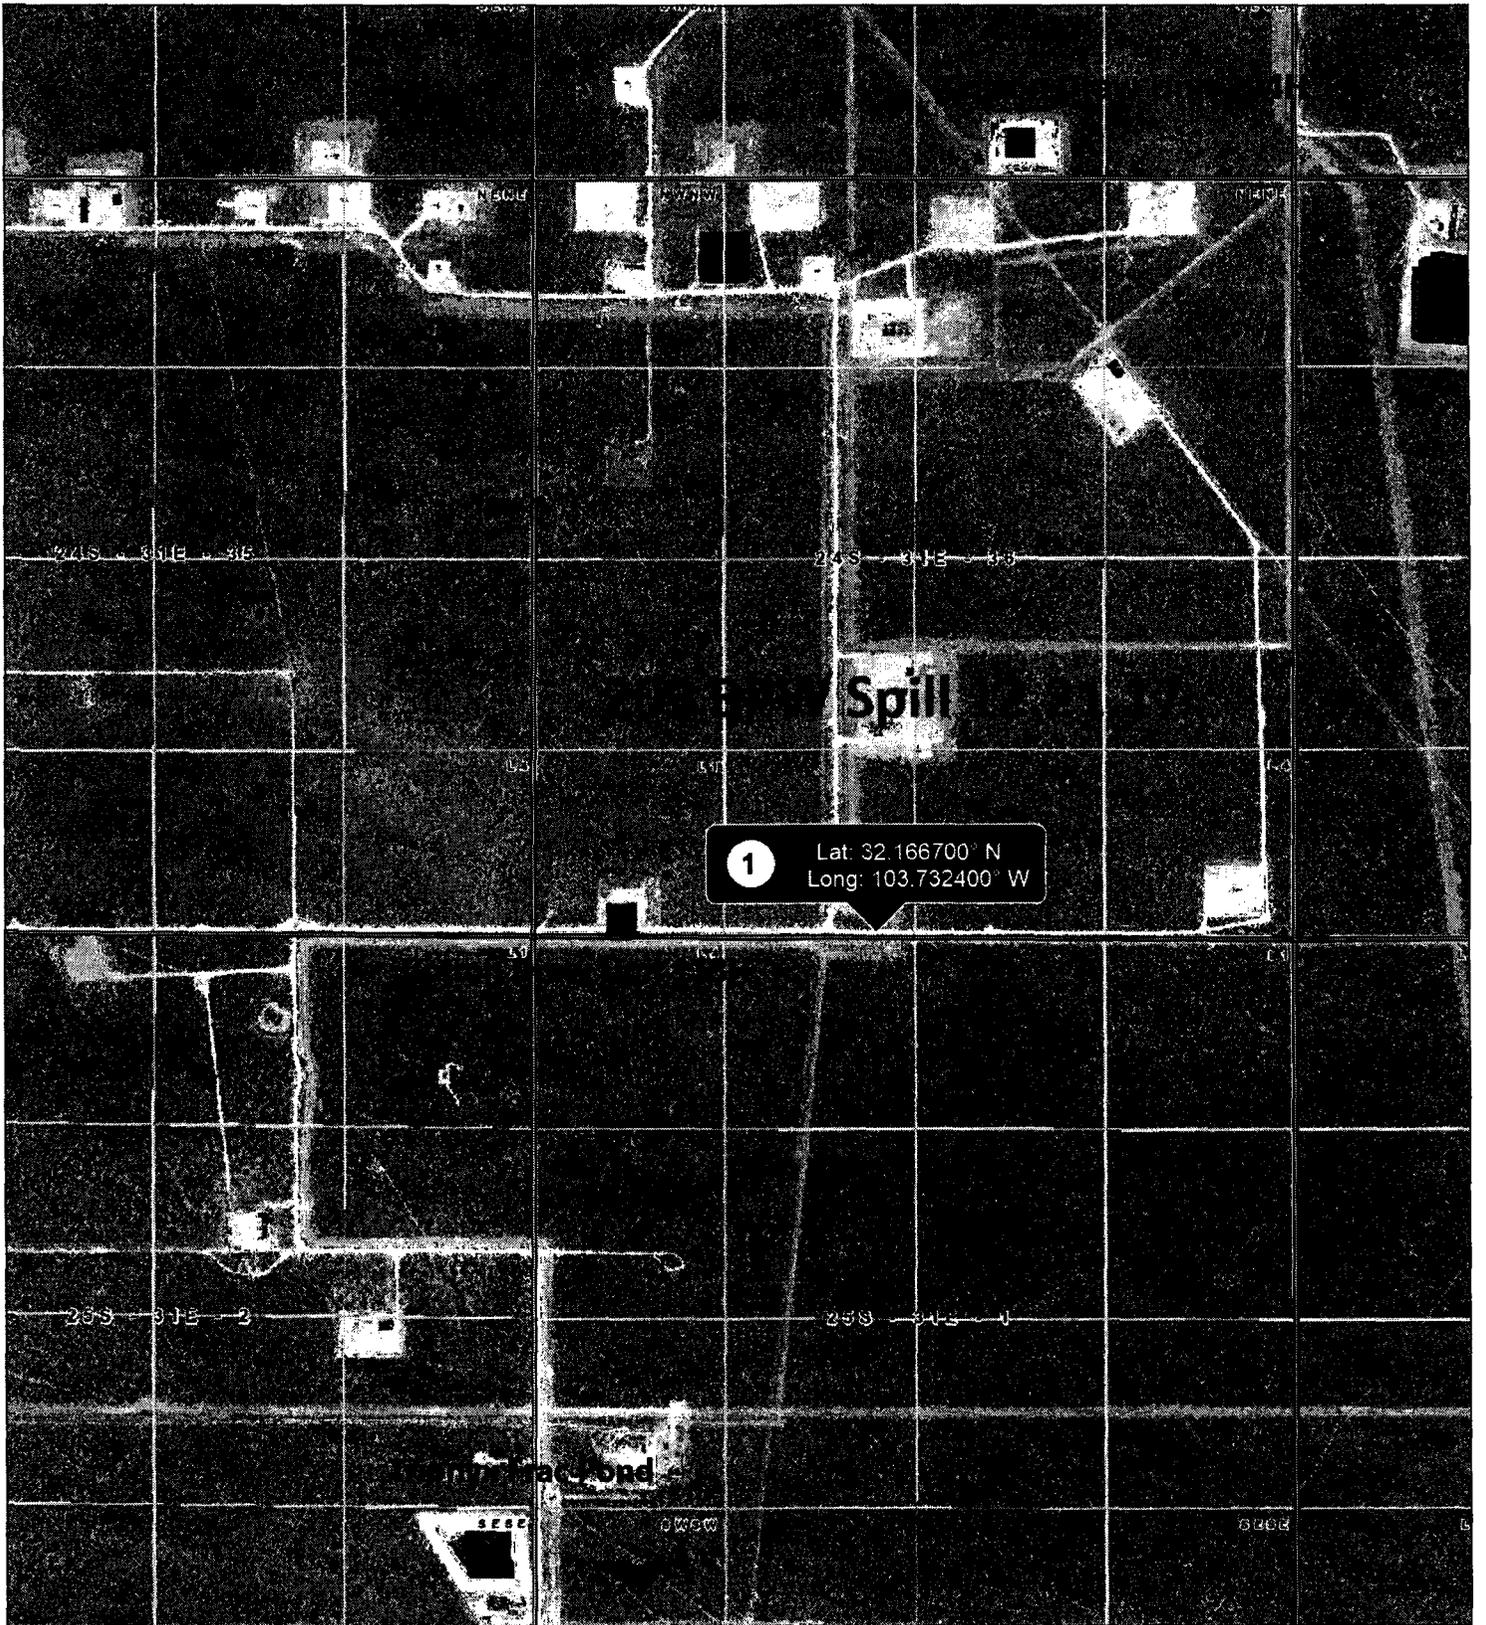
Describe Area Affected and Cleanup Action Taken.*
Approximately 209 barrels of produced water spilled on to the ground. A vacuum truck was dispatched and 50 barrels of produced water was recovered. The spill starts on State surface and minerals but crosses the property boundary and also has impacted Federal surface and minerals. A remediation contractor will be contacted to assist with the delineation and remediation of the impacted area.

209 BPW, Rec 50 BPW
