Release Notification and Corrective Action

Name of Company Fasken Oil and Ranch <i>151416</i>	Contact Aaron Pachlhofer
Address 6101 Holiday Hill Road	Telephone No. 432-687-1777
Facility Name Shell Federal No.2 SWD	Facility Type Salt Water Disposal Battery
Surface Owner: Federal	Mineral Owner: Federal
API No.: 30-015-22717

From: Aaron Pachlhofer <aaronp@forl.com>
Sent: Monday, August 6, 2018 12:20 PM
To: Pruet, Maria, EMNRD; Tucker, Shelly; Jim Amos
Subject: Fasken Shell Federal No. 2 SWD Spill/Fire
Attachments: 2731_001.pdf

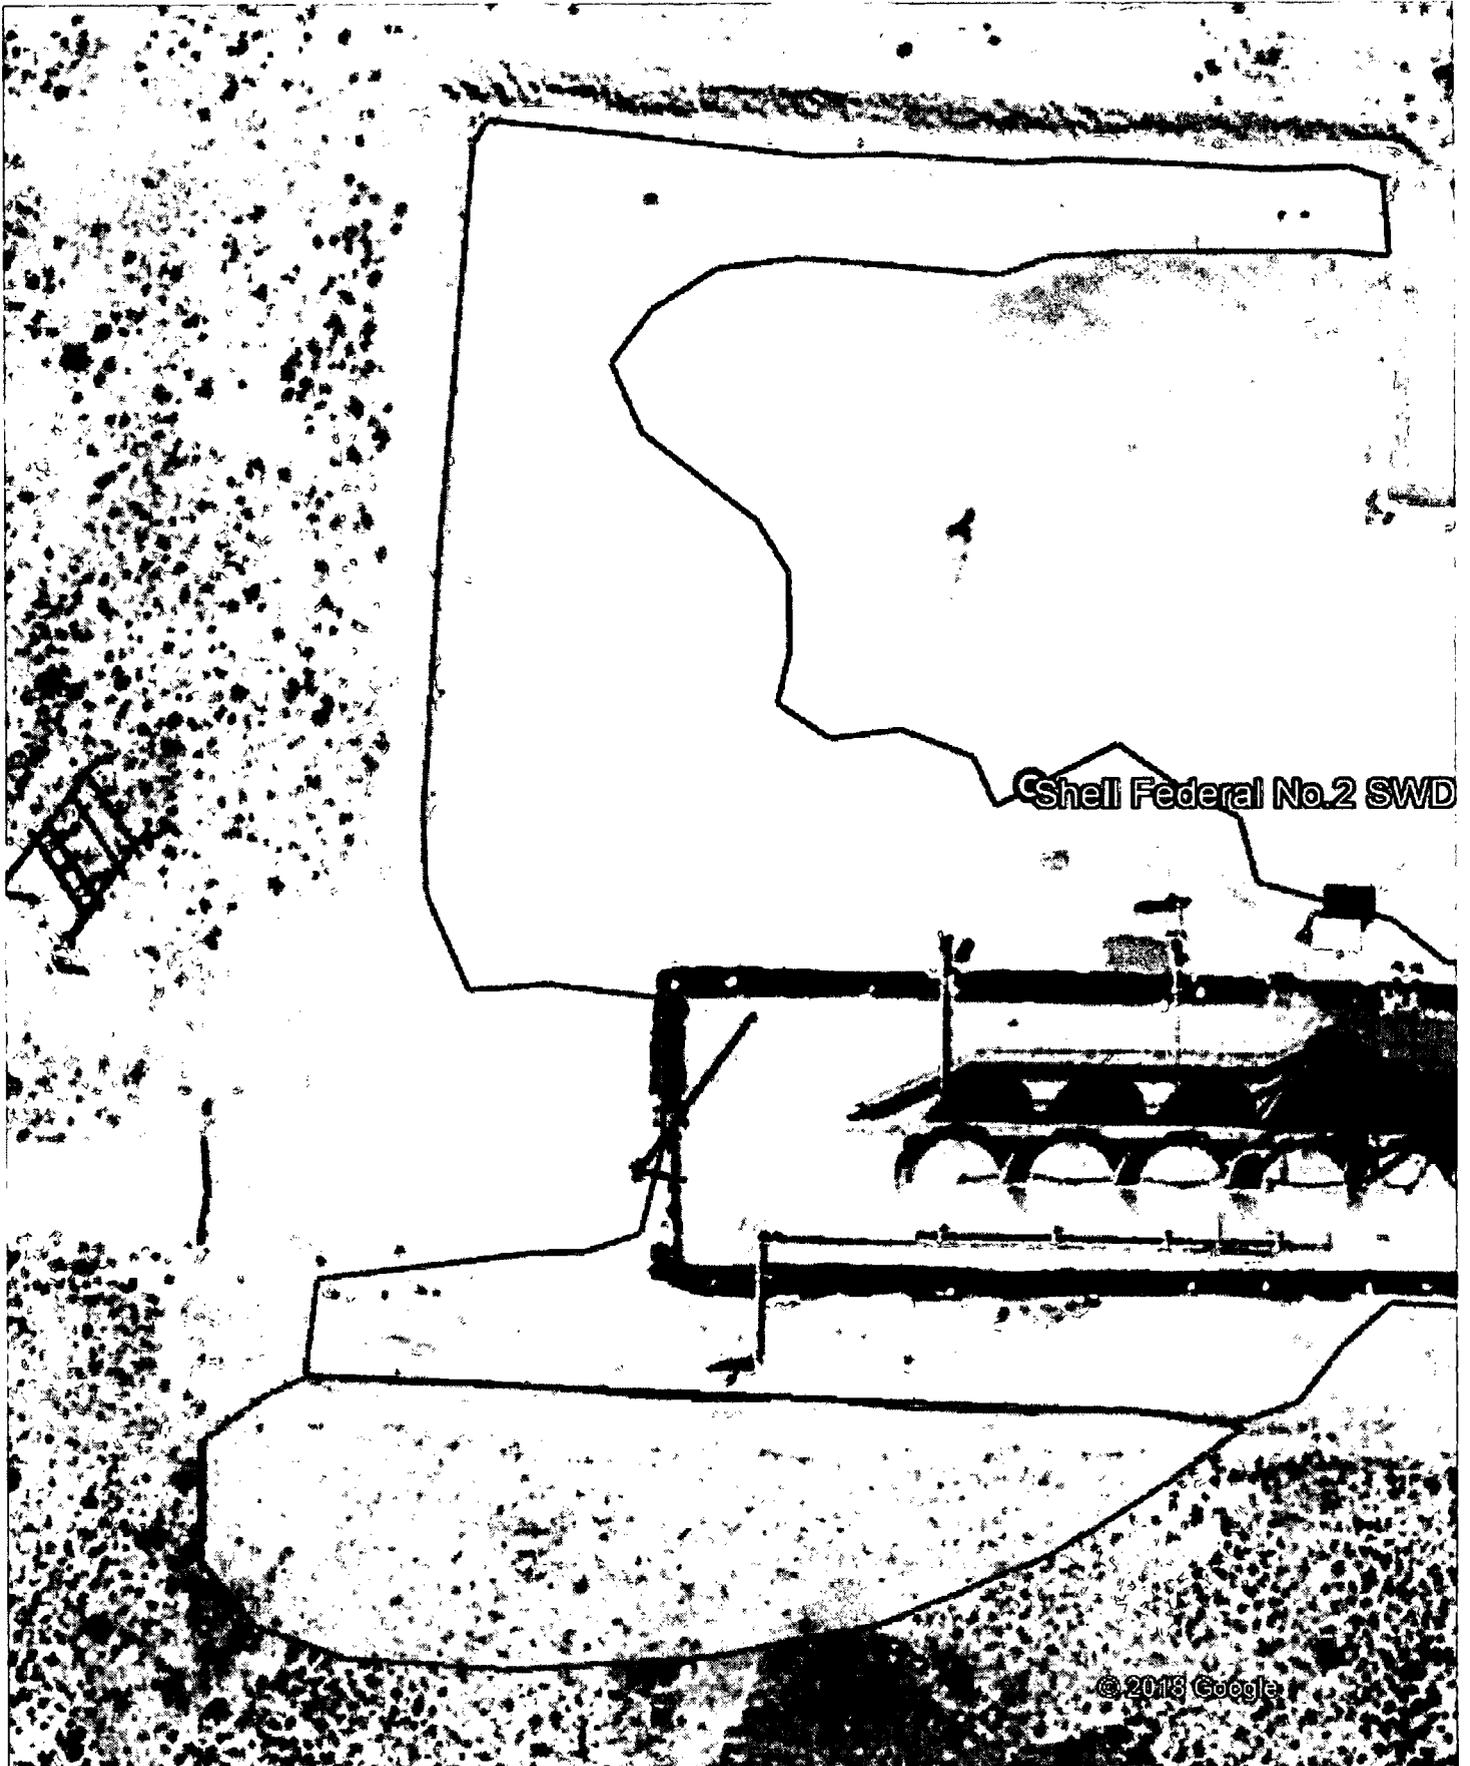
Shell Federal No.2 SWD

The spill was almost fully contained to the pad, due to good containment construction. As I noted on the phone; the liner appears intact so hopefully the vast majority of the fluids were contained. When we get the area cleared, we will get the liner pulled back so that we can see if it held up or not.

See below for an image with the spill area that I captured with my GPS. The yellow shaded area appears to have received a light overspray of oil (drops, not a mist) but it was also scorched. It was damp when I onsite Saturday so I can't tell if there was any produced water released. We should be able to see better once it dries out a bit more.

After Maria, Shelly, and I meet onsite tomorrow, I will put together a workplan to get this cleaned up. In discussion with the superintendent, we will need to rebuild this battery very soon. Fasken should be able to get this cleaned up before re-building begins.
