3RF - 28

**Leak Detection
Inspection Logs**

**Enduring
NEU 16B Facility**

10/22/18 - 12/26/18

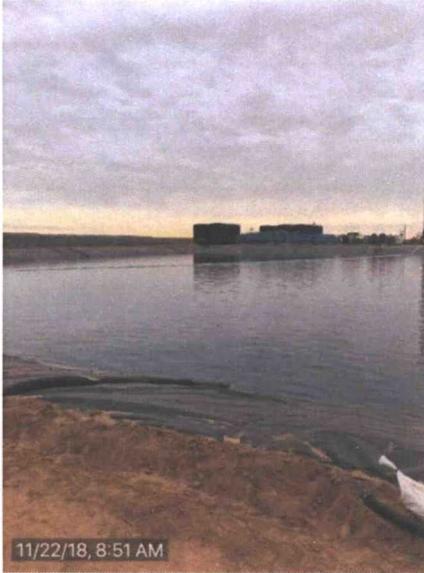
Appendix 1

Question	Response	Details
Leak detection was checked, and does not show signs of a release	No	Water in leak detection at 53.55 feet.

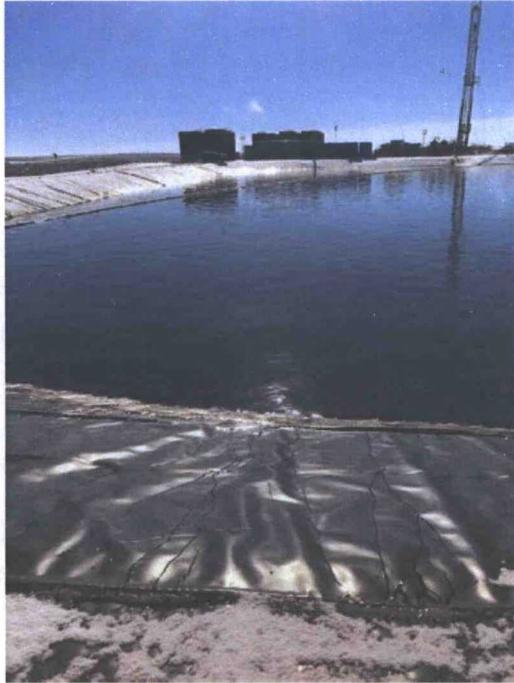
Photo 1

Leak detection had water. Level was at 53.5. Level did not Increase
