Release Notification and Corrective Action

**RE: INVESTIGATION & CHARACTERIZATION PLAN
BD M-9 ACCIDENTAL DISCHARGE SITE
UL/M SEC 9 T22S R37E**

INVESTIGATION AND CHARACTERIZATION PLAN

BD M-9 ACCIDENTAL DISCHARGE

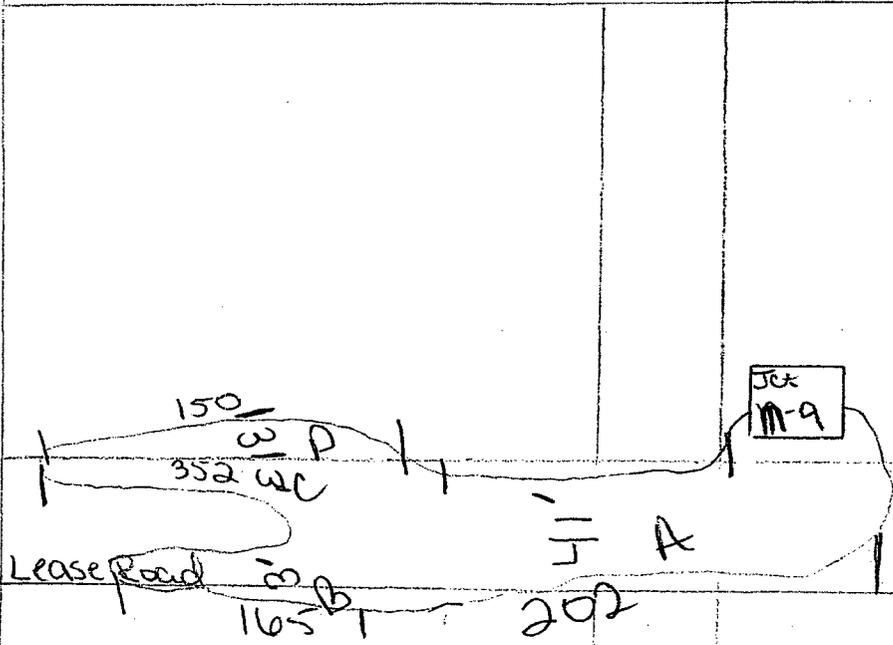
coupling blew out, replaced with 2 flanges fused together

- A 202x41 = 8282
 - B 165x3 = 495
 - C 352x3 = 1056
 - D 150x3 = 450
-
- 10,283
