Release Notification and Corrective Action

Name of Company	Southern Union Gas Services, Ltd.	Contact	Tony Savoie
Address	P.O. Box 1226 Jal, N.M. 88252	Telephone No.	505-395-2116
Facility Name	Lea County Field Dept.	Facility Type	Natural Gas Gathering
Surface Owner: State of New Mexico	Mineral Owner: State of New Mexico	Lease No.

Southern Union Gas Service Co Lea County, N.M.	Site Plan: S&W 4" Lateral	2006-036
	Lea County Area	Jal, N.M.

S and W 4" Lateral #2006-036 Ranking Analysis

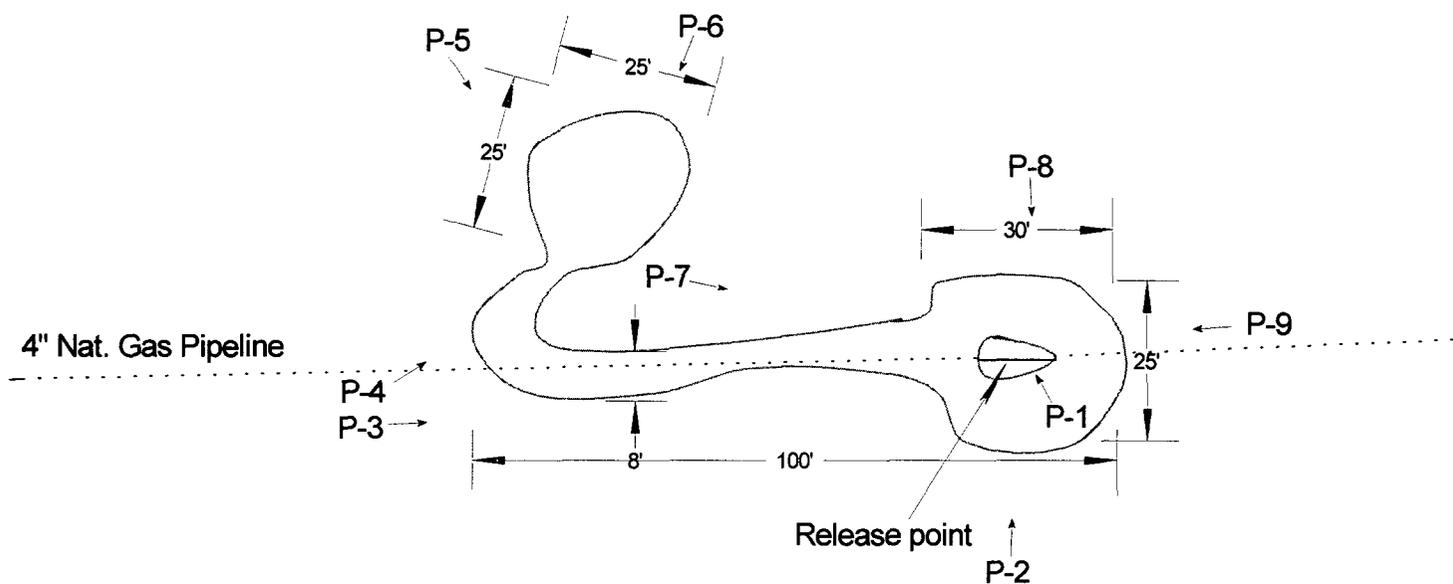
The 4" steel gathering pipeline, operating at 20 psi developed a leak, the line was blocked in an allowed to blow down on 5/27/06. Repair crews replaced the affected area of pipe by replacing approximately 400 ft. of steel pipe with poly-pipe on 8/11/06. Normal operating pressure on the line is 20 psi to 30 psi, with a potential H2S content of 4000 ppm.

Describe Area Affected and Cleanup Action Taken.* An area measuring approximately 2175 sq. ft of pasture land was affected around the immediate leak area with a mist of iron sulfide and natural gas liquids. No immediate cleanup action was taken. The impacted soil will be remediated using the NMOCD recommended guidelines. A Site sketch and remediation plan is attached.

All affected soil will be excavated and stockpiled on-site. Samples will be collected to determine TPH and BTEX values. Soil exceeding the site closure objective will be hauled to the Southern Union Gas Services Landfarm.
