Release Notification and Corrective Action

Name of Company Occidental Permian Limited Partnership	Contact Steven M. Bishop
Address 1017 West Stanolind Road, Hobbs, N.M. 88240	Telephone No. (505) 397-8251
Facility Name South Hobbs Unit Satellite #1	Facility Type Production
Surface Owner Mr. Dee A. Cochran	Mineral Owner
Lease No.

RE: Remediation Plan
South Hobbs Unit Satellite #1 Test Vessel
UL 'K', Sec. 5, T-19-S, R-38-E

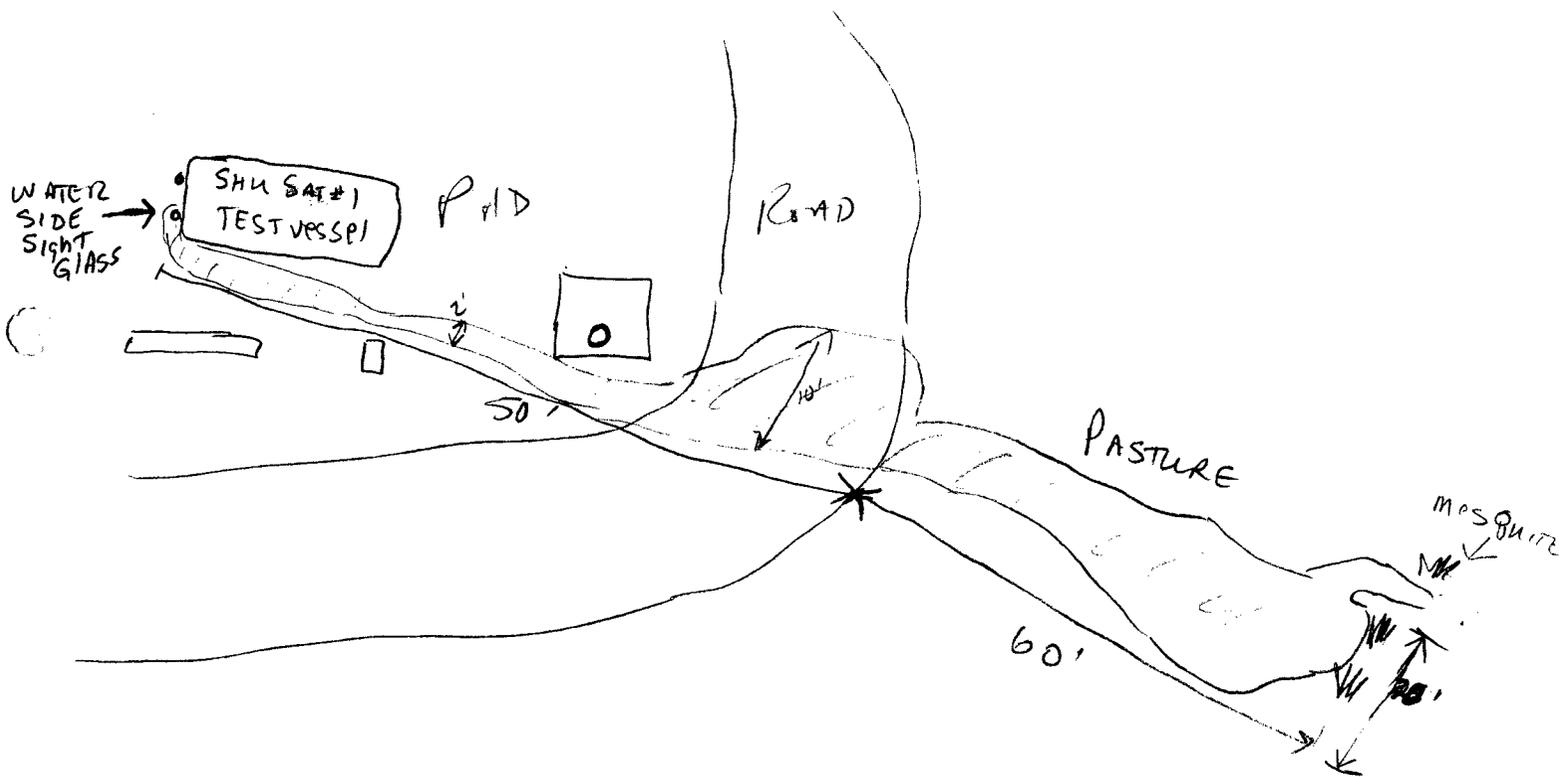
SPILL MAP

02/28/07 Ø80 X 15 BW REC Ø80 X 10 BW
SHU SAT#1 BROKEN SITE GLASS ON TEST SEPARATOR
UL'K' Sec 5, T-19S, R-38E
N 32°41'10.03" W 103°10'22.17"
