**Release Notification and Corrective Action**

Name of Company: <b>Occidental Permian Limited Partnership</b>	Contact: <b>Tony Summers</b>
Address: <b>1017 West Stanolind Road, Hobbs, N.M. 88240</b>	Telephone No: <b>505.397.8236 or 505.390.9228</b>
Facility Name <b>State D Battery</b>	Facility Type <b>Production</b>

RE: Remediation Plan  
State D Tank Battery  
UL 'G, Sec. 32, T-21S, R-36E

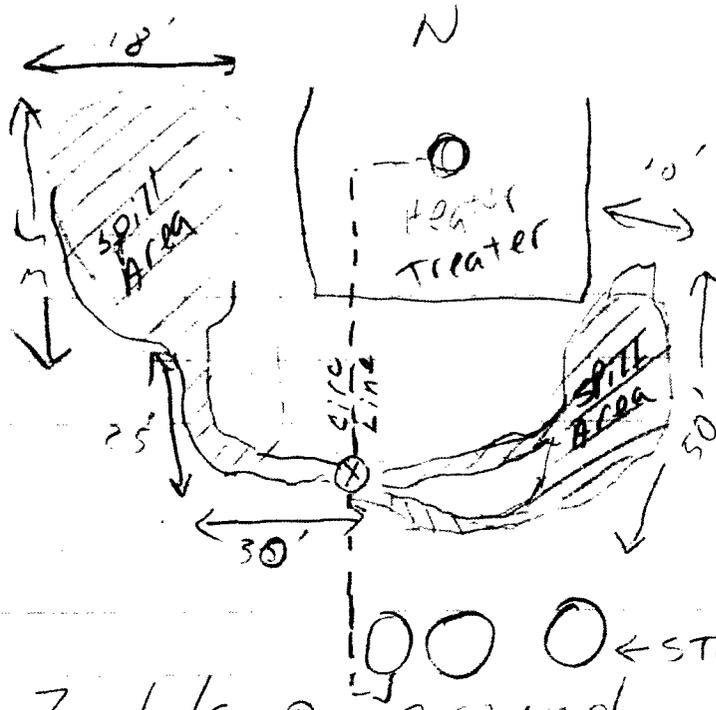
# STD Battery

At approximately 6 AM on 03/04/07 a hole occurred in a 3" buried steel circulation line between heater treater and storage tanks on existing Oxy tank battery. Lease was shut in while repairs were made and vacuum truck called. Approx. 60 barrels of crude oil were spilled and 50 were picked up by vacuum truck. All fluid spilled onto existing battery caliche pad, none got into pasture. The NMSEO data base has no info for this exact area. The closest is in section 25 which show average depth to water 148' giving a ranking of 0. Remediation of spill site will be as follows:

67 bls on ground  
30 bls picked up

1. Line will be replaced with new.
2. Contaminated area will be excavated and disposed of to JL Land farm.
3. NMOCD guidelines will be used to insure entire site is in compliance with guidelines.
