## Occidental Permian Limited Partnership

RE: Remediation Plan  
South Hobbs Unit #213 2" Steel Injection Riser  
UL 'A', Sec. 5, T-19-S, R-38-E  
API 30-025-29752

**Release Notification and Corrective Action**

# SPILL MAP

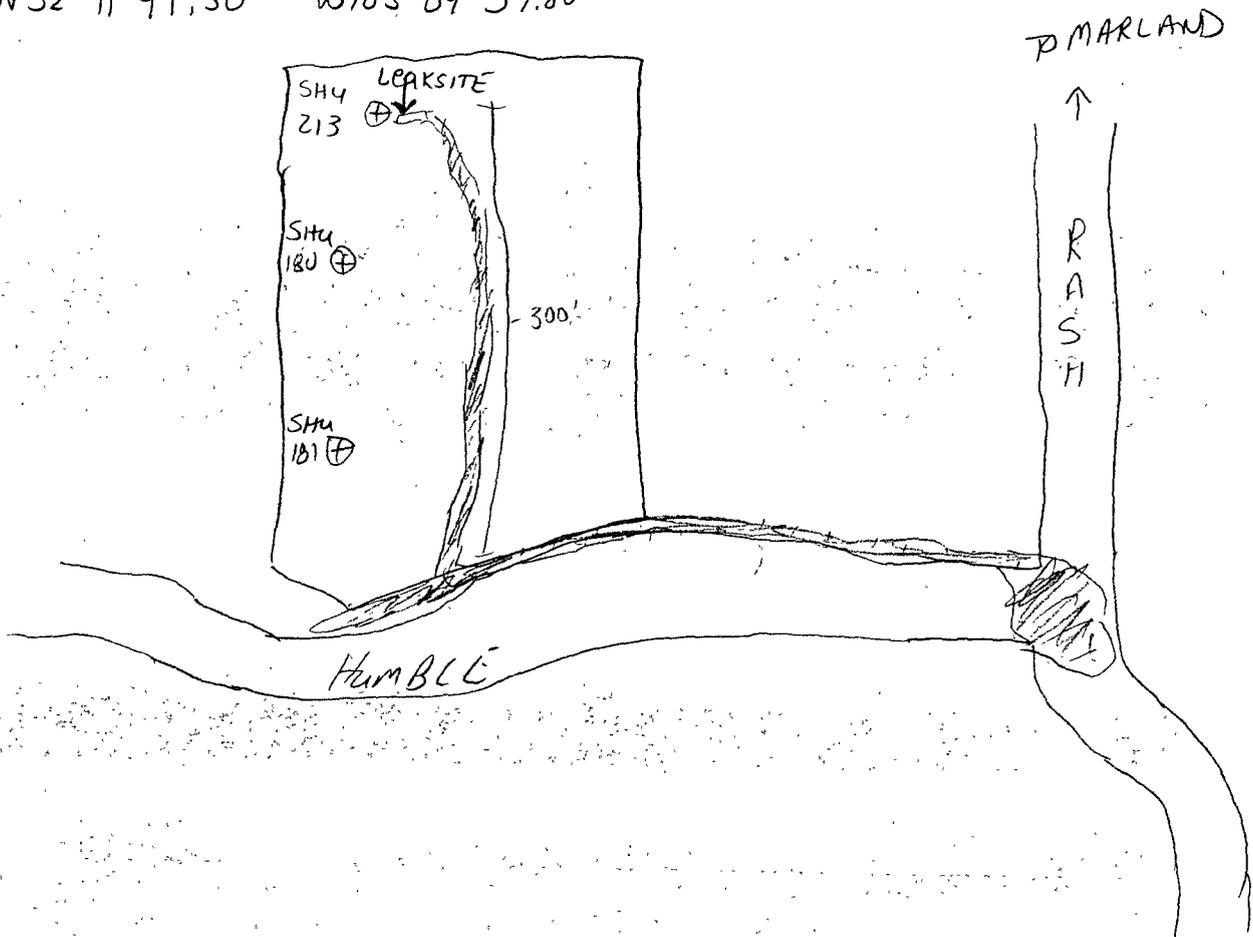
Describe Area Affected and Cleanup Action Taken.\*  
Spilled fluid ran approximately 300' to the south of South Hobbs Unit Well #213, into Humble Street, and to corner of Humble and Rash Streets where it pooled. Approximately 20 bbls was recovered from the intersection along with rain water standing due to recent rains. Area will be remediated to NMOCD spill guidelines.

9/12/07 12:00 PM 2" STEEL INJ. RISER

SHU #213 UL'A, Sec 5, T-19S, R-38-E

25 BW Spilled, 20 BW Recovered
