Date: March 14, 2008  
To: **Mr. Glenn Von Gonten**  
Company Name: New Mexico Oil Conservation Division  
Environmental Bureau  
Address: 1220 South St. Francis Drive  
City / State / Zip: Santa Fe, New Mexico 87505  
From: David P. Duncan  
CC: Billy A. Anderson, Chevron USA - Eunice, NM  
Targa Midstream, LLC - Eunice, NM  
Project #: OCD Case No. AP081  
NMOCD Ref. #NSL-5227-A: EPI Ref. #200074  
Project Name: Mark #13 Drill Pit  
Subject: **Initial NMOCD Form C-141**

RE: **Initial NMOCD Form C-141**

Reference: OCD Case No. AP081

Chevron USA – Mark #13 Drill Pit

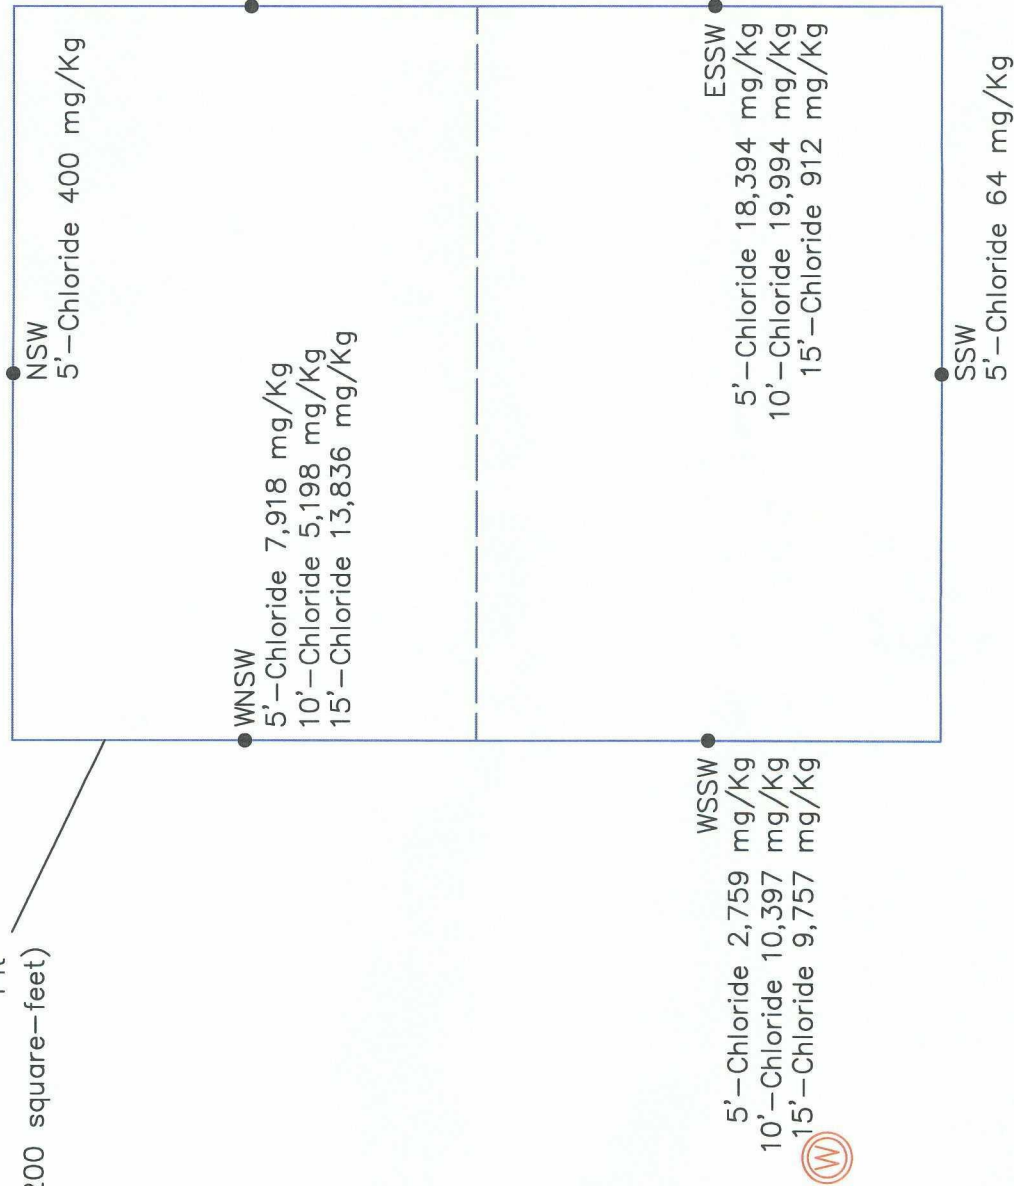
Figure 6

Sample Analytical Map - 4/5/2006  
Chevron Corporation  
Mark 13

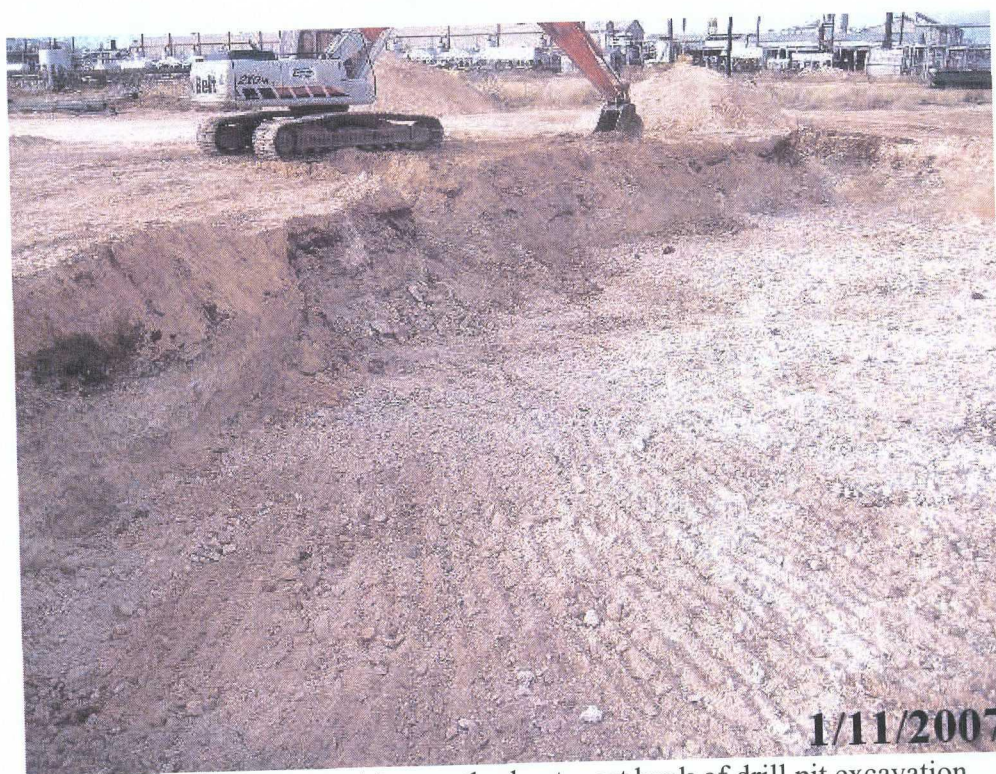
Photograph No. 2 – Looking northerly at west bank of drill pit excavation.

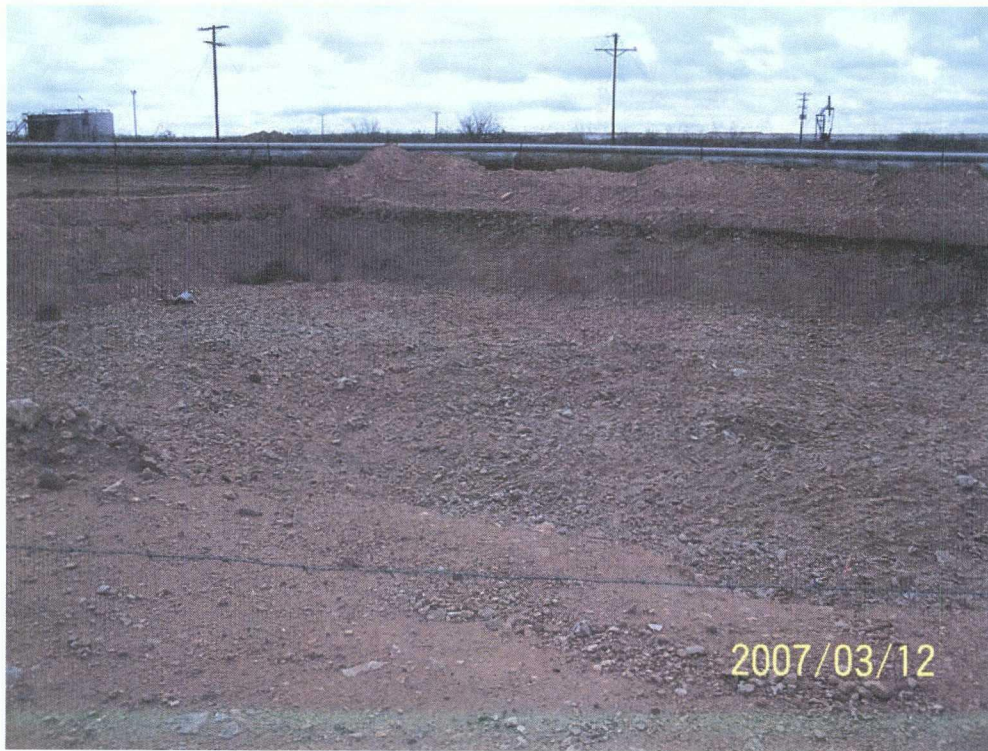
Photograph No. 3 – Looking at northeast corner of pit excavation.

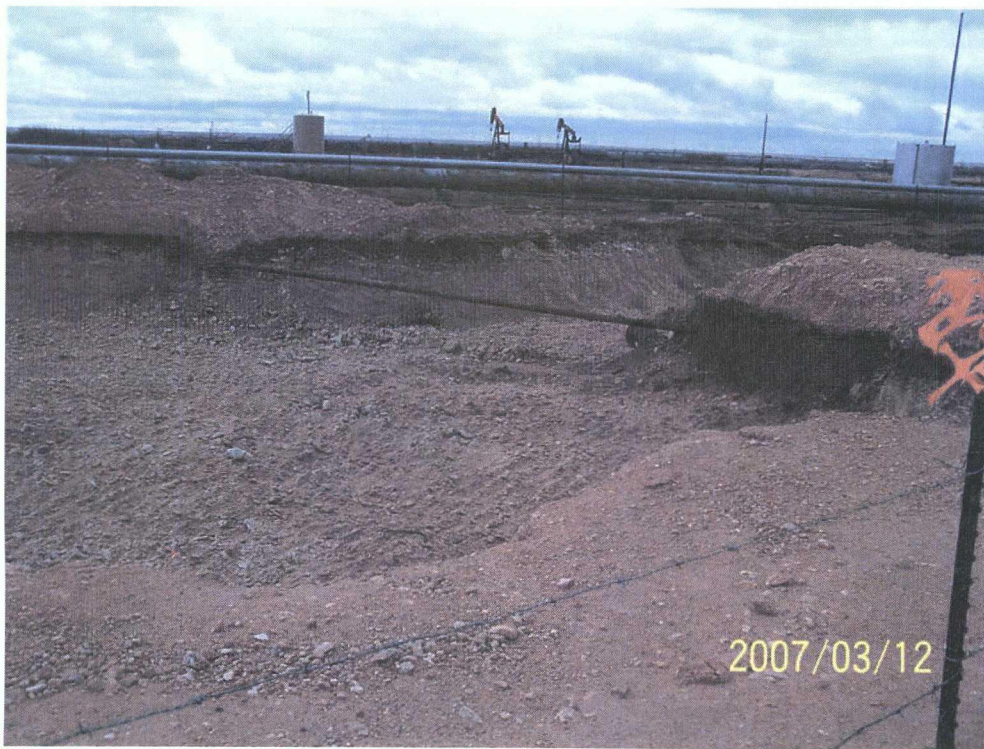
Photograph No. 4 – Looking at southeast corner of pit/northwest corner of overflow area.

| <b>Describe Cause of Problem and Remedial Action Taken.*</b> Possible leakage of fluids through the drill pit liner; inundation of overflow area after south-east corner of the drill pit failed | | |

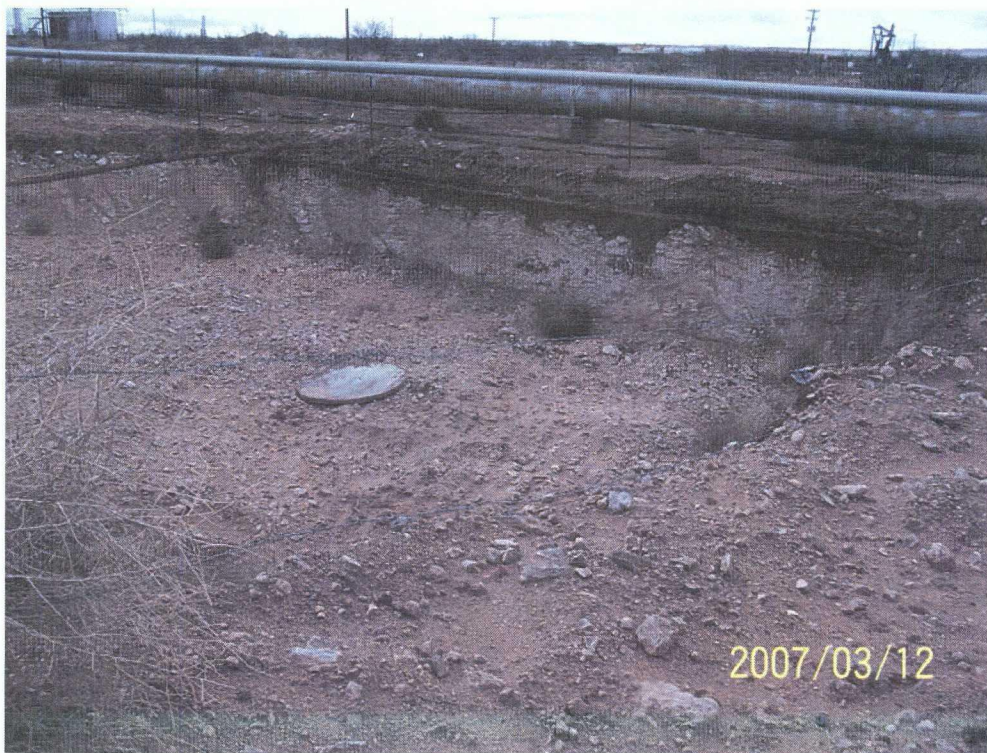
Photograph No. 5 – Looking northeasterly at overflow area excavation and buried pipeline.

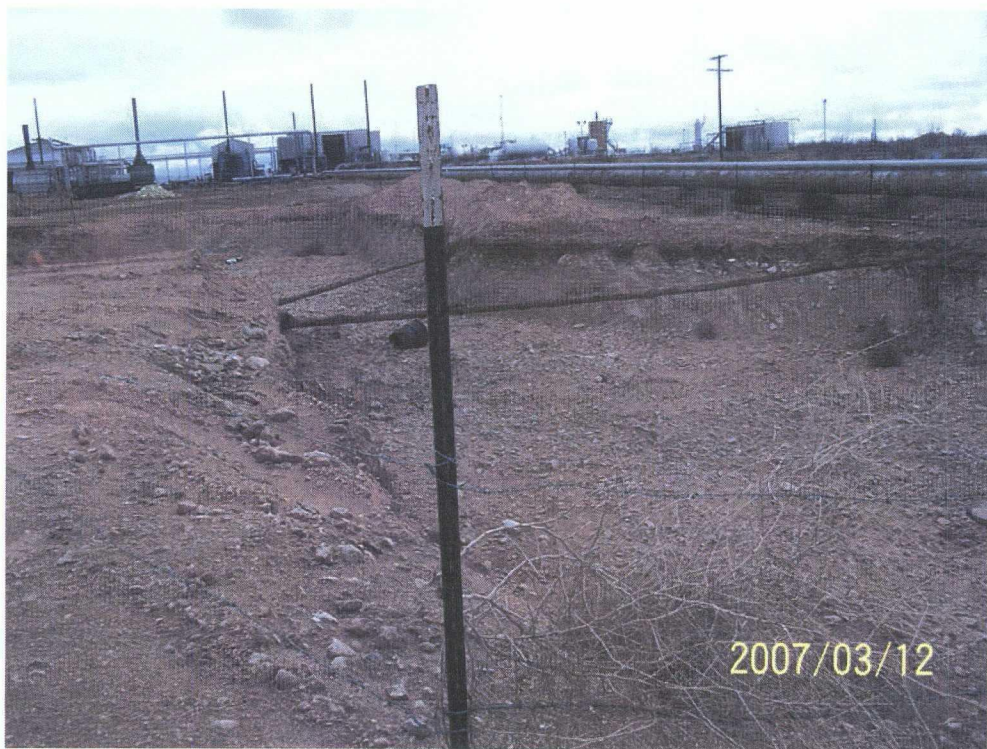
Photograph No. 6 – Looking northerly at junction of drill pit and overflow area.
