# **CLOSING REPORT**

## **Saltwater Spill Remediation**

### **Chalupa #004 SWD**

#### **Texas ReExploration Operating, LC**

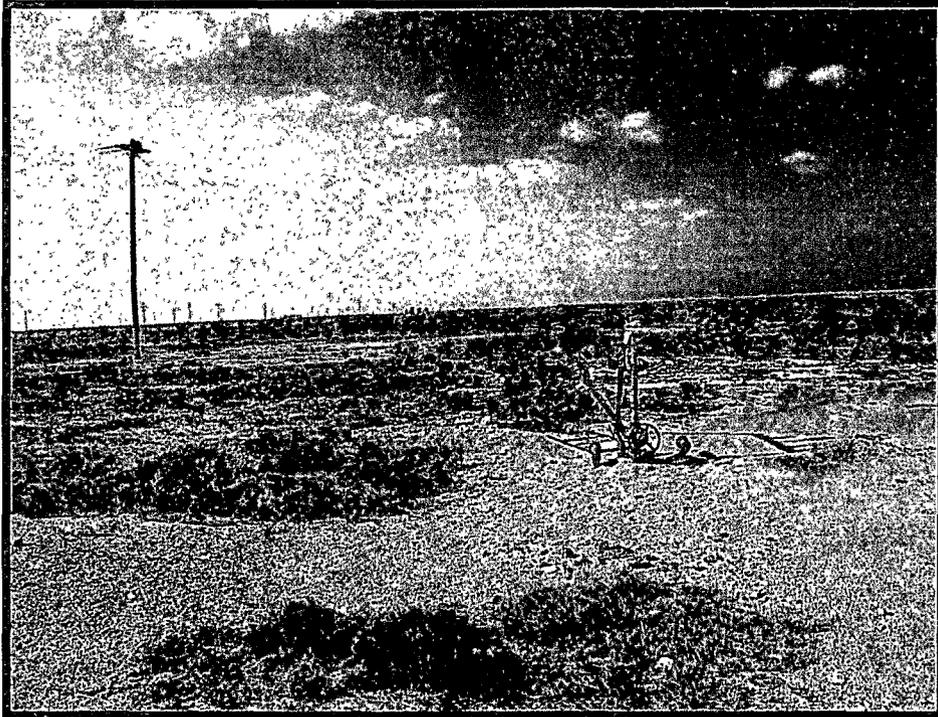
Chalupa #004 Injection Well – View north
