Release Notification and Corrective Action

Name of Company	McElvain Oil & Gas Properties, Inc.	Contact	E. Reed Fischer
Address	1050-17 th St, Ste. 1800 Denver, Colorado 80265	Telephone No.	(303) 893-0933
Facility Name	McElvain # 5	Facility Type	Tank Battery

SPCC PLAN
Facility Layout & Surface Drainage
Date of Inspection: 1-22-2008

Facility Description
McElvain Lease Well No.5
NMNM 0245247
SW SW, Sec. 25, T18S, R33E
Lea County, New Mexico

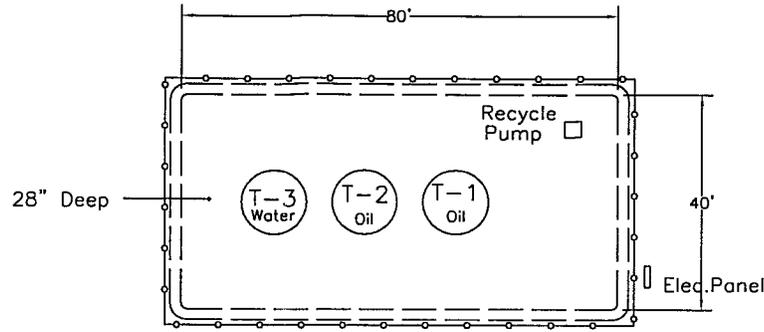
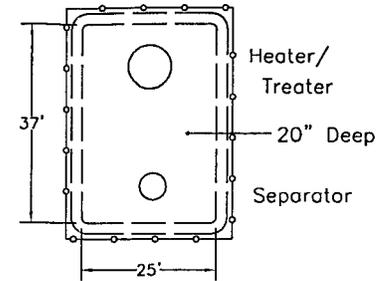
Note:
Meter is located off site at the
McElvain Fed. #4 location

Note:
T-4, 5 & 6 are 55 Gal Drums.
T4 has 38"x62"x9" plastic
secondary containment.
T5 & T6 are not being used.

Note:
To meet SPCC Plan requirements the following
repairs or changes need to be made:
-Tanks T5 & T6 need to be removed from
the site.
