**STAGE 1  
WORKPLAN**

# Highlander Environmental Corp.

**Stage 1 Abatement Plan  
OXY, USA, Inc.  
State L-2 Tank Battery  
Section 2, T10S, R33E  
Lea County, New Mexico  
NMOCD AP089**

July 9, 2008

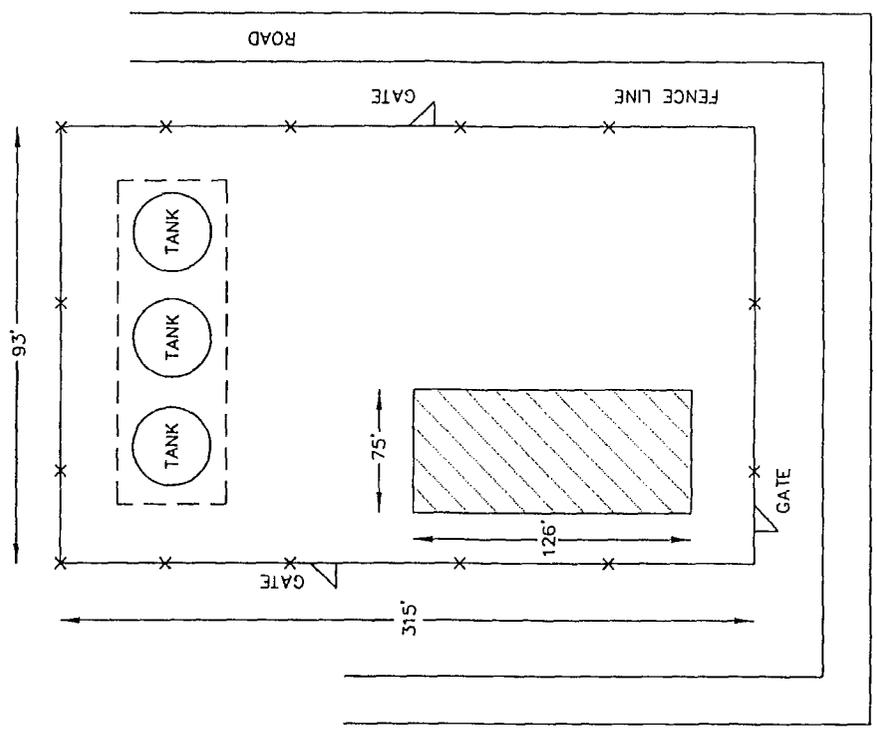
FIGURE NO. 3

LLC had performed an investigation and excavation at this facility. An area measuring 75' x 126' was excavated to a depth of 5' bgs and a clay cap was installed and the excavation backfilled. The site location is shown on Figures 1 and 2.

EXCAVATED & CAPPED AREA
